FIELD EXAMINATION OF CSRBA WATER RIGHT CLAIM

Claim Identification Number: 95-9676

Exam Report Completed By: Linda Werner on 9/27/2019 J.W.

Date of Exam: September 4, 2019

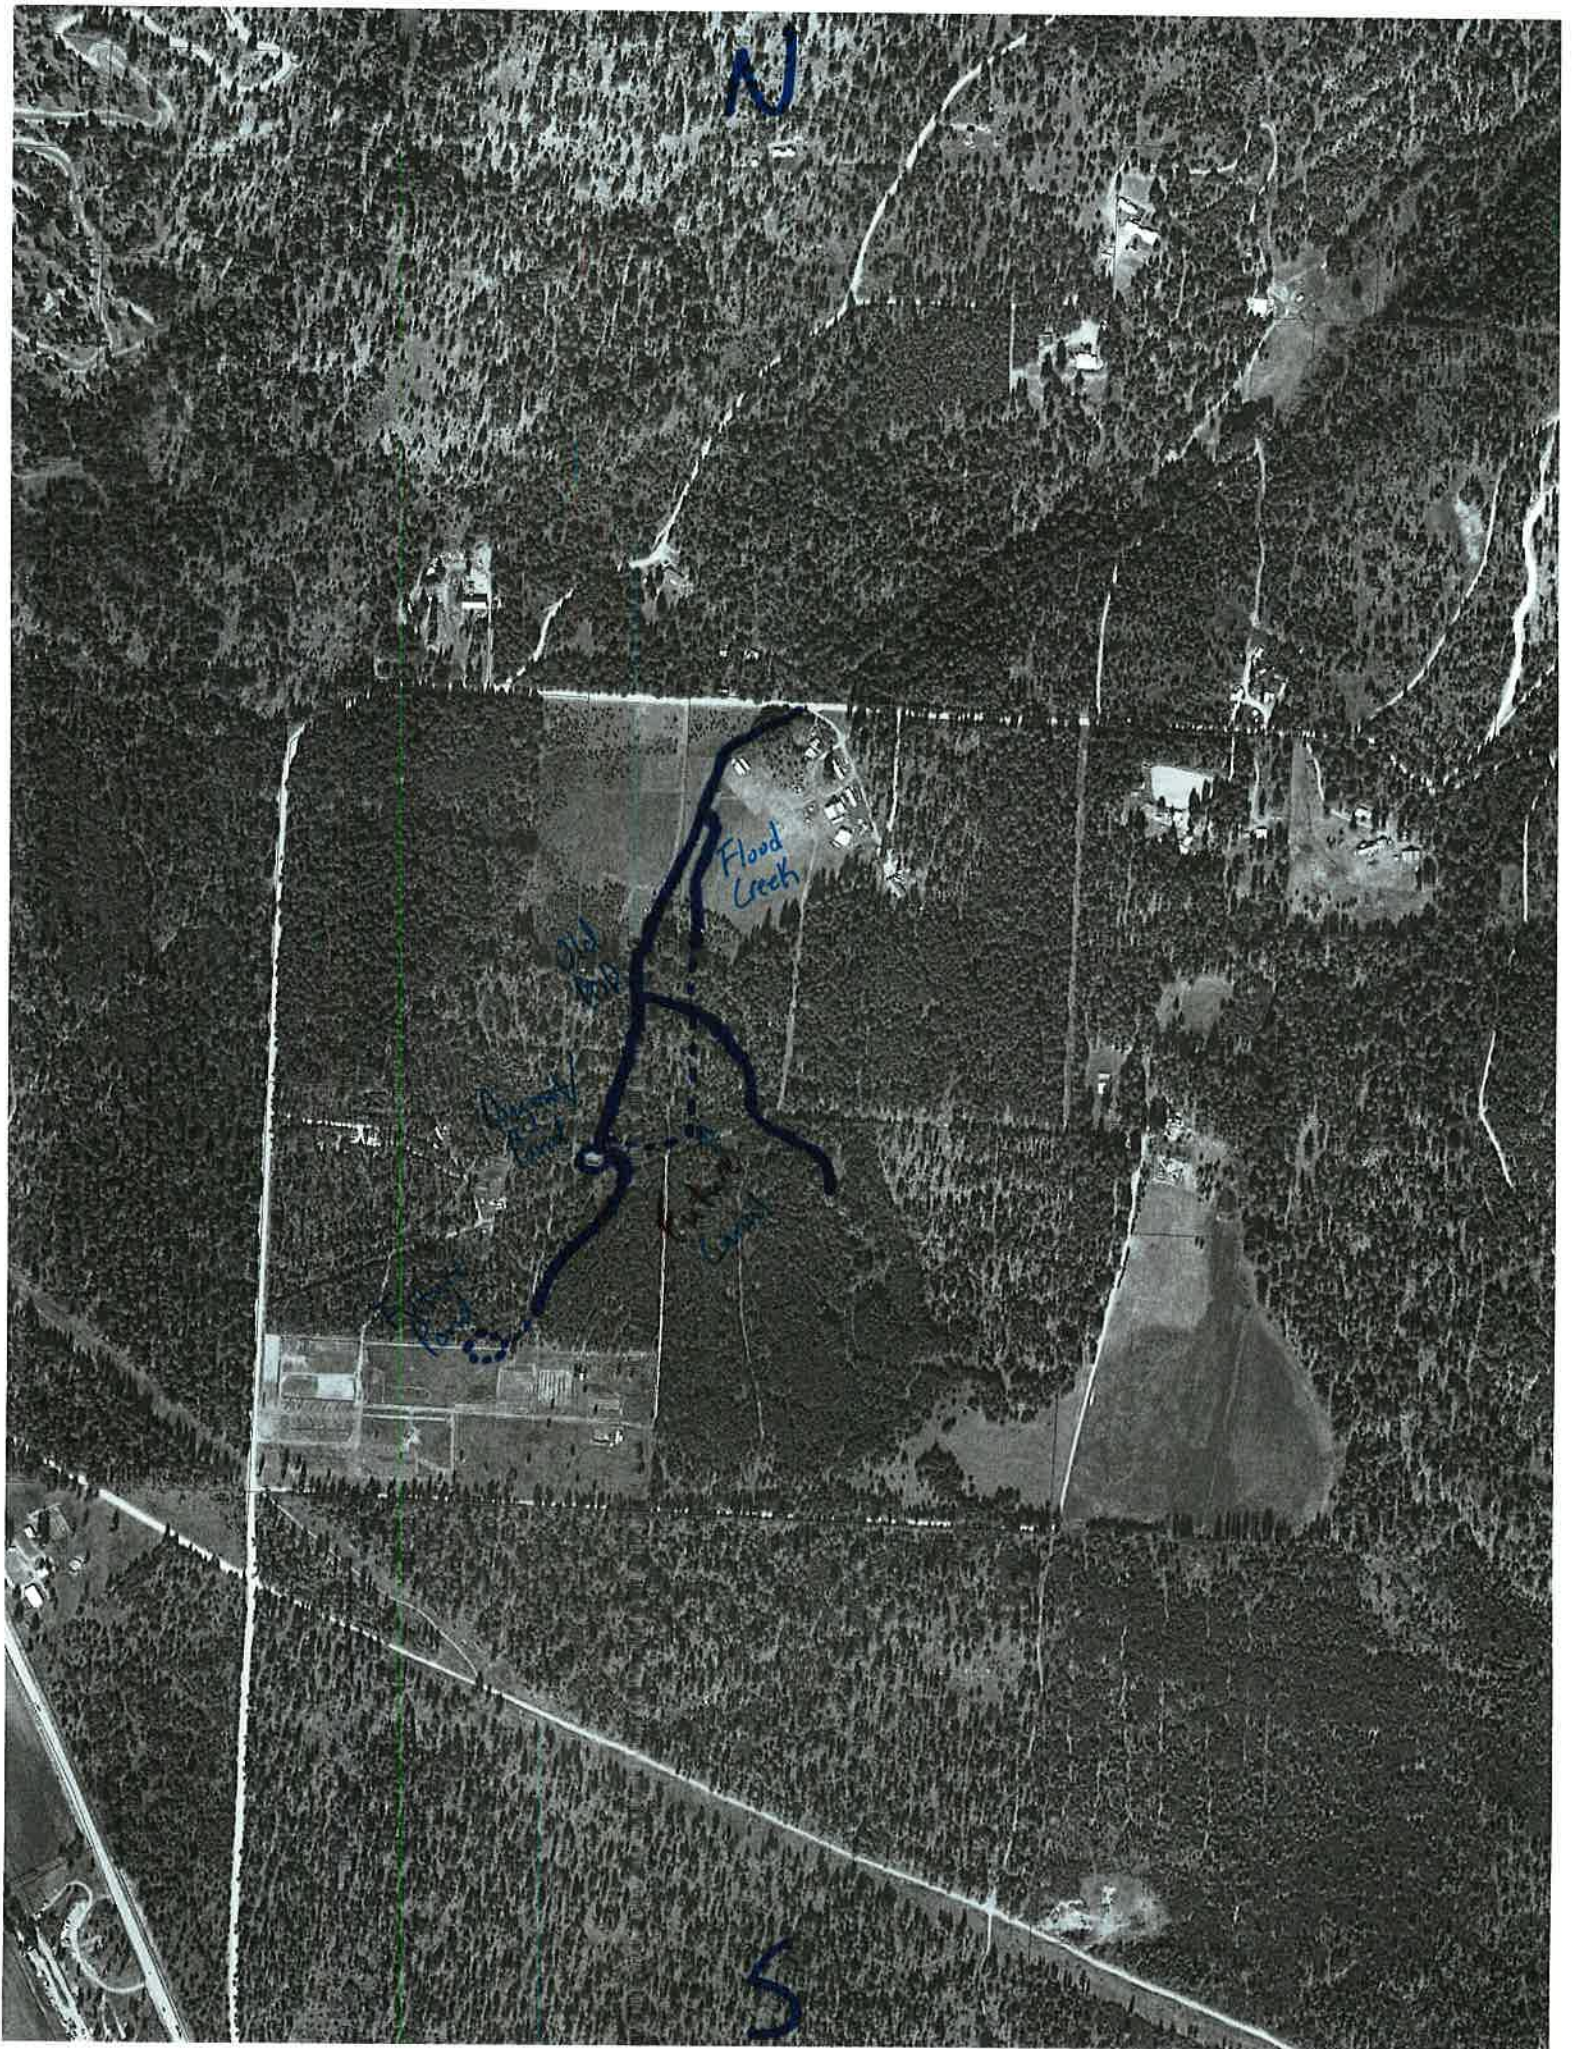
95-9676 Field Exam

Found: Water is diverted from an unnamed stream at a point of diversion in the NE1/4SW1/4, Section 8, T54N, R5W. This is the "flood ditch" diversion which is used to divert flood water from the creek to prevent it from flowing easterly over their access road. At this point water can also be diverted east or west to irrigate land around the vicinity of homes in the NESW and NWSW-8-T54N-R5W. The flood water runs southerly through a dirt ditch flowing to the channel's end where it becomes diffused and empties into the NESW, Section 8. Plans are to divert the water back into a channel and take it to a pond, of which construction began in April, 2008. The pond is located in the SWSW-8. Water from this pond is to be diverted and used to irrigate 600 larch trees, also located in the SWSW-8-T54N-R5W. The pond dimensions are approximately 50.4' long x 36' wide x 8' deep, or 0.33 acre-feet. Claimant intends to construct a second pond adjacent to the north side of the field in the SWSW-8.

There was no water in the stream so it was hard to tell where the stream actually ends but it appears that may be in the NWSW-8-T54N-R5W, as this is where claimant states the old point of diversion used to be. At this point there is a dirt ditch/channel where water could flow southerly to the pond. It is also noted that the application for permit, completed by N.L. Presnell, and approved on May 6, 1911, states that the creek has always sunk into the ground on the N1/2 of SW1/4 of Section 8, T54N, R5W.

It is recommended that the diversion recommendation include only the NESW, Section 8, T54N, R5W, as this is one of the claimed points of diversion and based on exam information, photos and claimant statements, the point in the SWSW of Section 8, was developed after 2006. Claimant may choose to file for a transfer in the point of diversion.
