Ott Water Engineers  
150259 Jim Ford Creek Hydro  
General

May 23, 1989

SUBJECT: Jim Ford Creek Hydroelectric Project

RE: JIM FORD CREEK HYDROELECTRIC PROJECT  
GEOTECHNICAL EVALUATION AND RECOMMENDATIONS  
WEIPPE, IDAHO

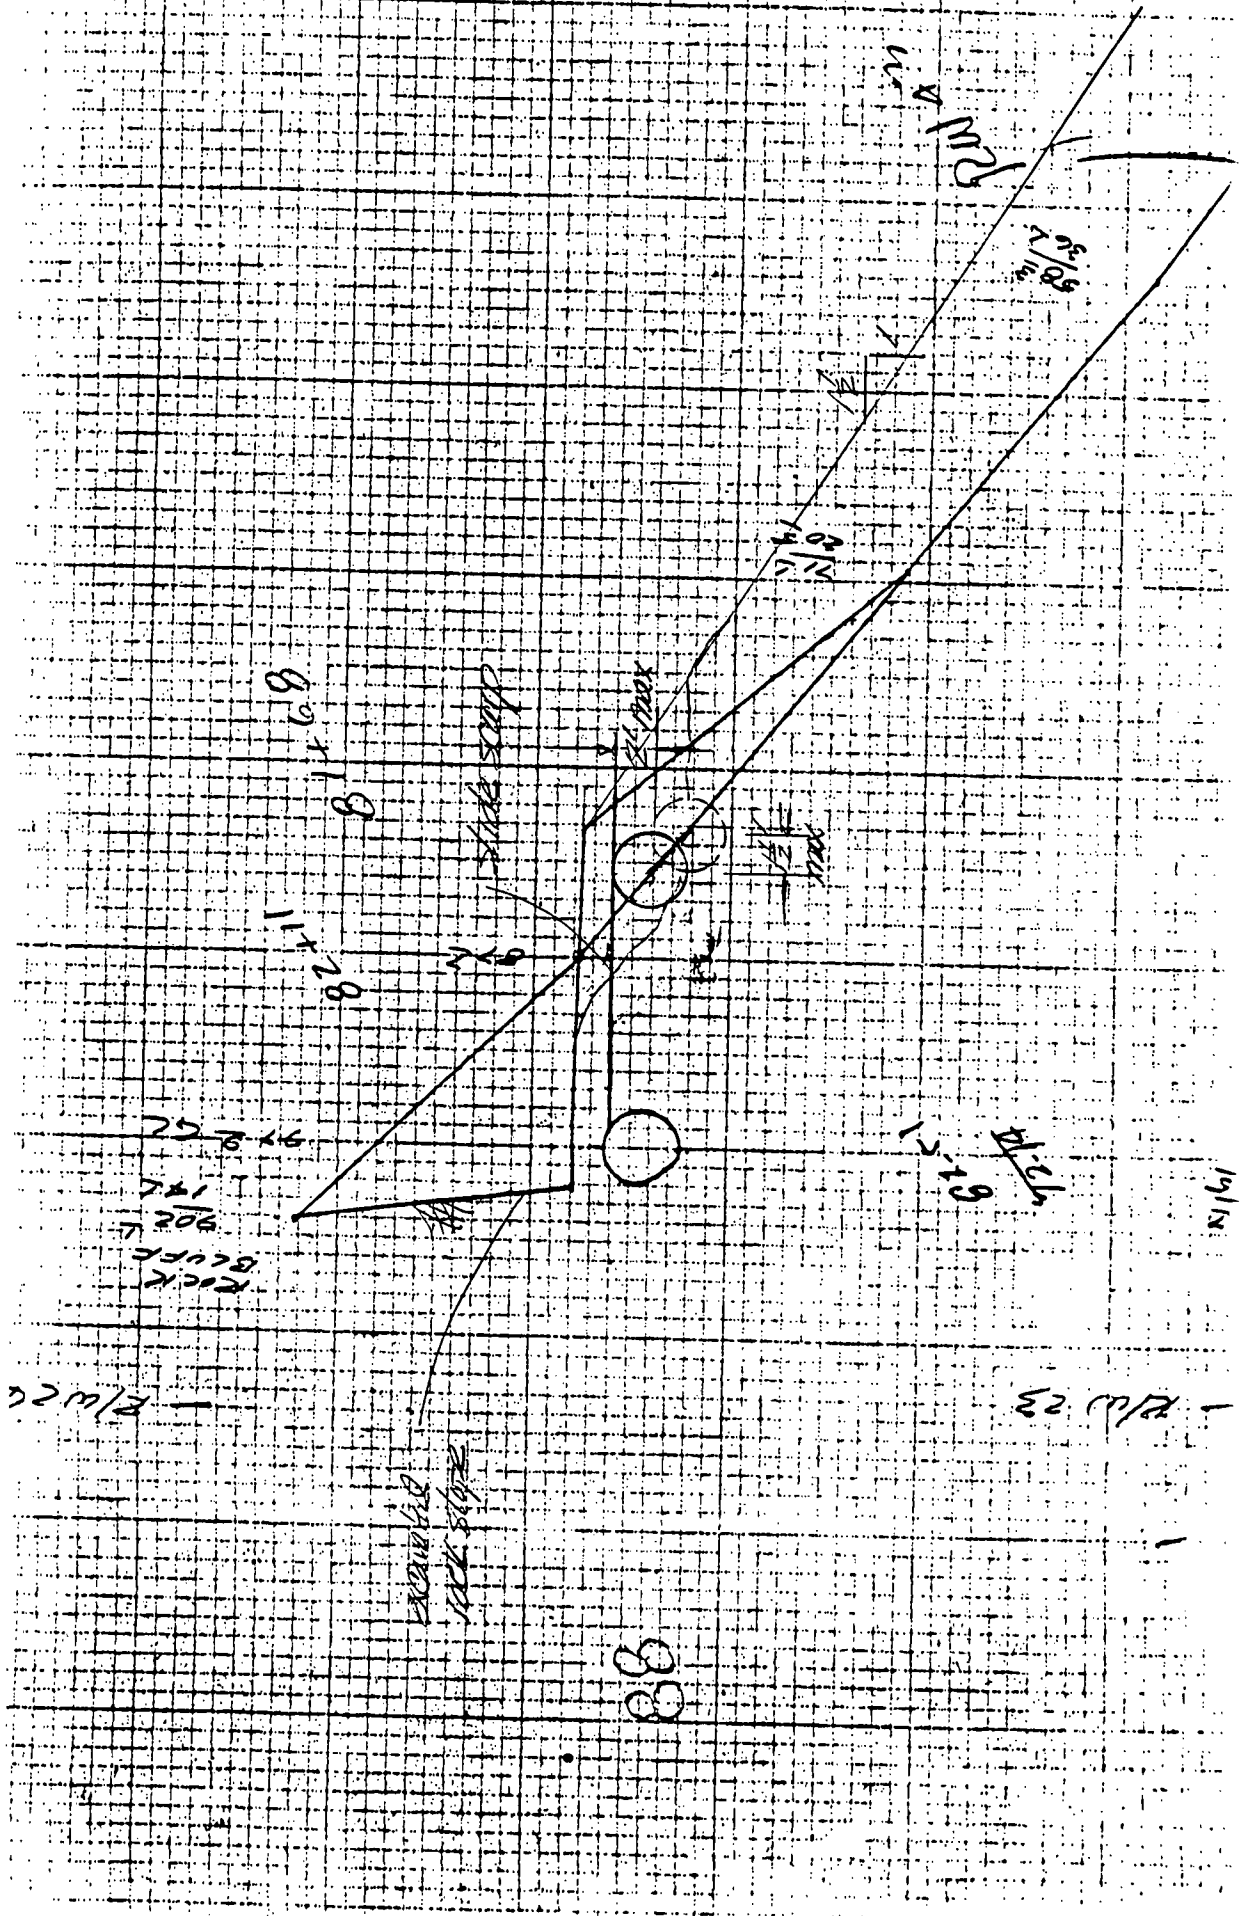
*Cross Section Through Slide of March, 1989*

the conclusion is that saturation of fill caused settlement which caused CMP to crack, adding more water and accelerating movement

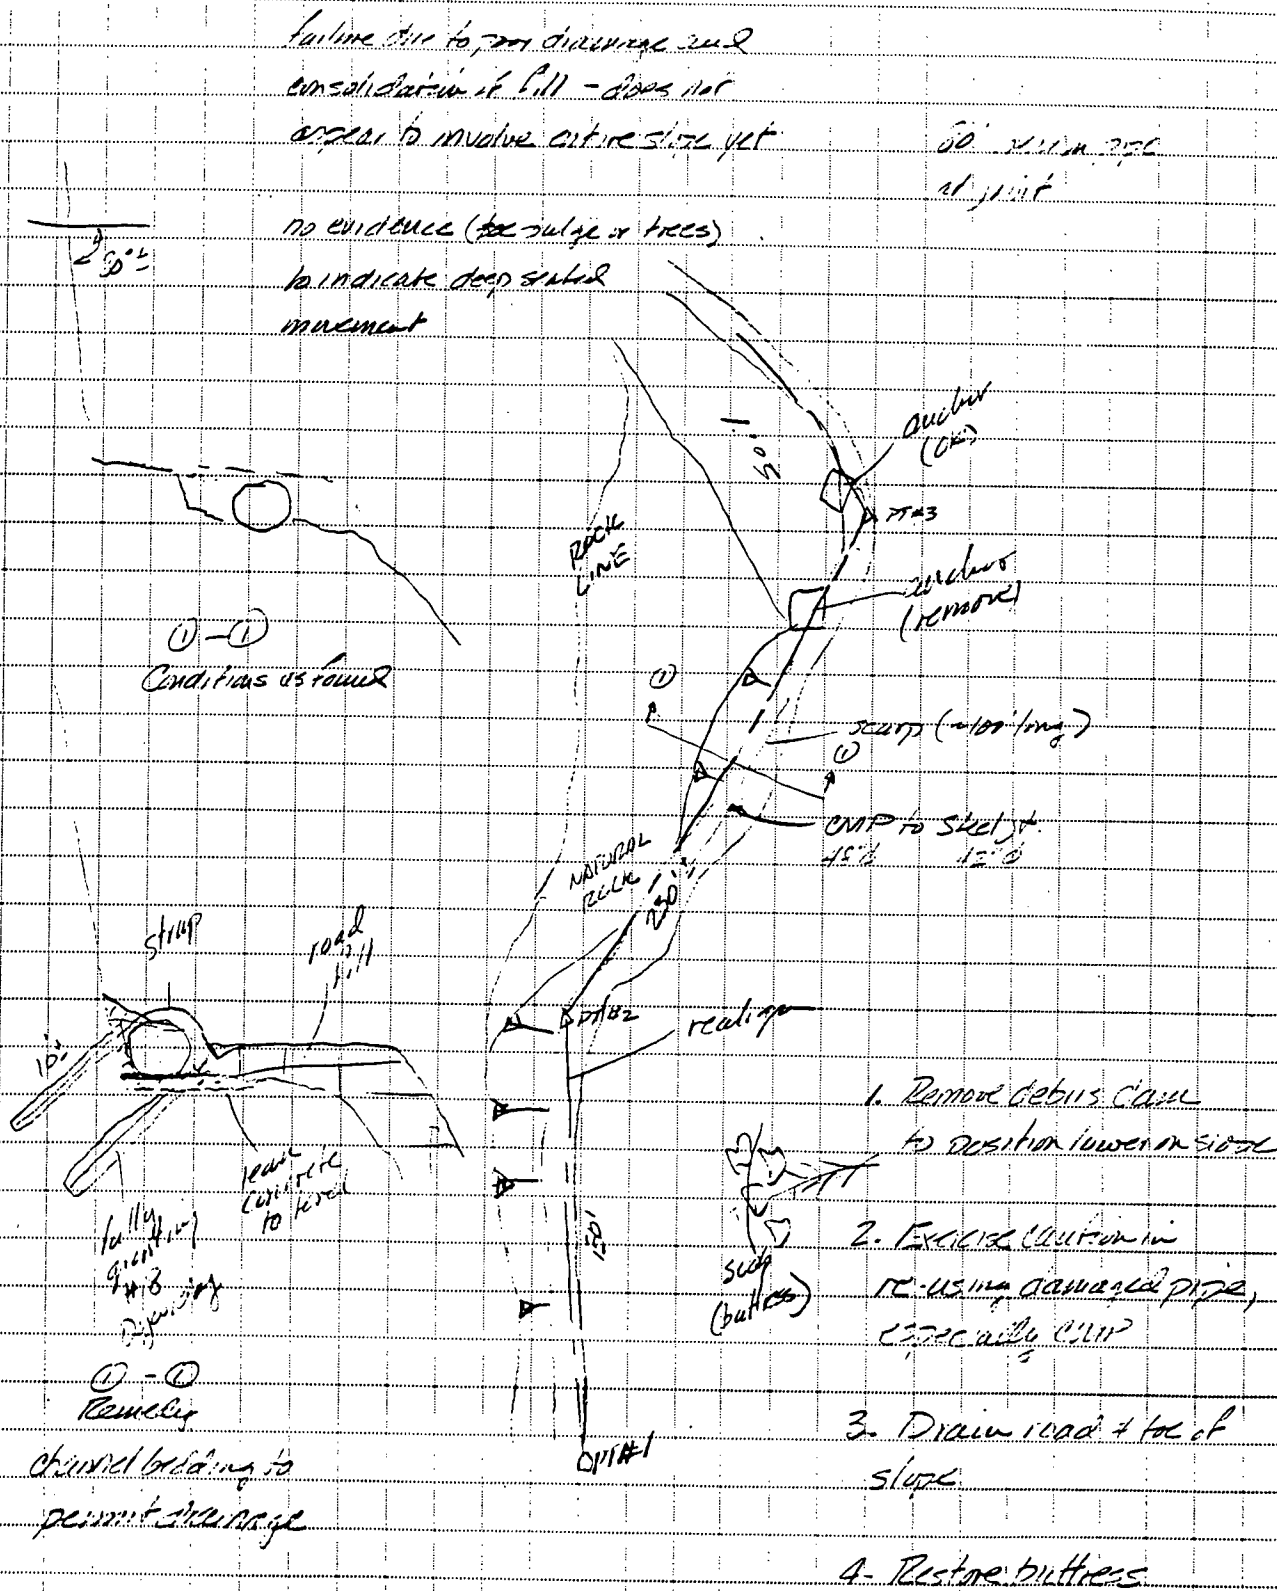
Problems: 1. moving equipment over perstreak with wet material 2. pipe sample 3. blasting & control line

consider relieving slide of ash material (trees show movement) back to scarp

scarp (crack) is exposed about 100' long

remove anchor block  
excavation, common, maybe some rock  
install anchors  
place bedding, drained  
realign pipe, anchor  
regrade road  
drain penstock  
buttress toe  
replace silt trap  
drain road and slope

pipe  
anchors, say 15' OC 2 reqd say 40 ea #8 Dipsidag x 10'  
bedding, lean concrete would be best if rough  
free draining backfill  
random fill

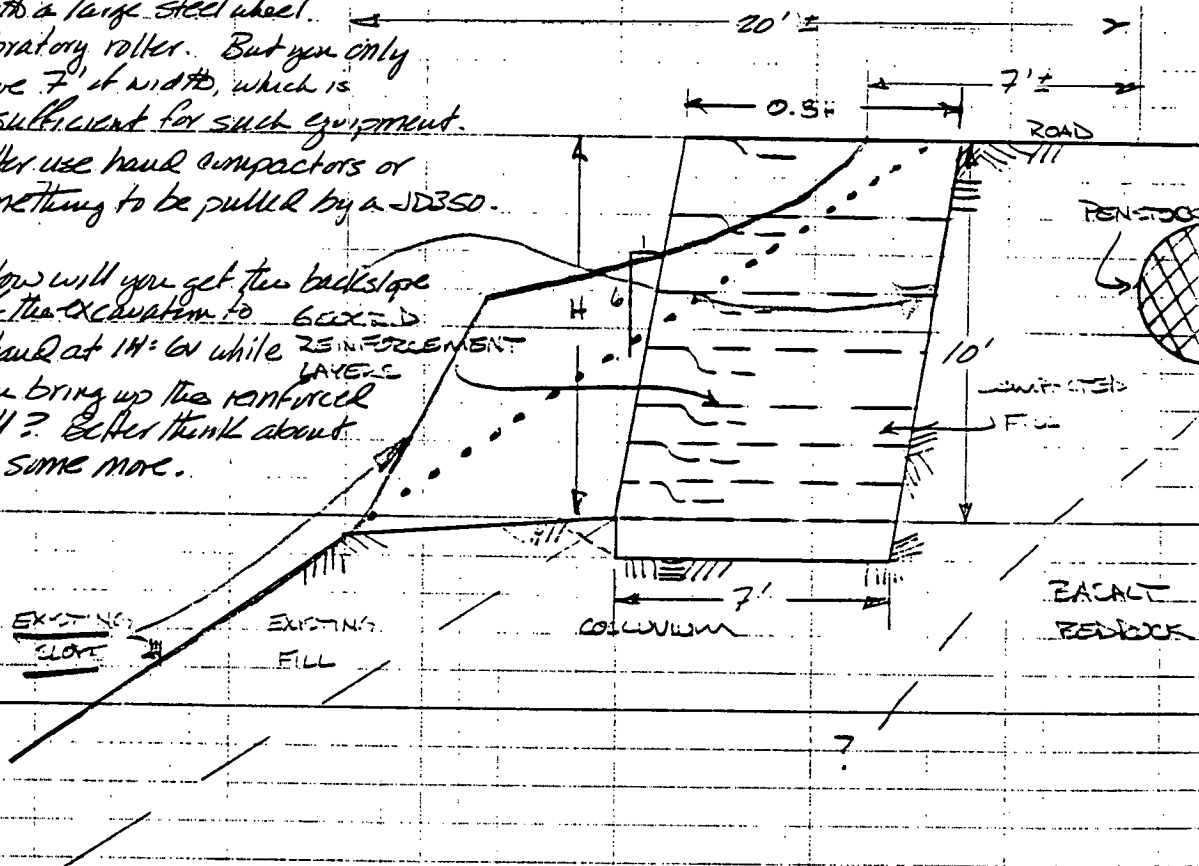
FIGURE 3.

② How will you get the backslope of the excavation to 60:40 stand at 14:60 while you bring up the reinforced fill? Better think about this some more.

For the proposed reinforced fill, we recommend using the reinforcement system illustrated in Figure 3. This section is based on a maximum fill height of 10 feet and a maximum surcharge load of 250 psf.
