## Field Investigation – Narrative

# **Eckhardt Enforcement Case #E2017-1235 (potential unauthorized pond issue)**

Enforcement Case No: E2017-1235

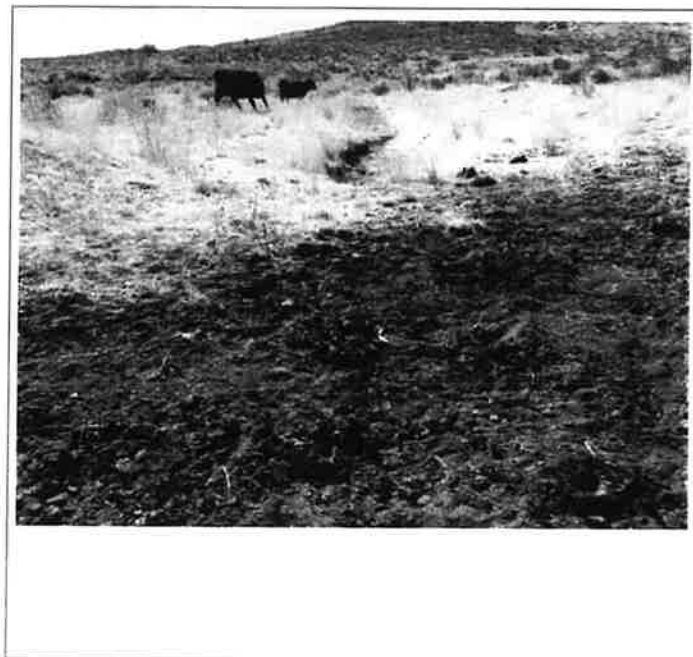
**Picture15**

Site Identification/Details:  
Pond #2

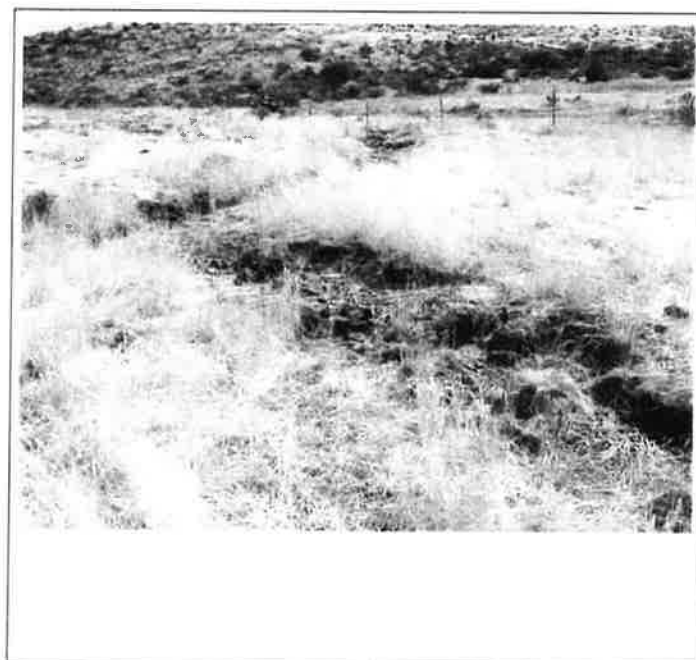
**Picture16**

Site Identification/Details:  
Pond #2, downstream.

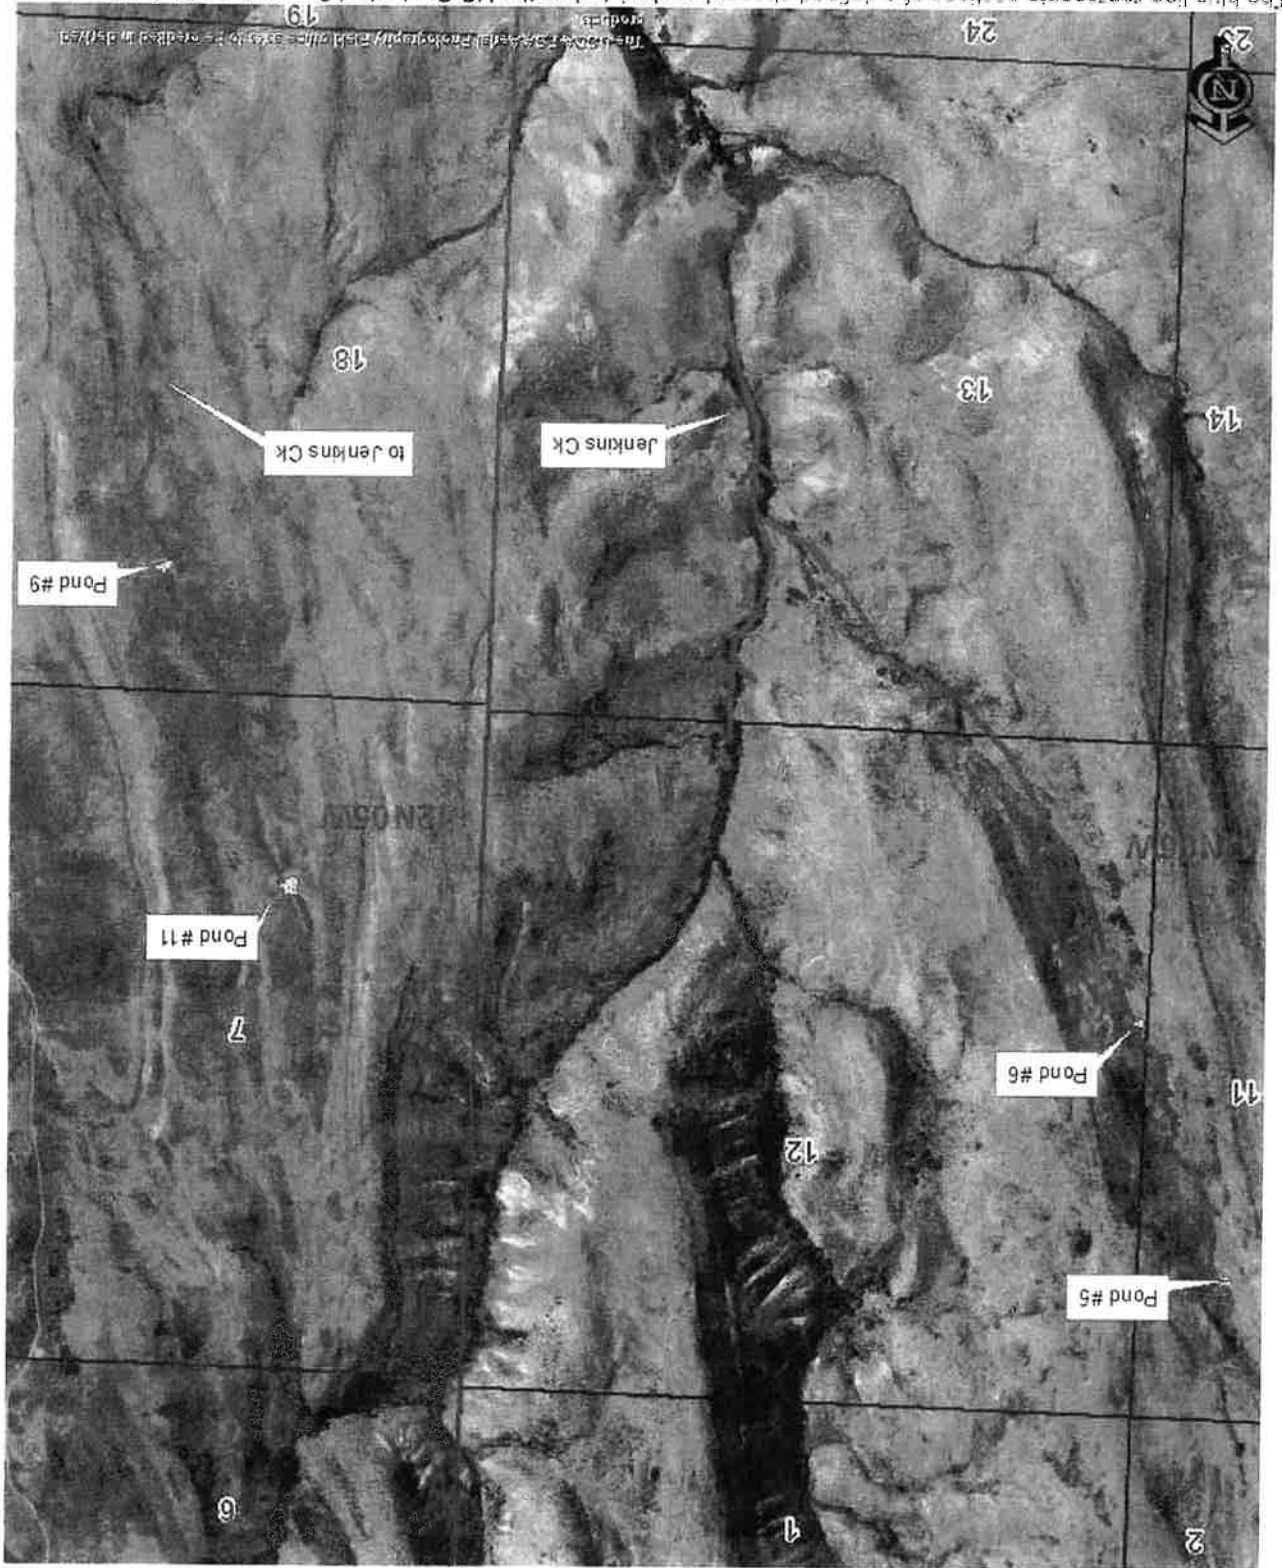
Eckhardt ponds on Jenkins Ck drainage

The blue line represents sections of a defined channel as depicted on the US Geological Survey topo Digital Raster Graphics (DRG) map. Historic DRG map shows water discharging in the depicted channel into Jenkins Ck.

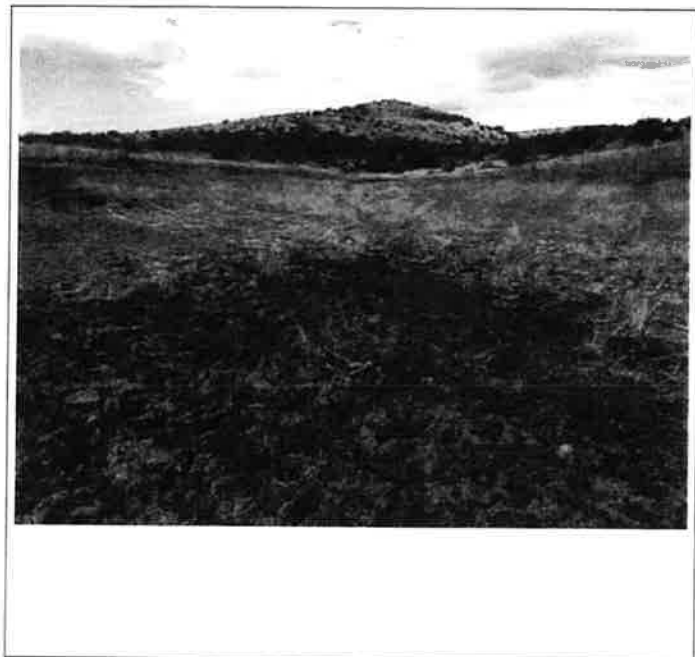
**Picture 5**

Site Identification/Details:  
Pond #12

GPS Location or other Location Information:  
Looking north from the pond

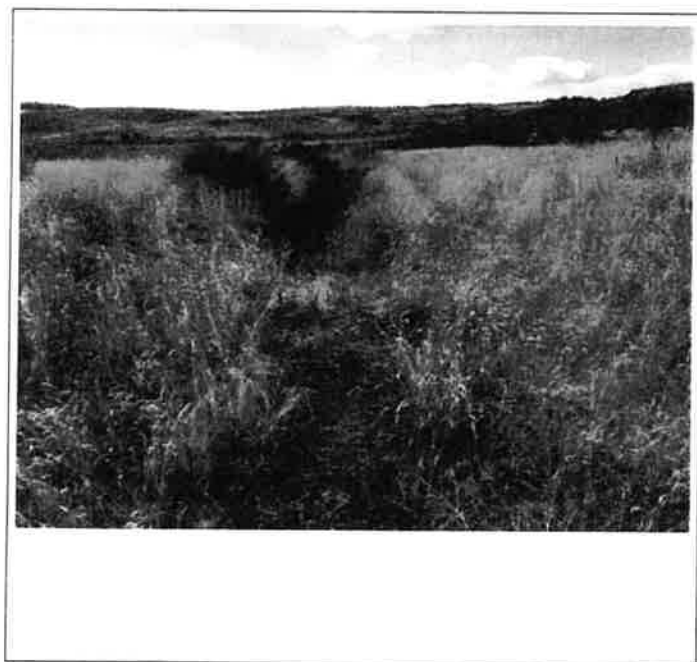
**Picture 6**

Site Identification/Details:  
Pond #12

GPS Location or other Location Information:  
Looking upstream of the pond-to the north
