**Date:** December 31, 2013  
**To:** Water Right File 95-9502  
**From:** shemenway  
**Re:** Field Exam Narrative and Licensing Review

Subject: Sanitary Survey of PWS #1280030 conducted on June 16, 2009

**Panhandle Health District  
Drinking Water Supply Report**

**System:** Camp Mivoden

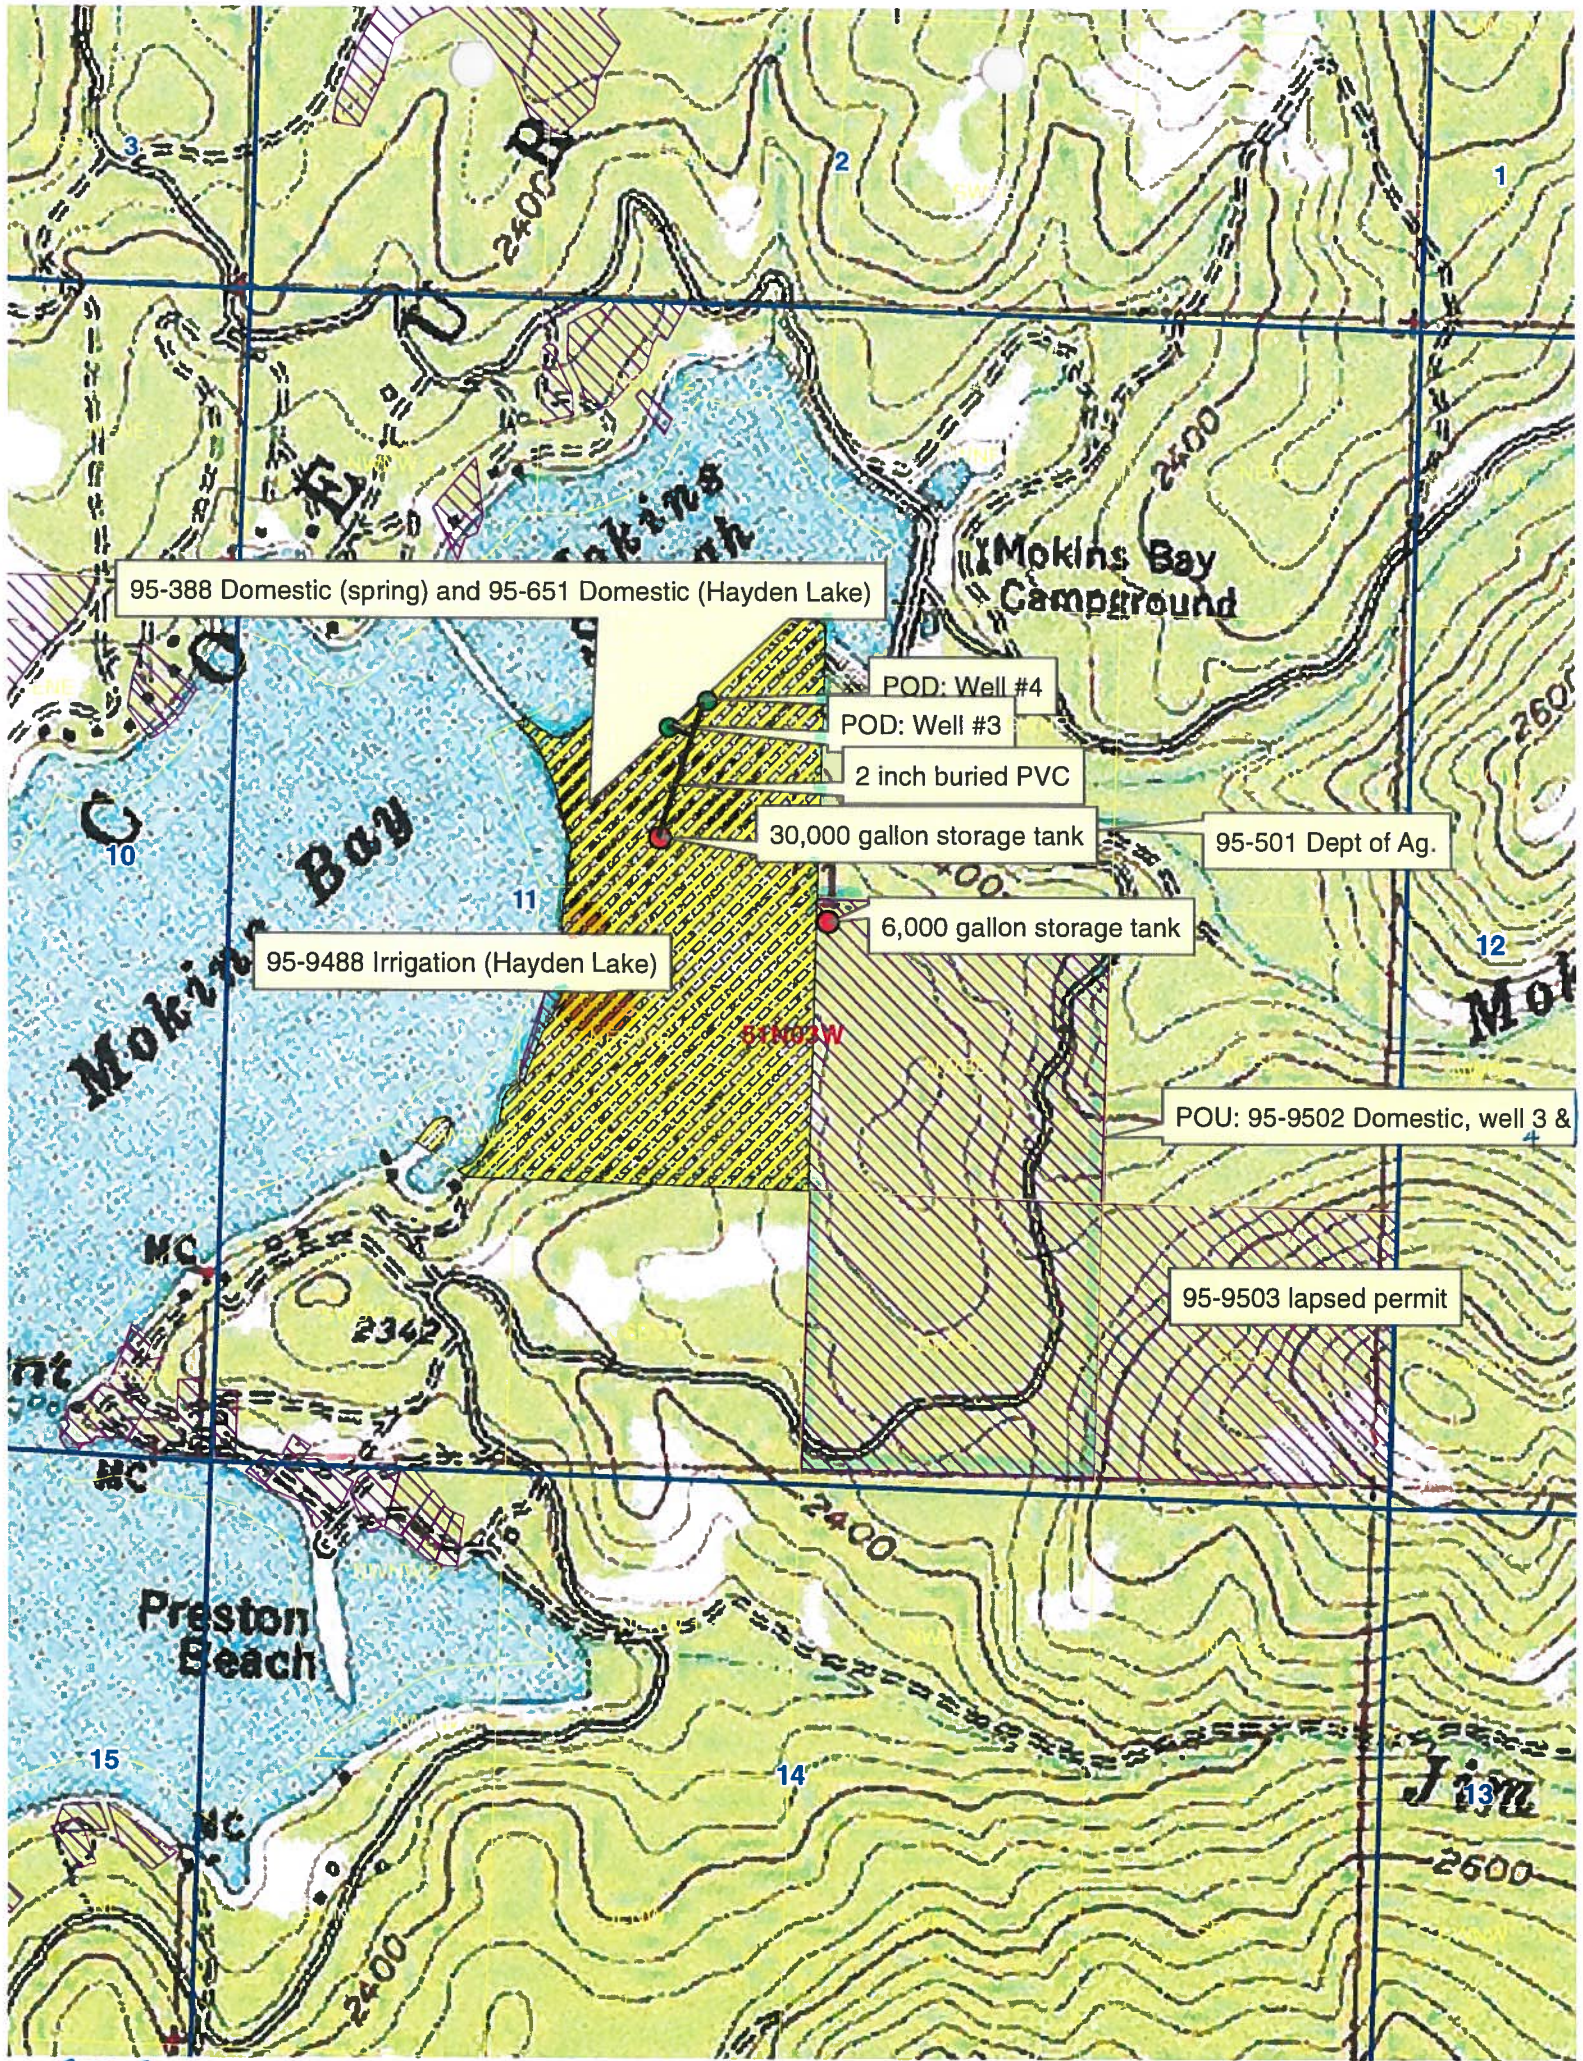
95-388 Domestic (spring) and 95-651 Domestic (Hayden Lake)

POD: Well #4

POD: Well #3

2 inch buried PVC

30,000 gallon storage tank

95-501 Dept of Ag.

6,000 gallon storage tank
