Exam Date: 10/3/2012

State of Idaho  
Department of Water Resources  
**Field Exam Map**  
57-7385

**System Diagram**  
Permit 57-7385

**IDAHO DEPARTMENT OF WATER RESOURCES  
--- DAM SAFETY RECORD OF INSPECTION ---**

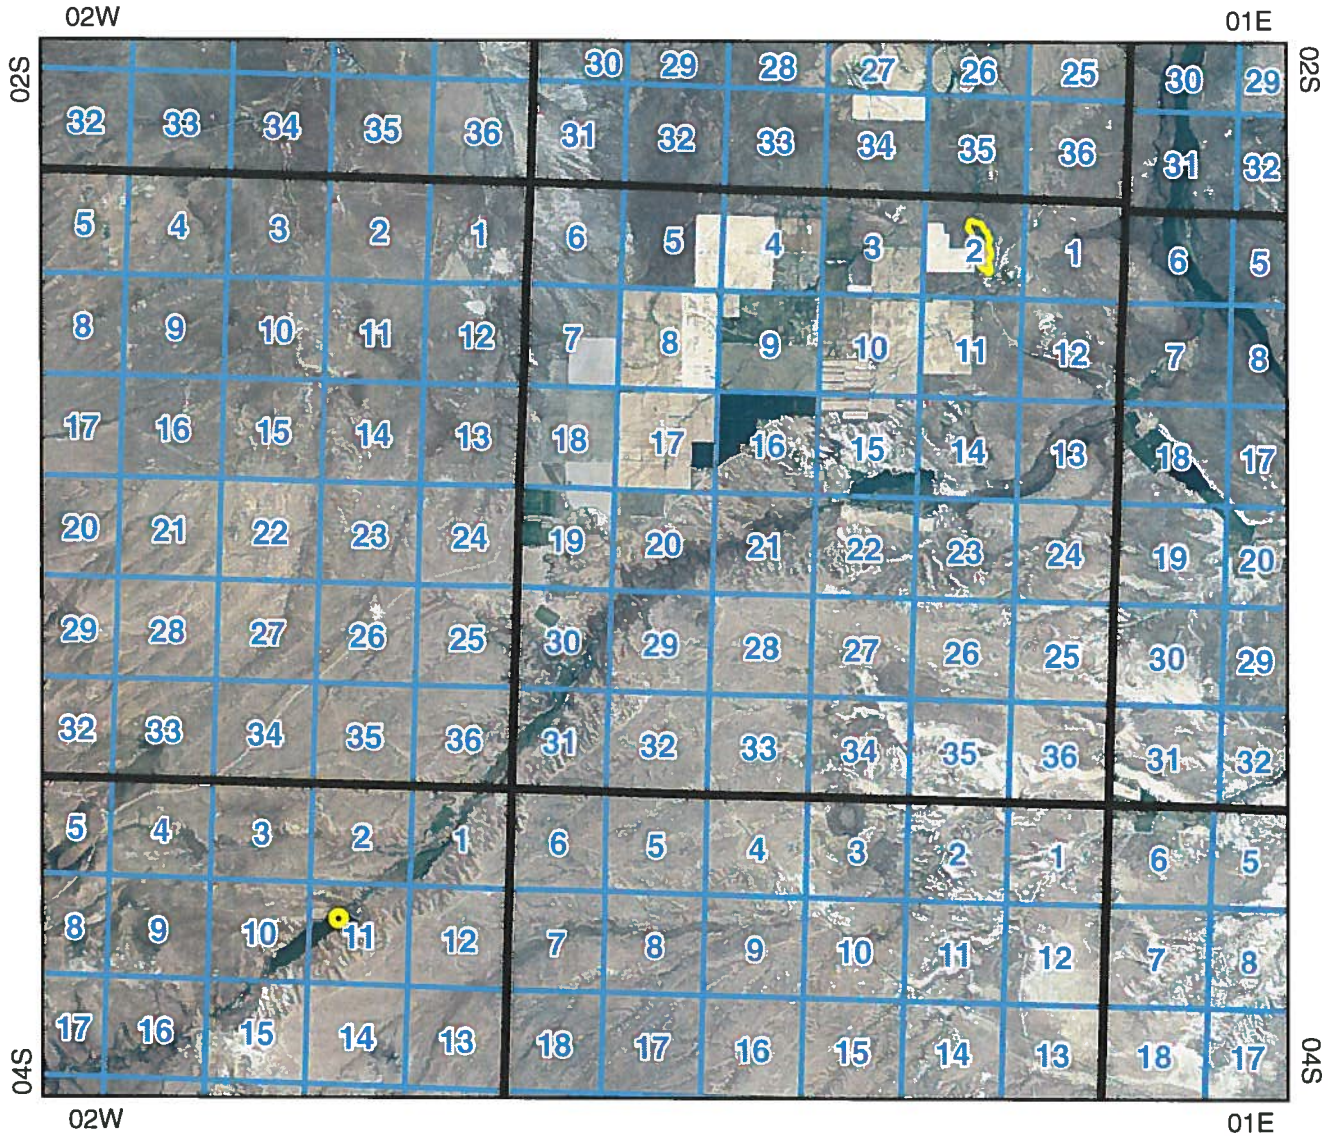
This map depicts the IRRIGATION STORAGE place of use boundary for this water right at the time of this approval and is attached to the approval document solely for illustrative purposes.

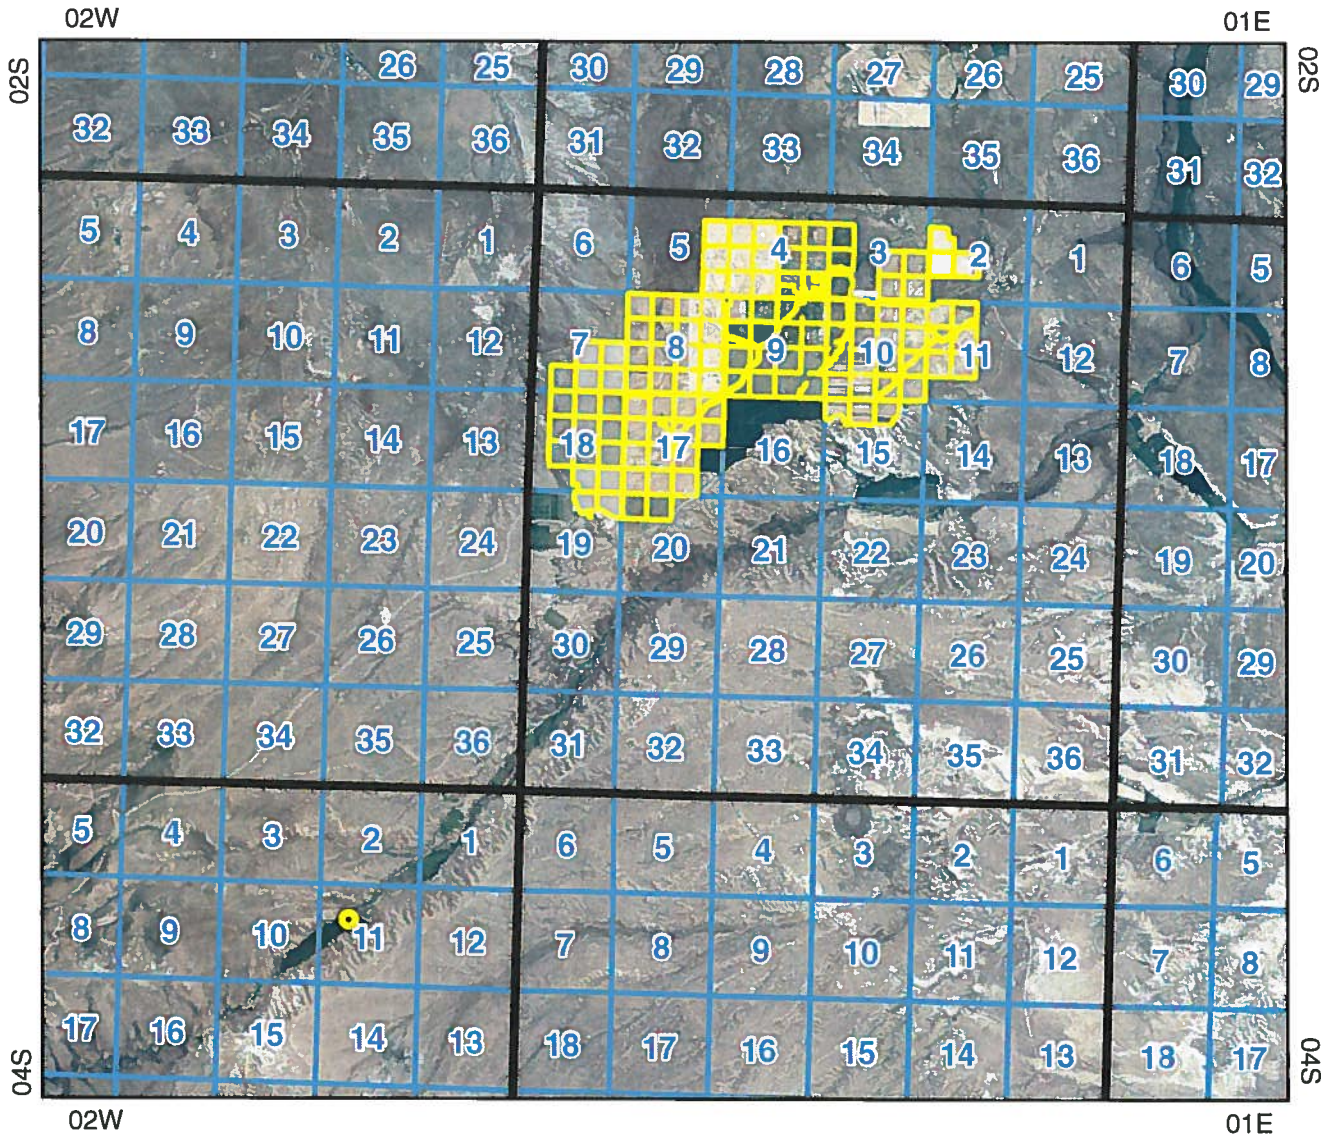
State of Idaho  
Department of Water Resources  
**Field Exam Map**  
57-7385

This map depicts the IRRIGATION FROM STORAGE place of use boundary for this water right at the time of this approval and is attached to the approval document solely for illustrative purposes.

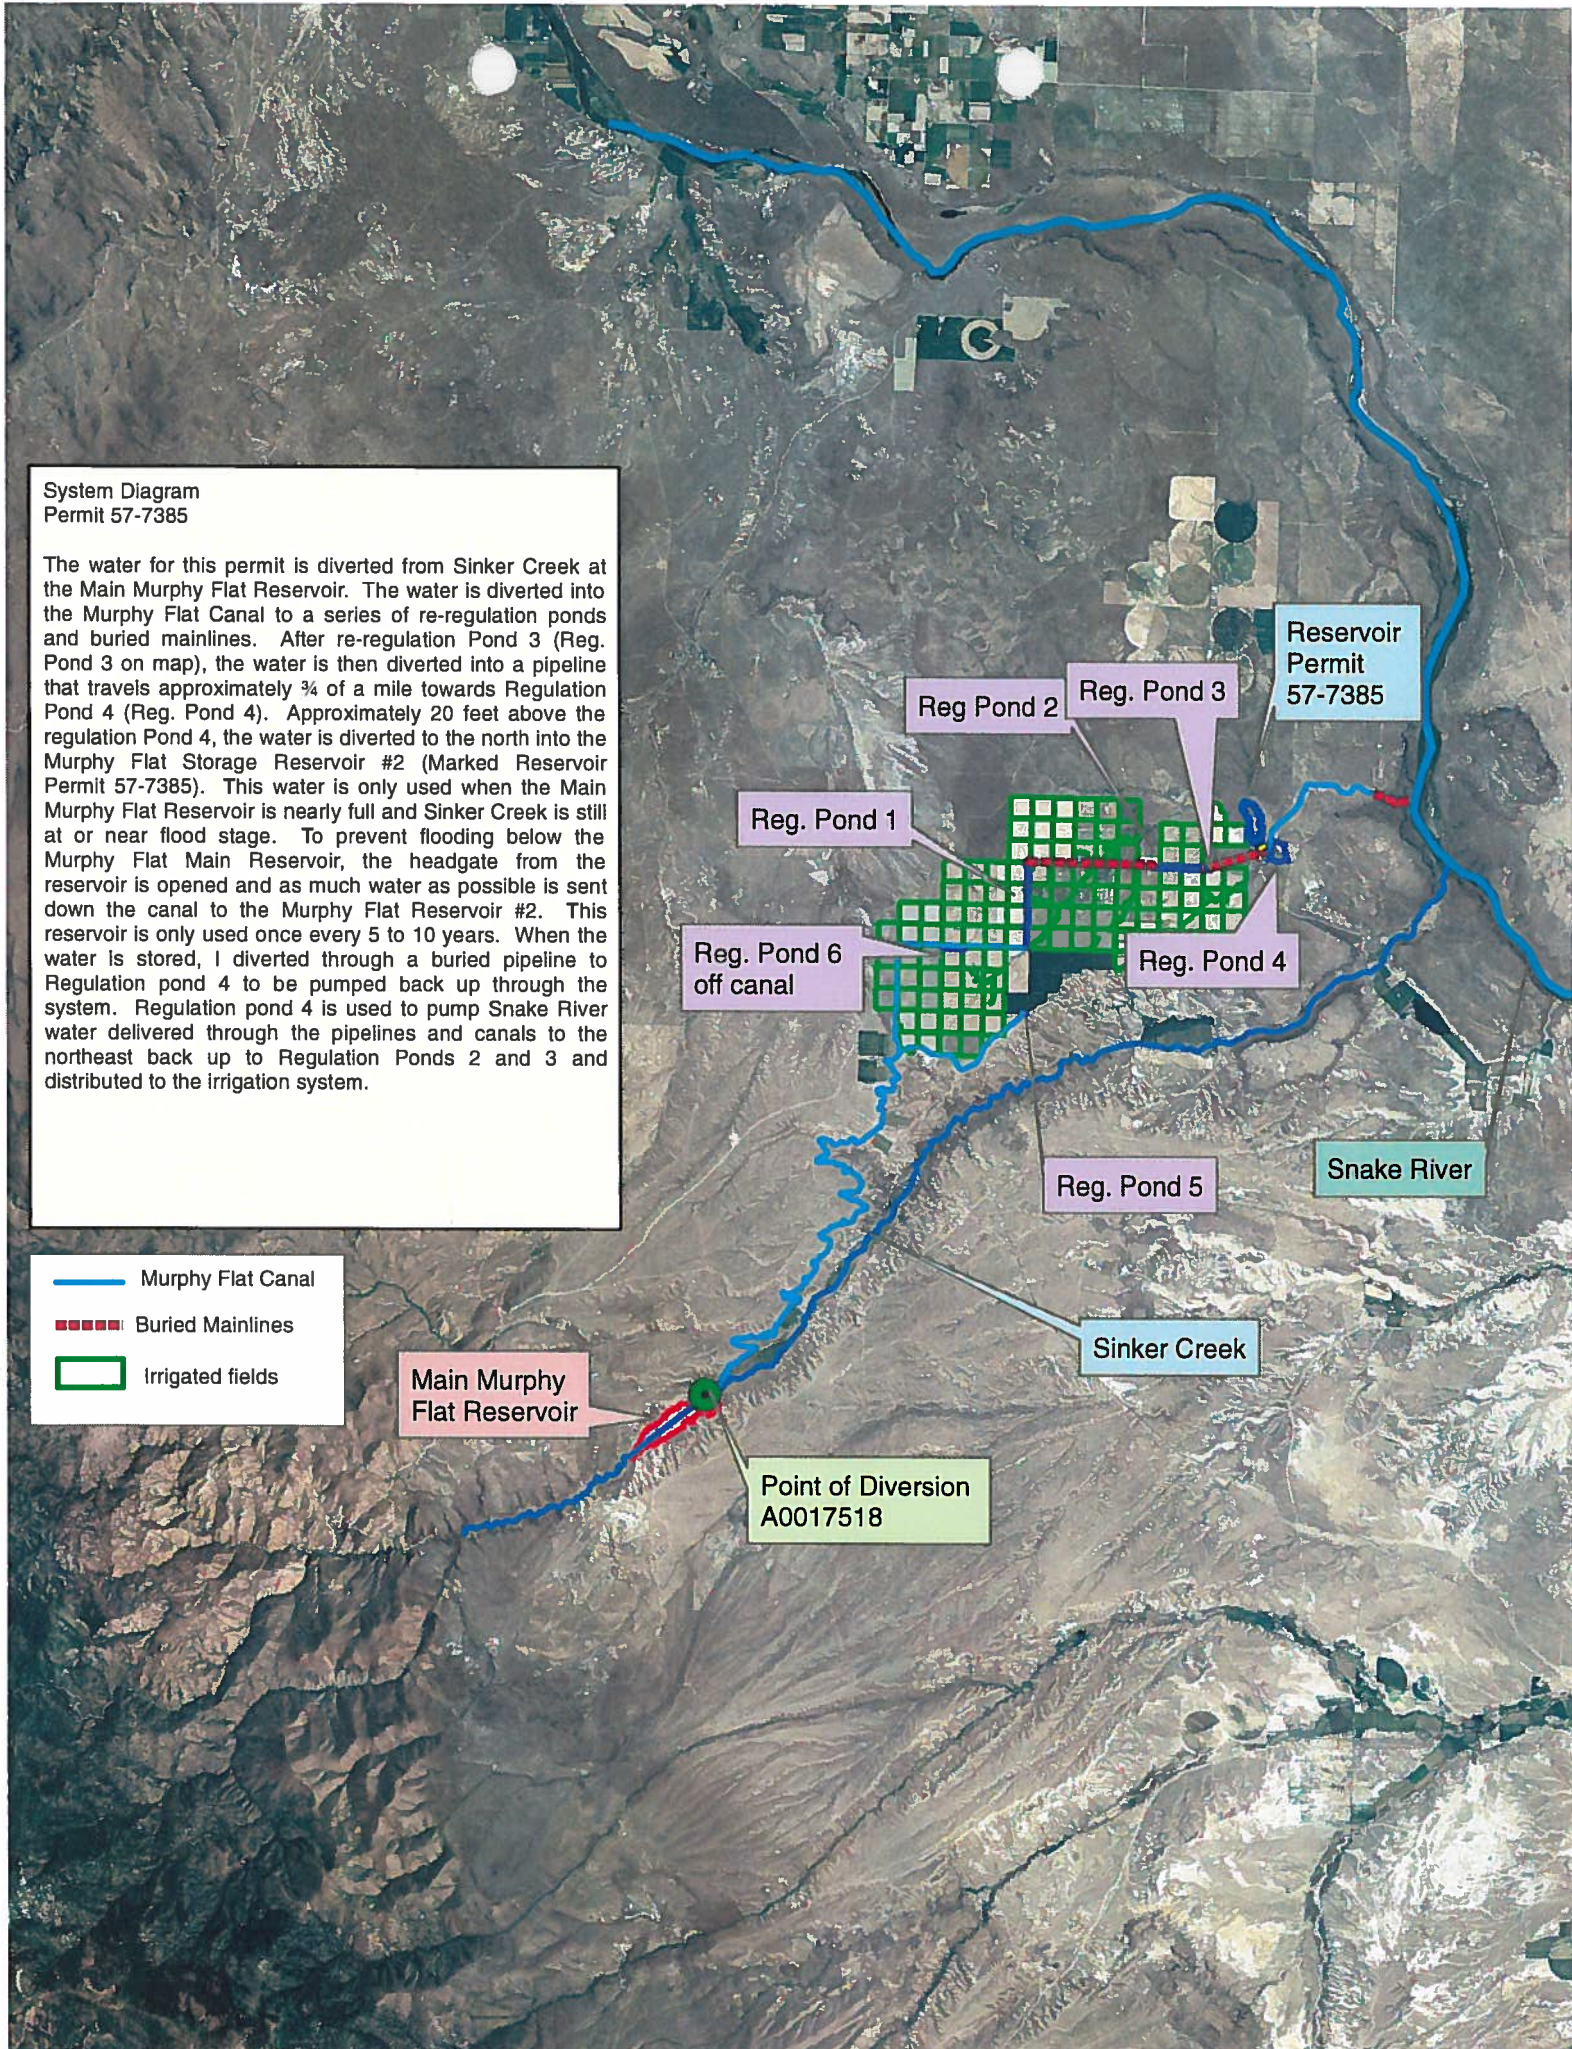
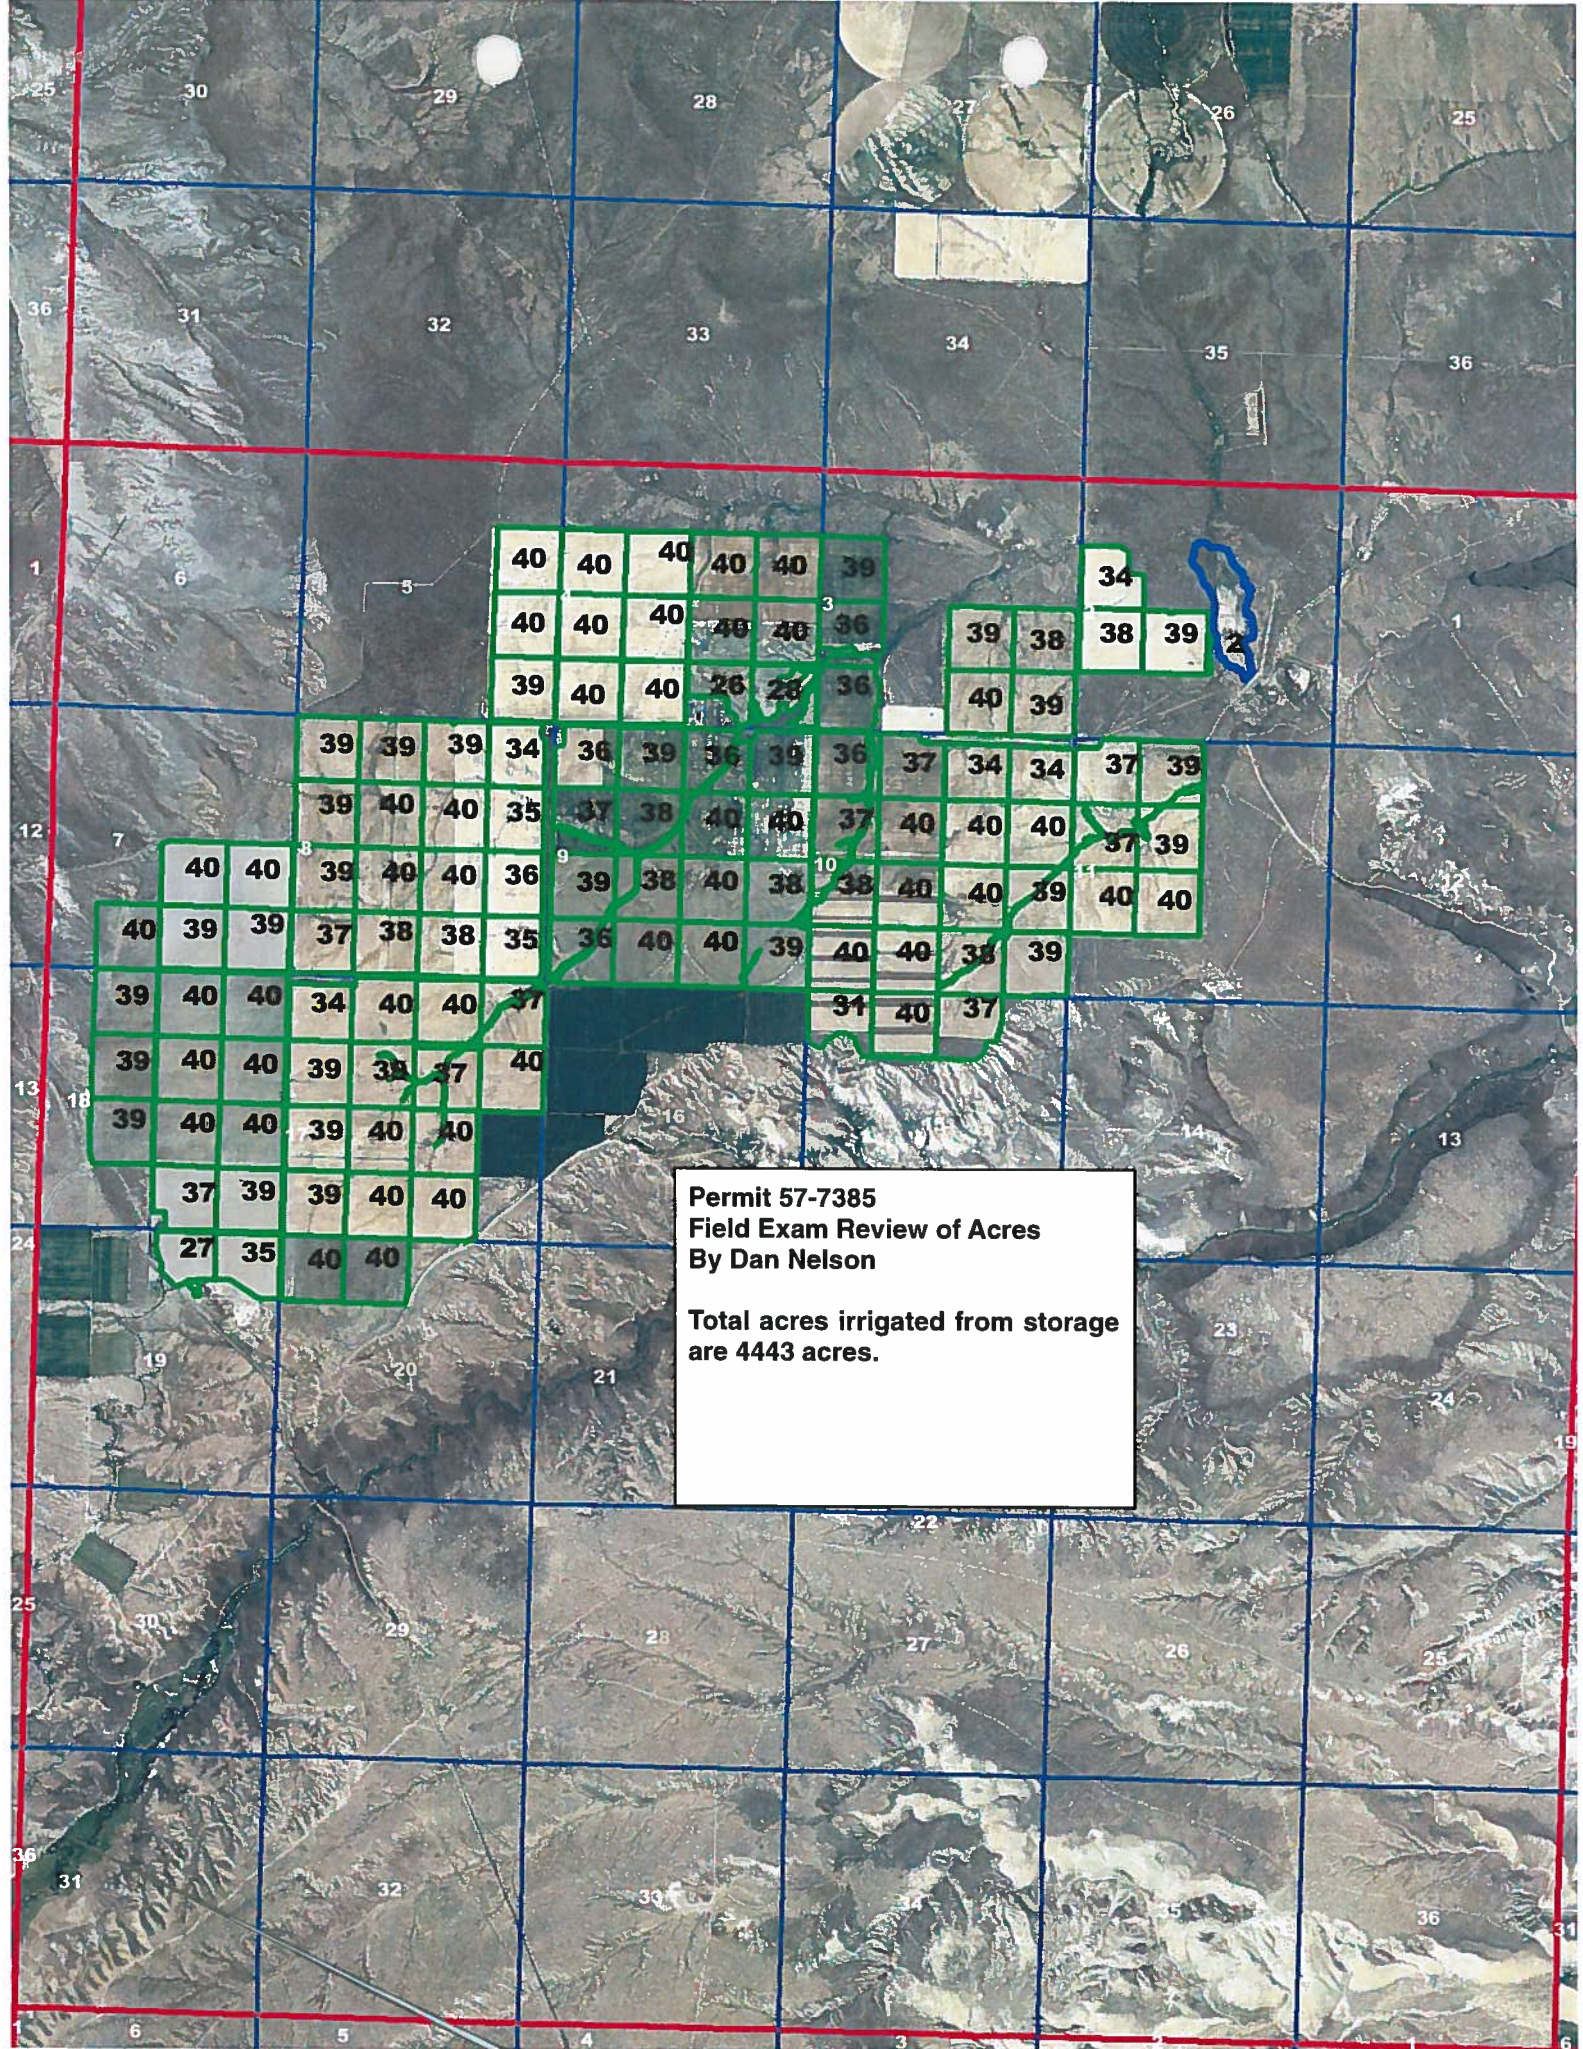
**Permit 57-7385**  
**Field Exam Review of Acres**  
**By Dan Nelson**

**Total acres irrigated from storage**  
**are 4443 acres.**

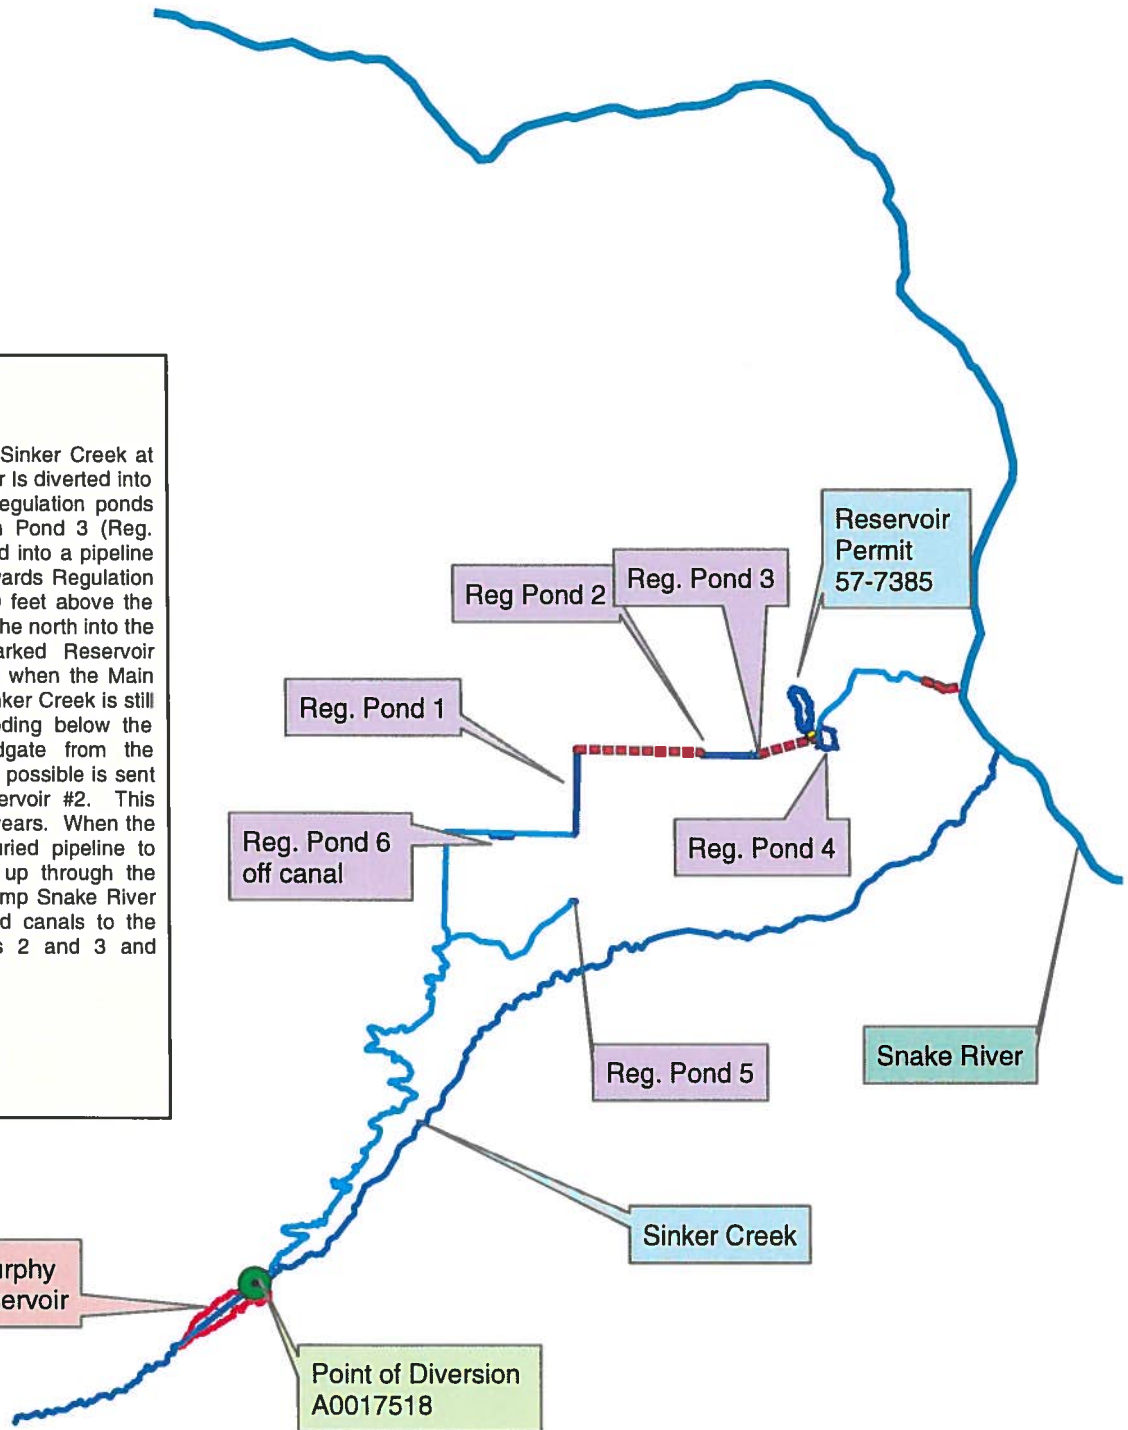
**System Diagram**  
Permit 57-7285

The water for this permit is diverted from Sinker Creek at high flow times and diverted through the irrigation's canal system to Reg. Pond 3. At Reg. Pond 3 the water is gravity fed into the pipeline and run towards Reg. Pond 4. Approximately 20 feet uphill or southwest of Reg. Pond 4, there is a valve that determines whether the water flows to the storage reservoir or Reg. Pond 4. This pipeline is used during the non-irrigation season to store water in the storage reservoir, and the same pipeline is used to lift water from Reg. Pond 4 up to Reg. Pond 3 by the use of a series of pumps at Reg. Pond 4. Reg. Pond 4 is used to collect water that is diverted from the Snake River through a High Lift Pumping plant to for irrigation of the same acres described in this permit.
