**Year:** 2000  
**PWS:** 1090243  
**County:** Bonner  
**System:** Northern Lights Sagle Headquarters  
**Ownership:** Tim Cochran  
**Address:** PO Box 310, Sandpoint, ID 83864  
**Information obtained from:** Tim Cochran  
**Location:** Chevy Road at Monarch; T56N R2W Sec15  
**Inspector:** Mike Nelson  
**Population:** 3 building office/industrial complex

Subject: Enhanced Sanitary Survey conducted on *September 9, 2008*

## **Drinking Water Supply Report September 25, 2008**

**System:** Northern Lights                      **PWS#:** ID1090243  
**Date of Survey:** September 9, 2008      **County:** Bonner  
**System Representative Present at Survey:** Rod Babcock  
**Surveyed by:** Jamie Barton, PHD and Suzanne Scheidt, DEQ  
**Source:** Ground water well                      **Population/Connections:** 50/3  
**Water System Type:** Non-transient, Non-community

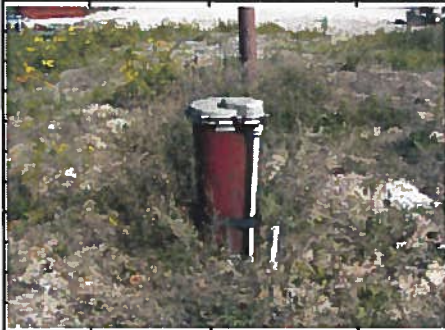
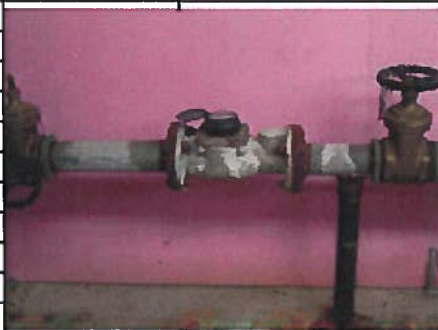
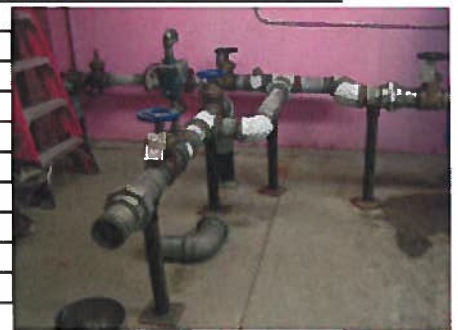
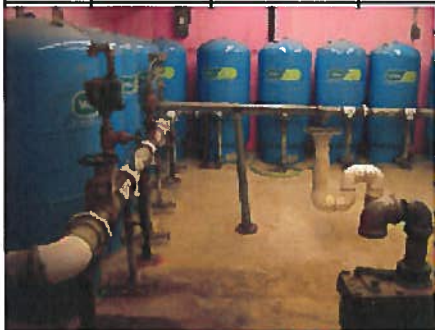
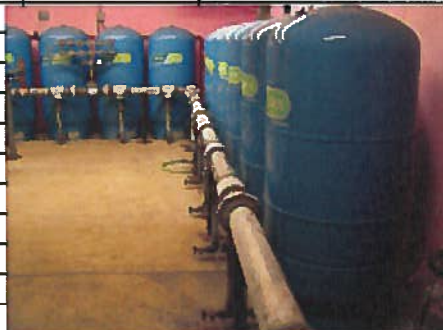
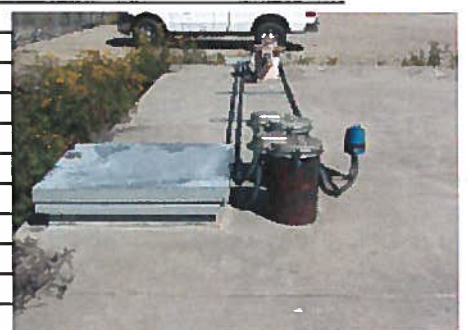
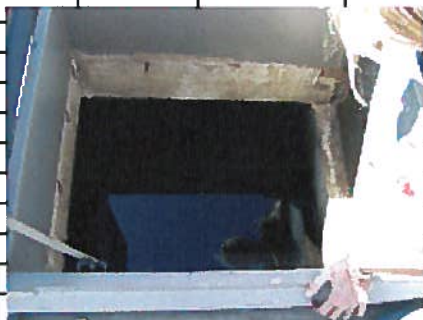
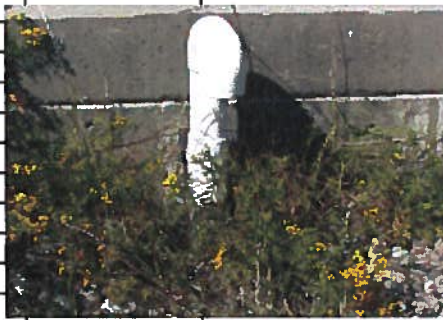
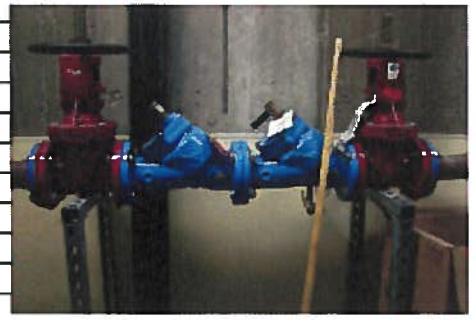
| Photo: | Date: | By: (initials) | Direction: (N,S,E,W, etc.) | File Name: | Description: |
|---|---|---|---|---|---|
| | 9/9/2008 | JB | | | Reservoir overflow |
| | 9/9/2008 | JB | | | Double check valve assembly between distribution and heat exchange syst |
