## IDAHO DEPARTMENT OF WATER RESOURCES

### WELL INSPECTION FORM

1. DRILLING PERMIT NO: NONE OTHER APPLICABLE NO: 47-08147
2. OWNER: MARILYN S. UERLIN BROOK Phone: (208) 734-1845  
Address: 3169 E 3500 N, TWIN FALLS, IDAHO 83301

3. WELL LOCATION: Twp 11S, Rge. 17E, Sec. 02, NW 1/4 SE 1/4  
County TWIN FALLS (Provide sketch map and photo on reverse.)
4. DRILLER: UNKNOWN Lic. No. UNKNOWN  
When Drilled? UNKNOWN

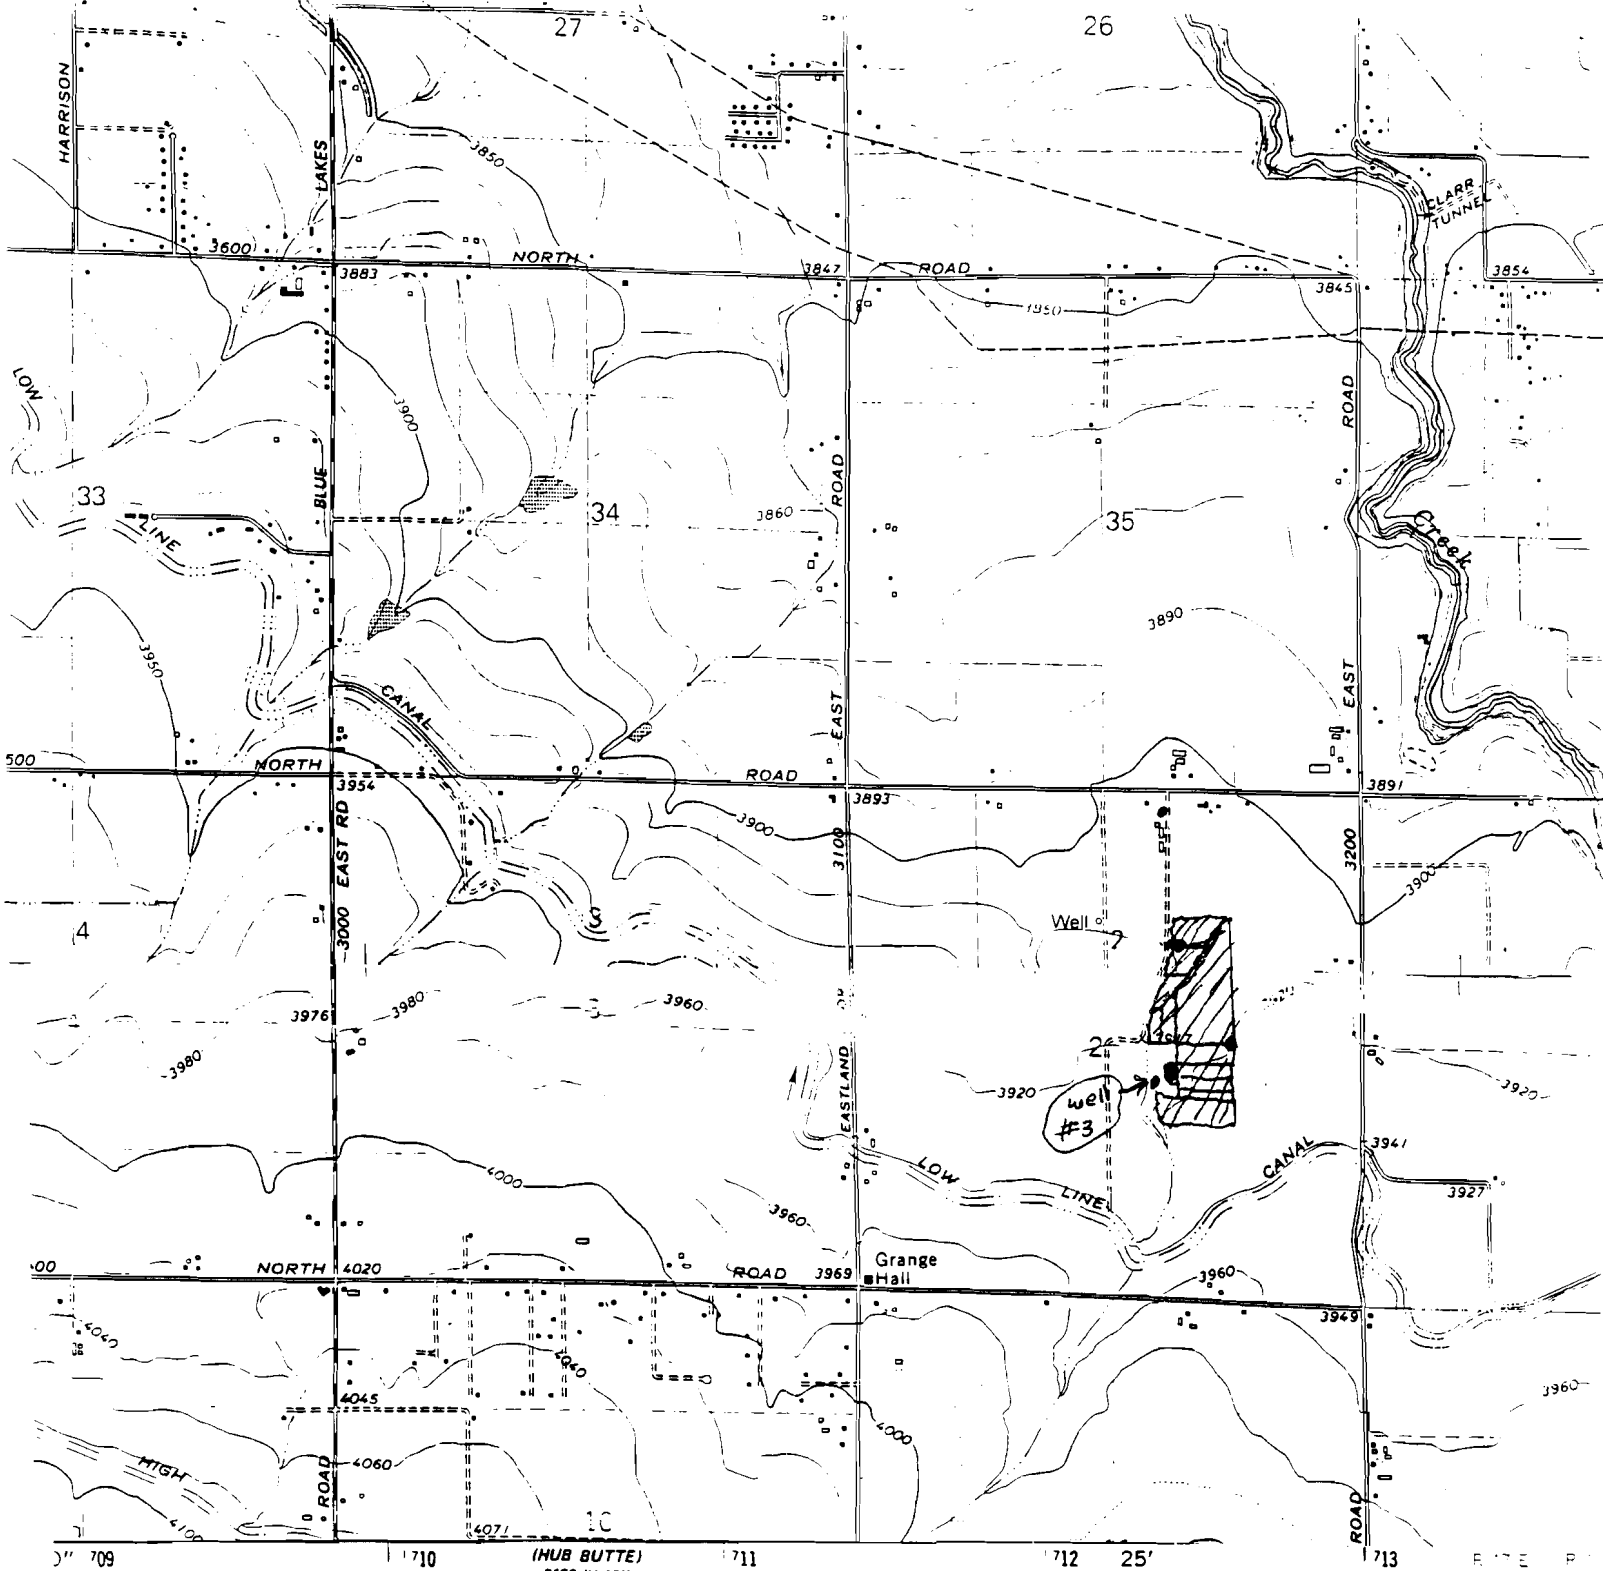
PHOTOS, DRAWINGS, OTHER ATTACHMENTS:

9. REMARKS: THIS WELL LOOKS IN GOOD CONDITION.  
THE POSSIBLE THREAT TO CONTAMINATION WOULD  
BE GROUND SEEPAGE. HOWEVER, THE WELL HEAD  
IS NOT 12 INCHES ABOVE GROUND. THE WELL  
HEAD HEIGHT SEEMS TO BE THE ONLY PROBLEM  
WITH THIS WELL.
