*no drilling permit*  
IDAHO DEPARTMENT OF WATER RESOURCES

WELL INSPECTION FORM

2. OWNER: Aardena's Heida Dairy Phone: (208) 536-2187  
Address: P.O. Box 140, Weiser, ID 83355

3. WELL LOCATION: Twp 6S, Rge. 1E, Sec. 11, NW 1/4 SE 1/4  
County Gooding (Provide sketch map and photo on reverse.)

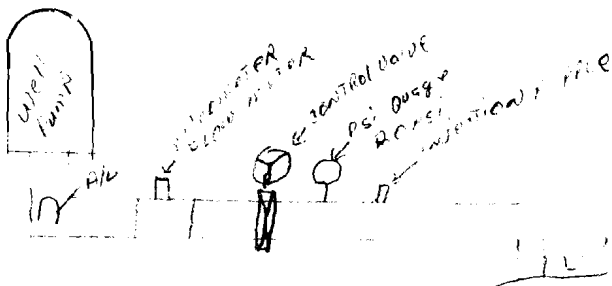
THESE ARE PICTURES OF DIRT FILL-IN AROUND PUMP.  
 WITH OUT A CAP ON THE ACCESS PORT & NOW OR DIRT COULD  
 FILL INTO OPENING OF PUMP. THERE IS LESS THAN 2"  
 CLEARANCE FROM GROUND TO PUMP VENT.
