## Dam Safety Section

### TRIP REPORT

TO: Lava Thunder Canyon Golf Course Pond  
FROM: Ryan Madsen, John Falk  
DATE: April 11, 2008  
SUBJECT: Site Visit

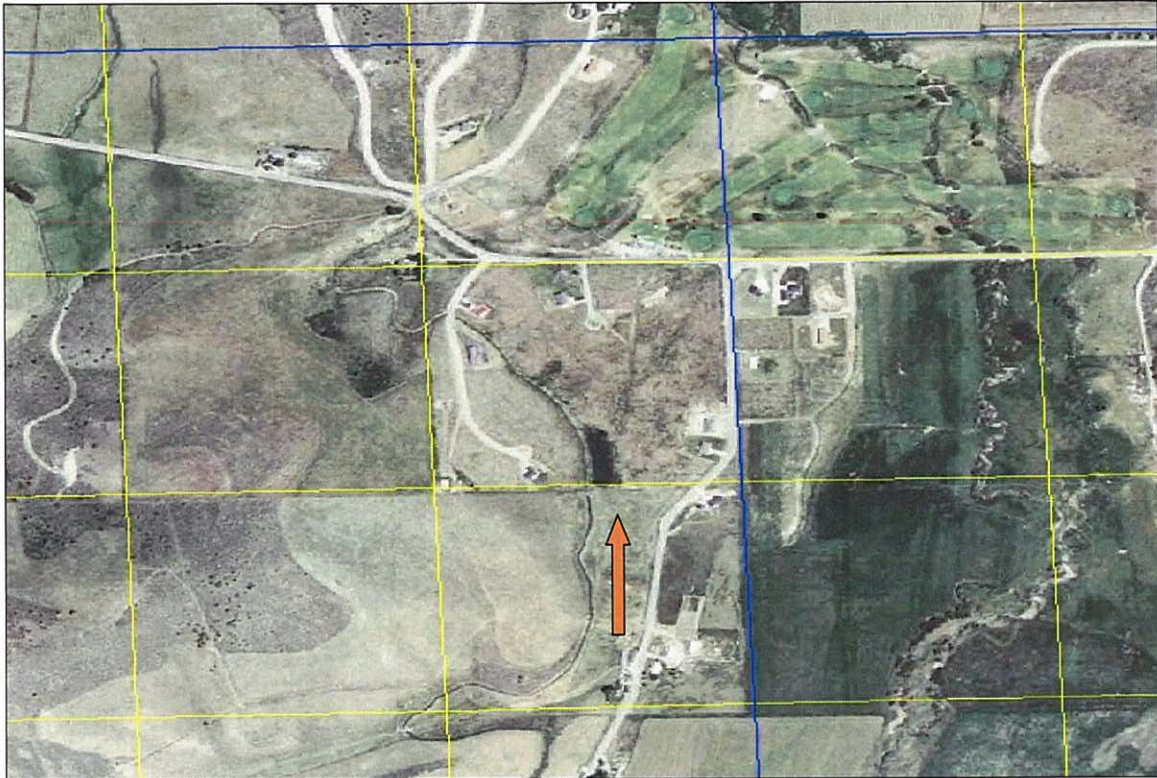
Photo 1 - Aerial photo of Lava Thunder Canyon Golf Course pond. The yellow grid lines are quarter-quarter boundaries for Section 32, whose perimeter is shown by blue lines.
