State of Idaho  
DEPARTMENT OF WATER RESOURCES

DAM SAFETY PHOTOGRAPHS

BLACKWELL

RECORD OF INSPECTION OF DAM

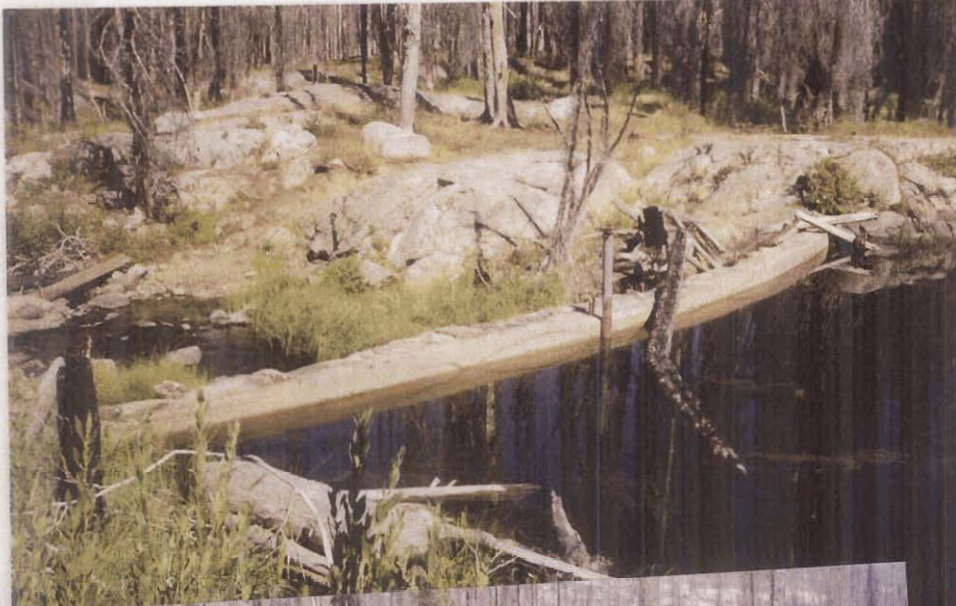
on face of the dam.

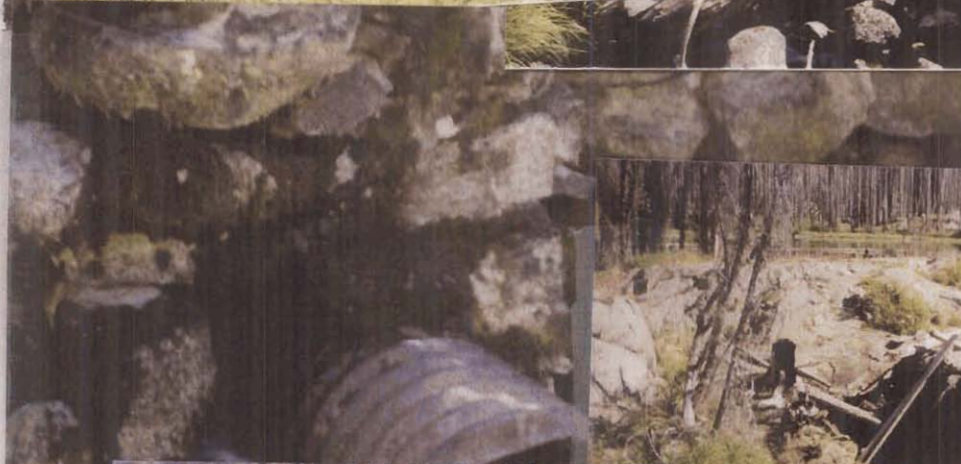
view of the downstream face,  
leakage through the rock at the

1. Continue to remove driftwood/debris from the area.
2. Keep outlet gate and control in good working order.
3. Monitor leakage thru the dam, repair mortar where leakage is concentrated.
4. Maintain log boom.

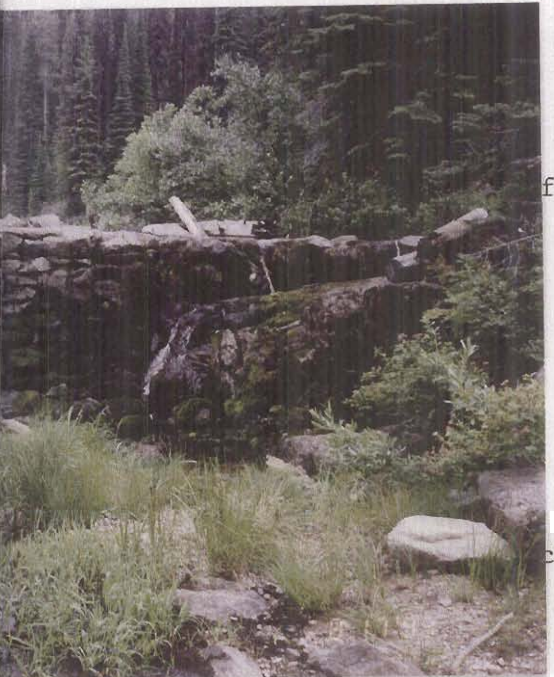
| | TOE AREA | DOWNSTREAM SLOPE | ABUTMENTS | OTHER |
|---|---|---|---|---|
| Flowing water (Est. G.P.M.) | Significant leakage through mortar between rocks near outlet pipe, photo #3 | | | |

face,

area.  
cks
