Here is the info on the Williams Lake  
Overflow (or Spillway as the State calls it).  
This is the entire file - # 075-XX05 Williams Lake -  
that is held by DWR's Data and Information  
Division.

WILLIAMS LAKE  
Lemhi County, Idaho  
by W. Gossett  
24 June 1976

WILLIAMS LAKE

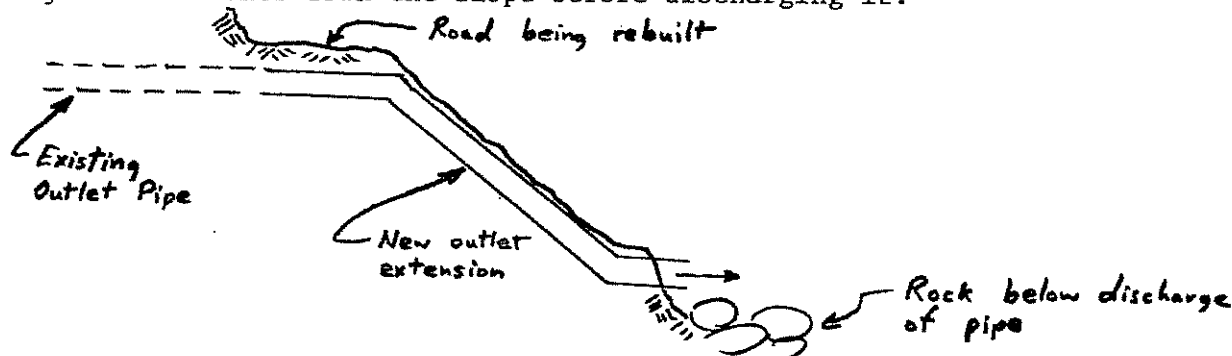
Cooper Plumbing Company of Salmon is working for the owners of Williams Lake Resort, and is rebuilding the downstream end of the outlet pipe from the lake. I talked to Willy Heald of Cooper Plumbing at the site. The old outlet extended out from the embankment to reduce erosion; however, the pipe broke off and washed out the county road above it. Cooper Plumbing is now constructing a bend in the pipe to carry water farther down the slope before discharging it.

In the embankment near the outlet pipe no seepage was noted anywhere except a 3-4 GPM flow along the outside of the newly installed pipe mentioned above. Cooper Plumbing had dug out a hole near the upper end of this new work, (see backhoe location in photos) and I could hear water running and observed much turbulence in the water standing in this hole. Mr. Heald said that the seepage all originated at a longitudinal seam in the new C.M.P., and none was emerging along the pipe upstream from this location. Cooper Plumbing was in the process of installing

2. Check downstream end of outlet pipe after construction complete to see if pipe leak has stopped.
3. Suggest that resort owner maintain a good trashrack at pipe entrance and provide protection against hazard to people caused by presence of the pipe entrance near a heavily used resort. Several bars are present now to screen out large debris.

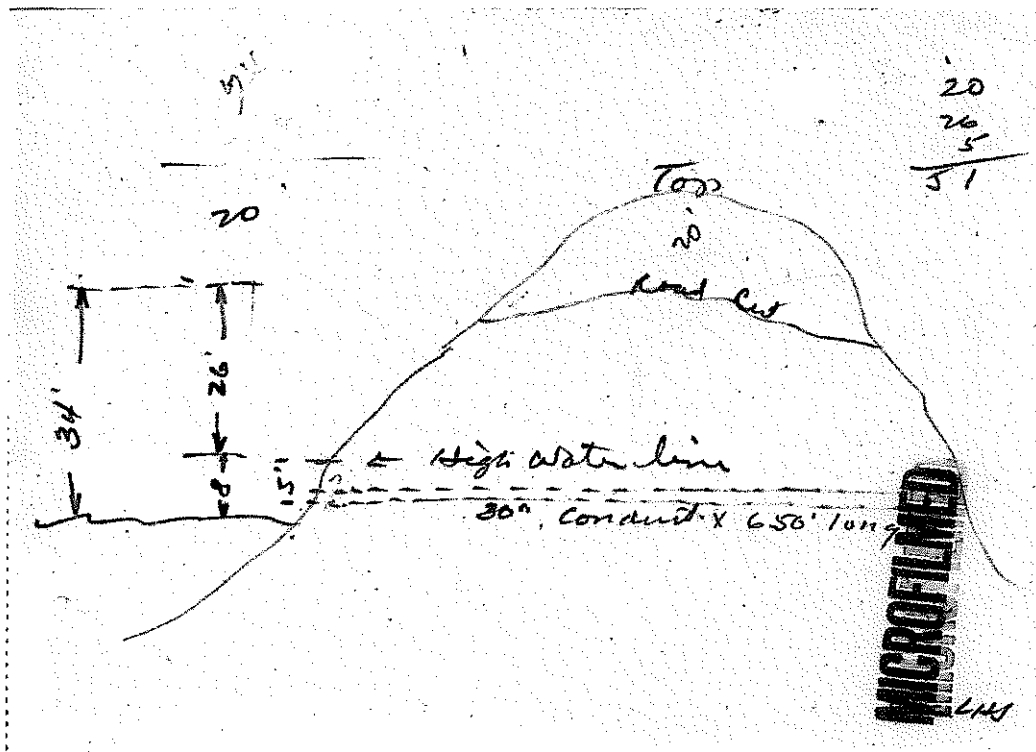
water another 10' onto steep hillside. Gully washed  
Maintenance Condition: Debris \_\_\_\_\_ Growth \_\_\_\_\_

GULLY AT END OF SPILLWAY PIPE

4. The outlet end should be protected in such a manner so as to not undercut the end support of the pipe or cause excessive erosion down stream. Let the water spill into a heavily riprapped area at the end of the pipe.
