## MEMORANDUM

**Date:** June 17, 2005  
**To:** Water Right File 37-7707  
**From:** eretelle  
**Re:** field evaluation

# 37-7707

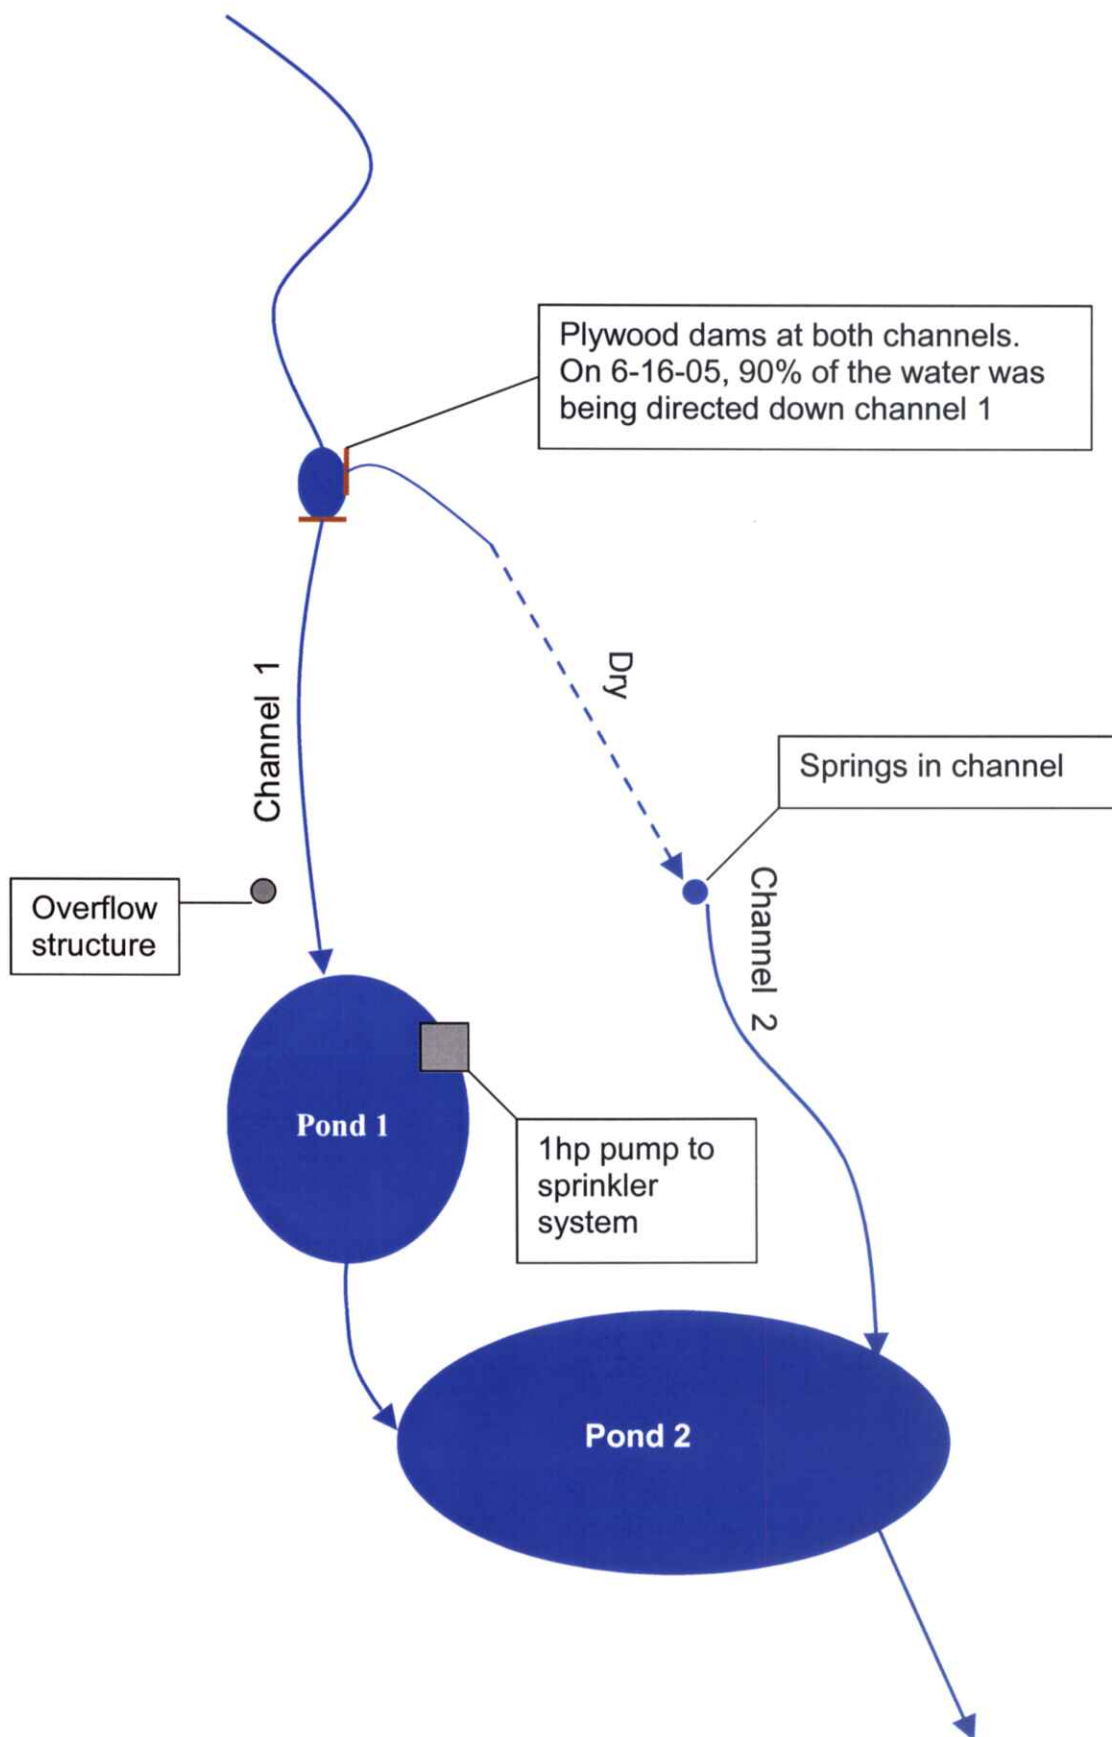
Looking SE from near road into PoU. Land on far side of fence is supposedly irrigated by sprinklers (absent at time of last 2 field exams) attached to pump in pond #1. Land on near side of fence is supposedly not irrigated.
