RE: Water District 34 Water Measurement Matters.

# **EIM CANAL PRESEASON COMPLIANCE REPORT**

RE: Compliance Report Notification

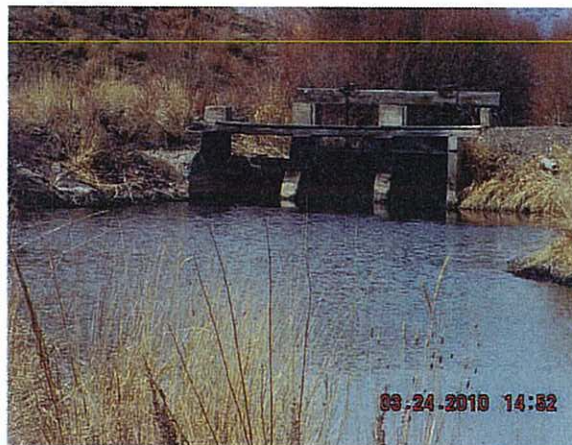
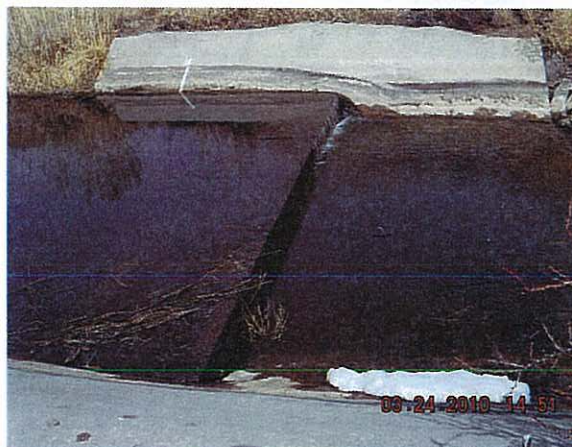
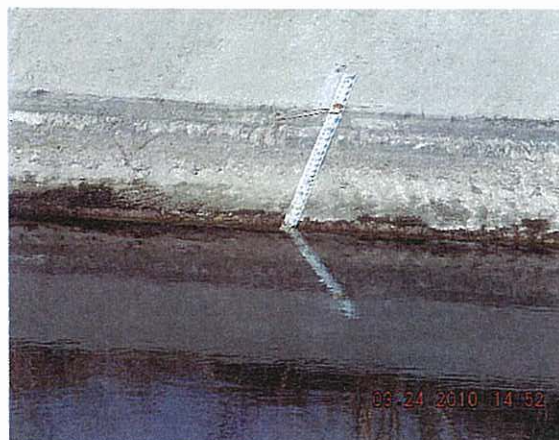
Broad Crest measuring device. Data logger will be installed at this canal heading.

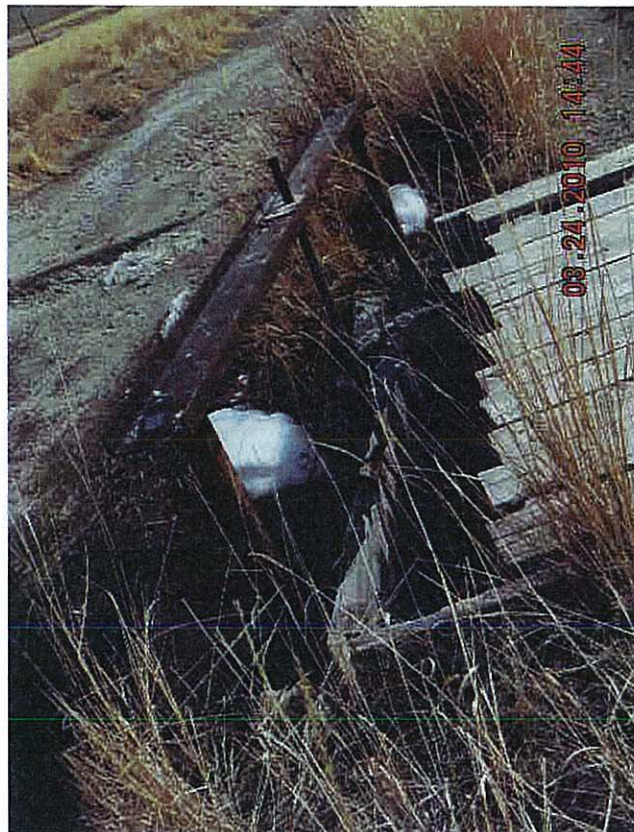
Eastside Canal  
Recharge Headgate  
17"

Active headgate. 4 ft. Parshall flume. Approach needs cleaning for accurate measurement. No wheel on gate stem (no control). Jim Rindfleisch and Ronald Sorensen had to hammer gate closed after a unauthorized diversion in 2007. Jim Rindfleisch put the wheel in his pickup.

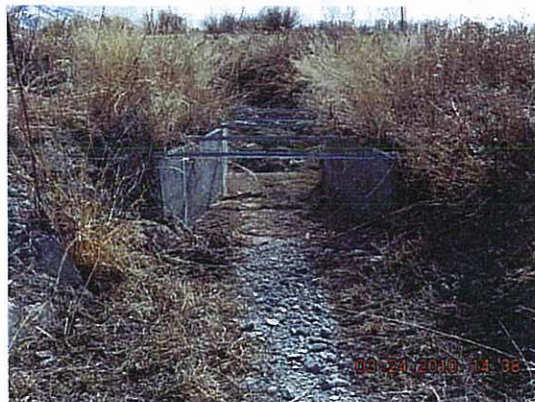
Eastside Canal  
King Mountain Ranch (lawn)  
52"

Unknown if this account is active or inactive. No measuring device.  
Control is not adjustable and lockable.

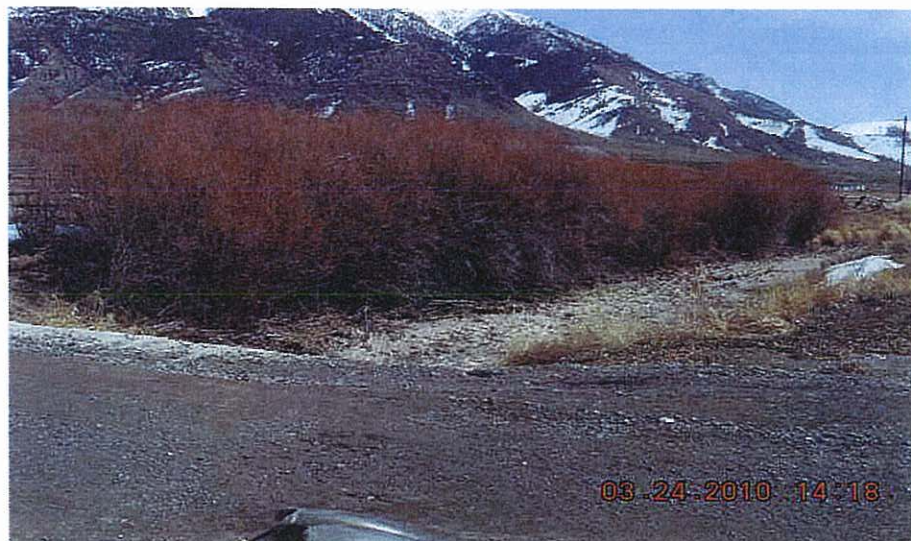
Eastside Canal

North East of Steve Keller's home. Heavy vegetation on side of canal is causing flow obstruction in canal.

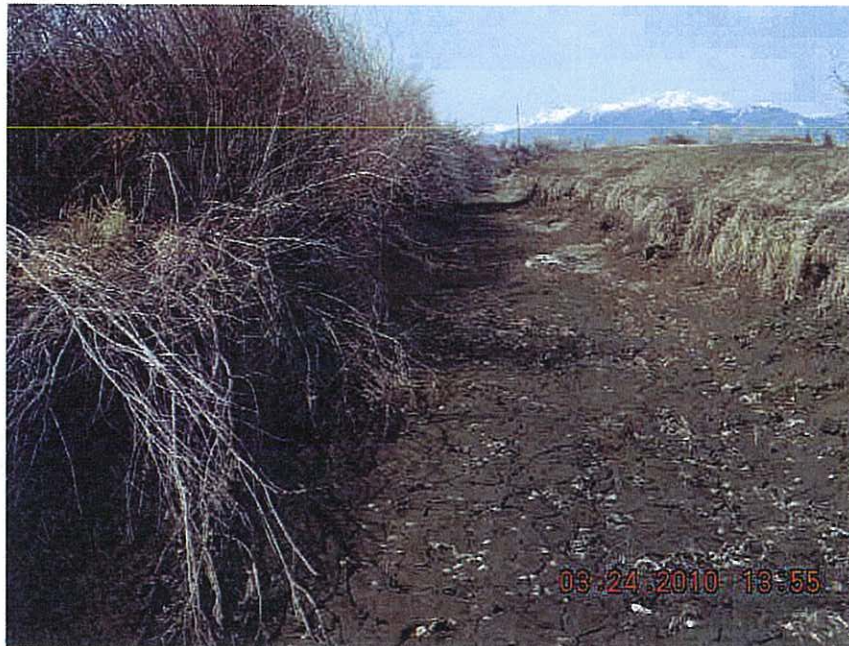
This debris has been here since the spring of 2007.

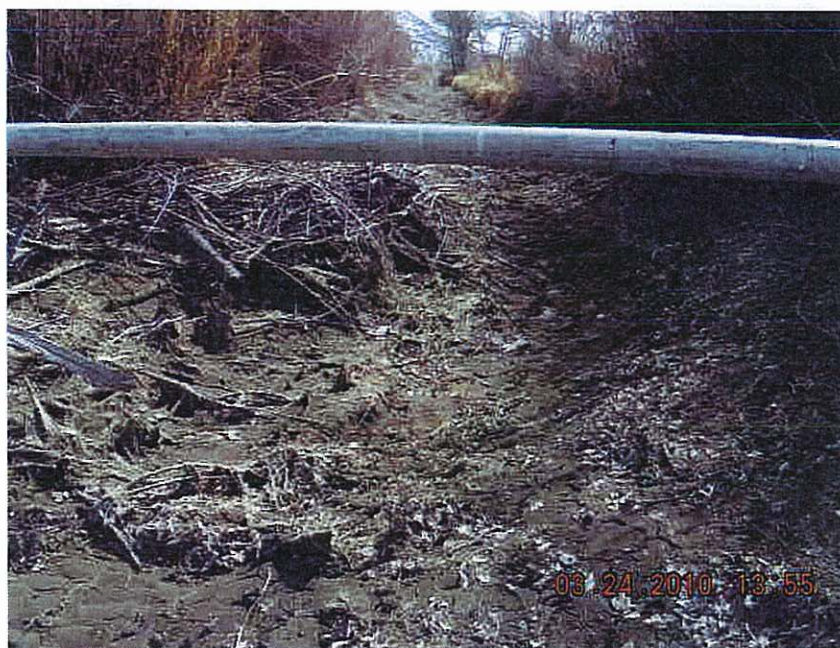
Eastside Canal  
Steve Keller

Active headgate. No measuring device. Control is adjustable and lockable. Note the vegetation and sediment fill in front of gate causing reduction of flow.

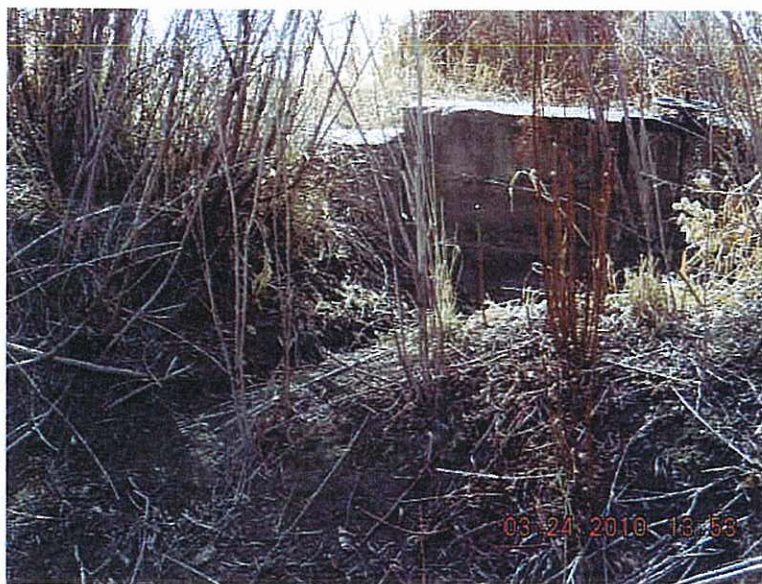
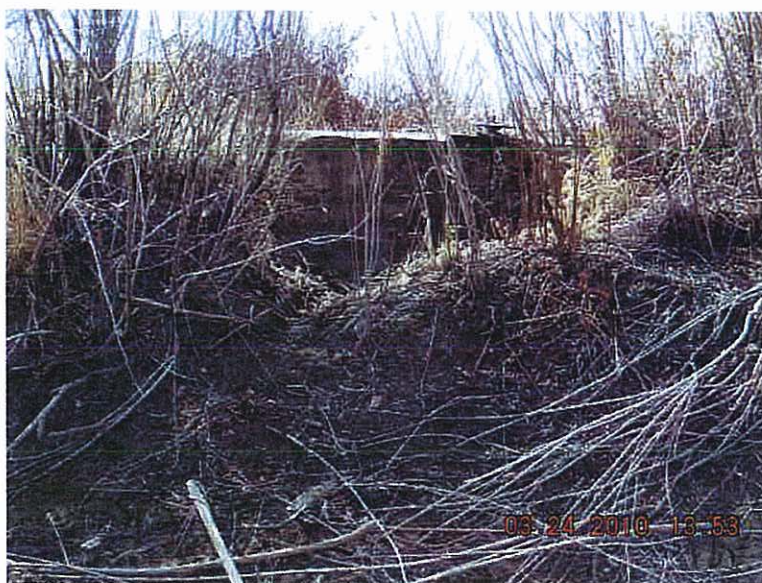
Eastside Canal

South of Steve Keller's home and North of 3400.  
Inactive headgate.

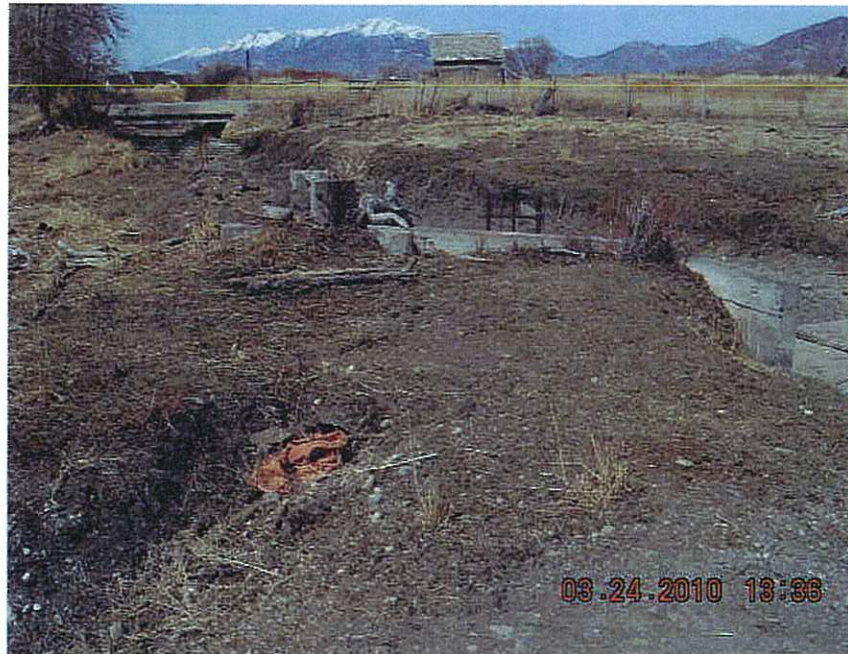
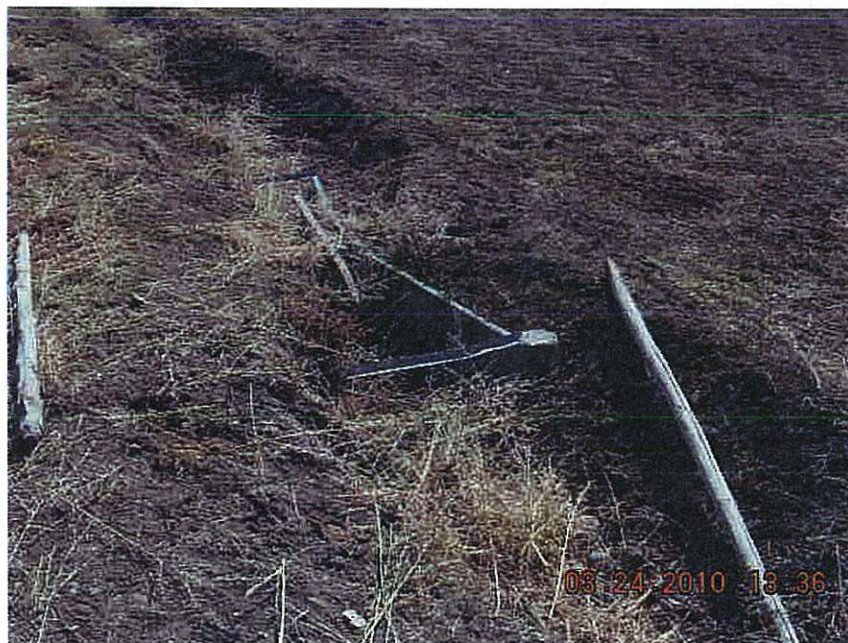
Eastside Canal  
Jay Jensen (3400)

Inactive headgate. Filled in behind headgate. Measuring device is also partially filled in.

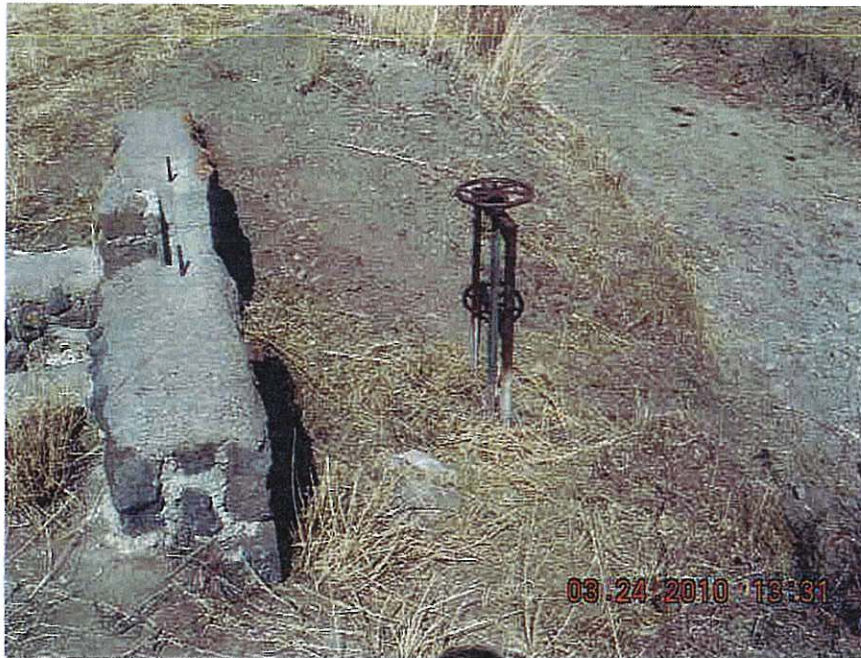
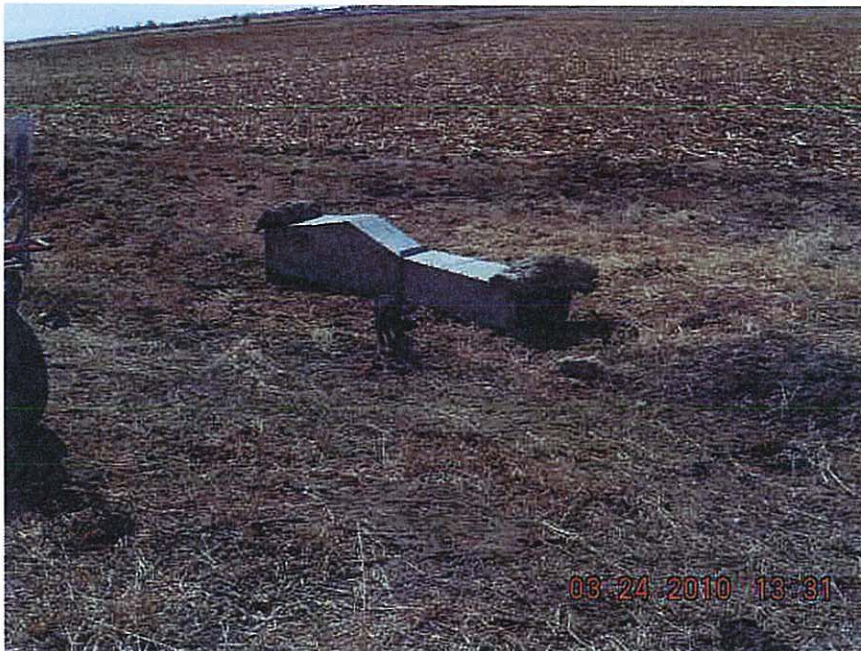
Eastside Canal

South of 3400 in Jay Jensen's field.

Inactive headgate. Sediment in control gate. Parshall flume removed.

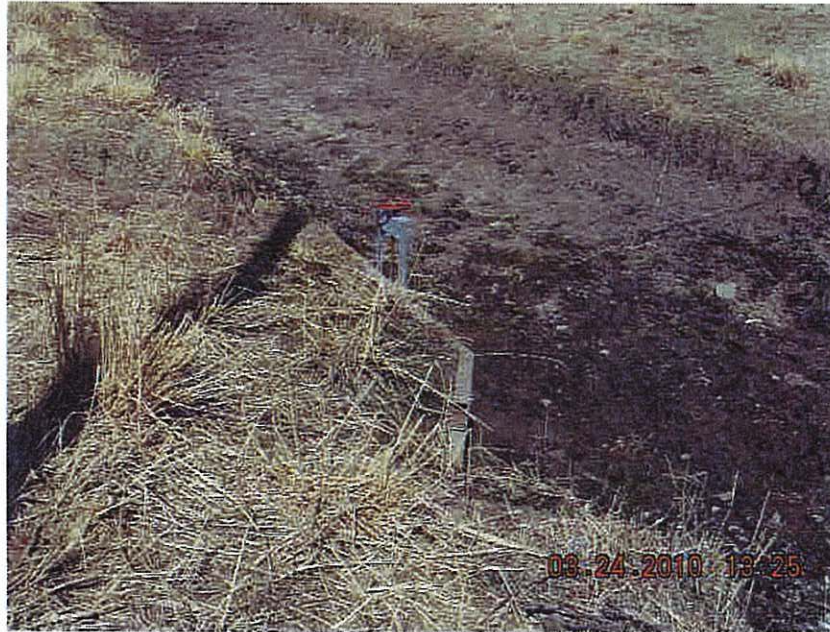
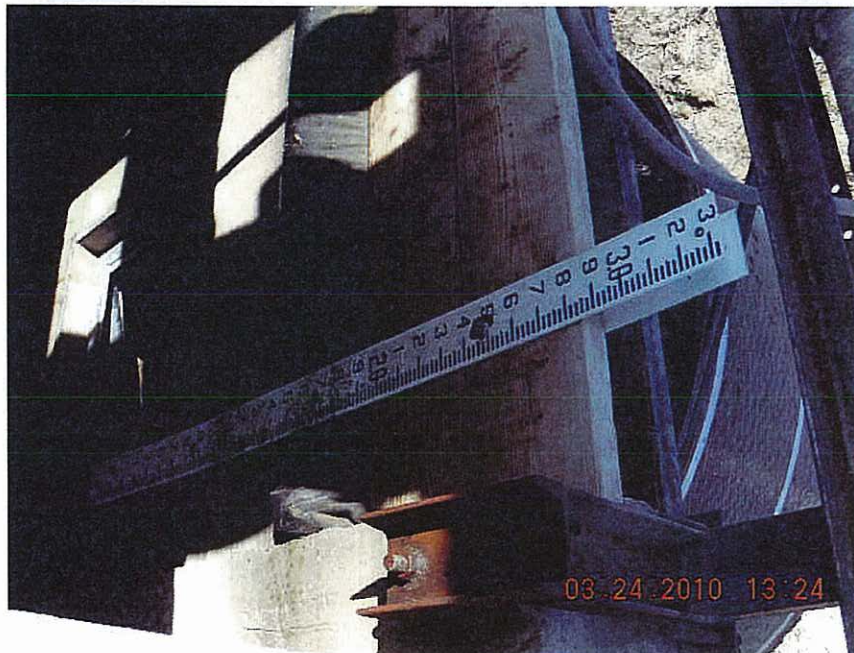
Eastside Canal  
Jay Jensen  
10"

Active headgate. Control is adjustable and lockable. Rectangular submerged orifice of unknown size.  
(Submerged orifice charts are for increments of  $\frac{1}{4}$  square ft.)

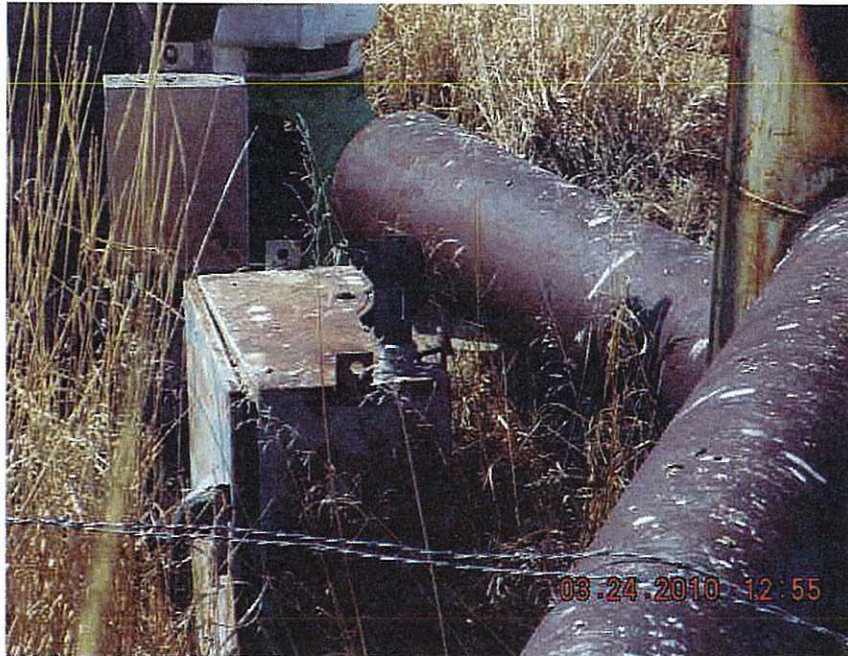
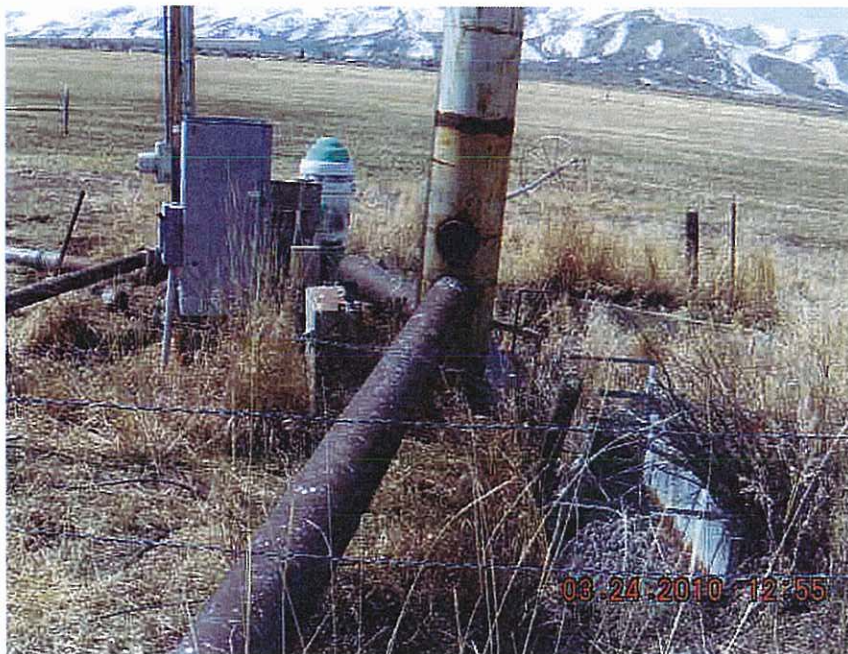
Eastside Canal  
R.D. Bowman  
53"

Inactive station.

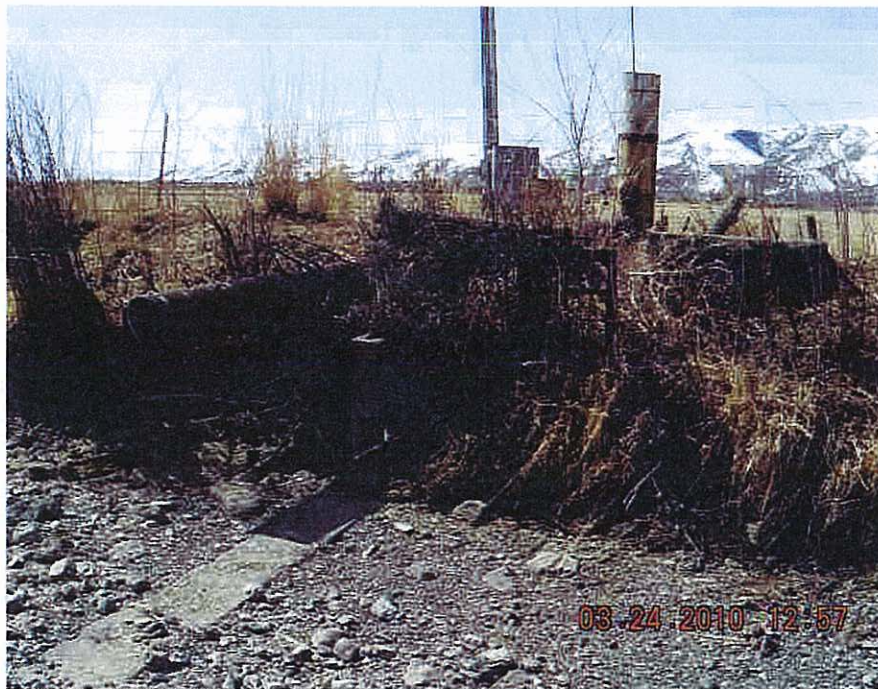
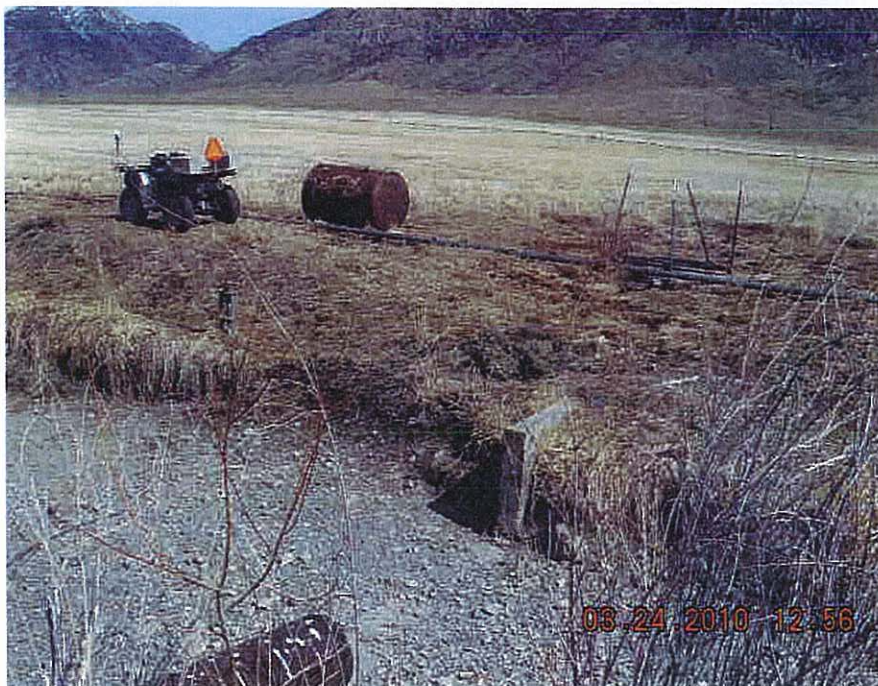
Eastside Canal  
R.D. Bowman  
53"

Inactive station.

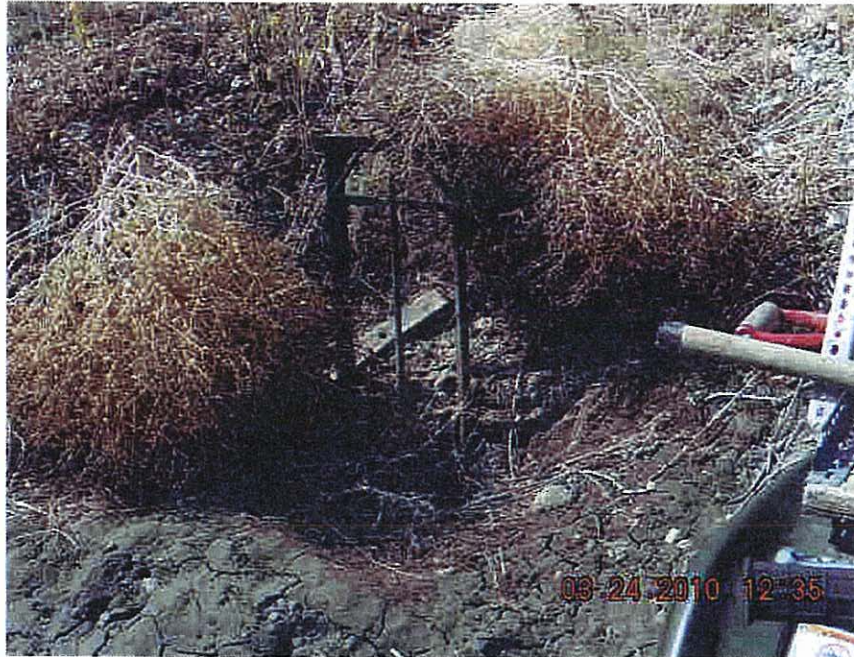
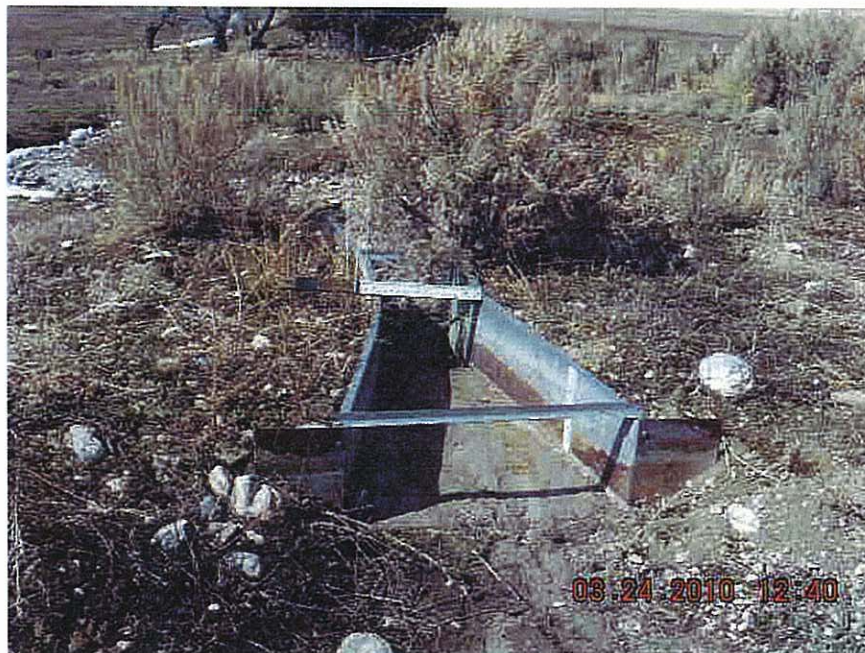
Eastside Canal  
Crump/Melling  
50"

Active headgate. 18 in. Parshall flume. Approach and discharge need cleaning. Control is adjustable and lockable.

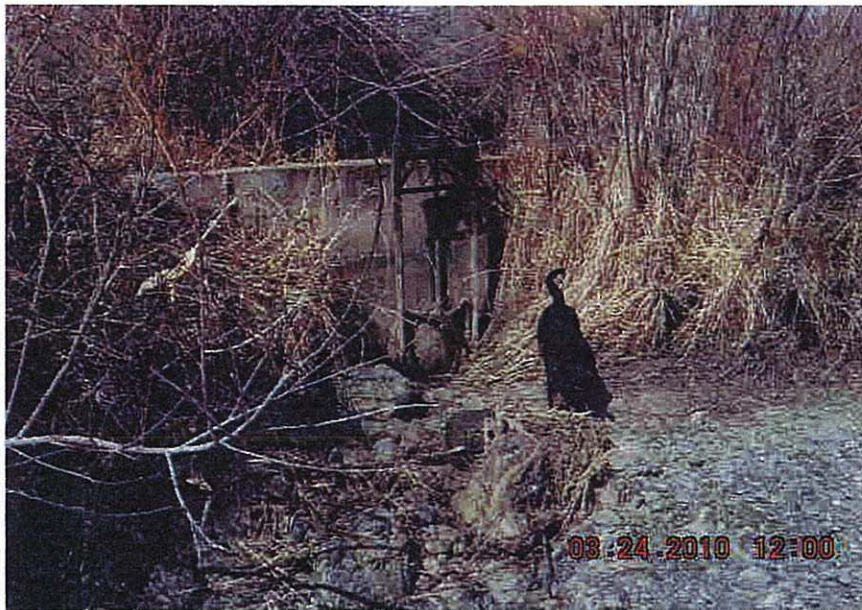
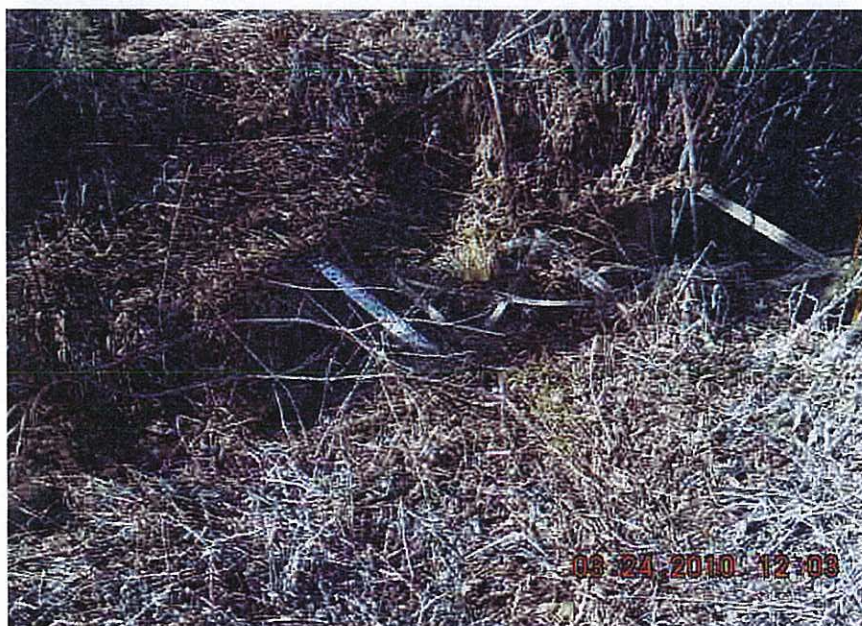
Eastside Canal  
Garth Blattner (Phyllis Jones)  
39"

Active headgate. 18 in. Parshall flume. Device is not level front to back. Approach needs cleaning and straightening. Control is adjustable and lockable. Getting to the Parshall is a half mile walk one way, and then 50 yds. of tangle debris even if you wade in the canal. Poor access.

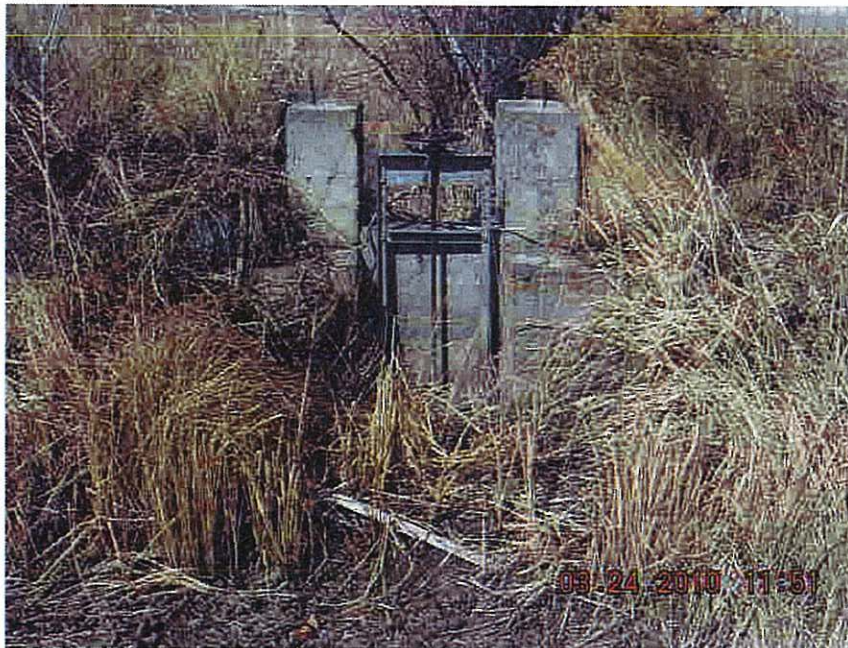
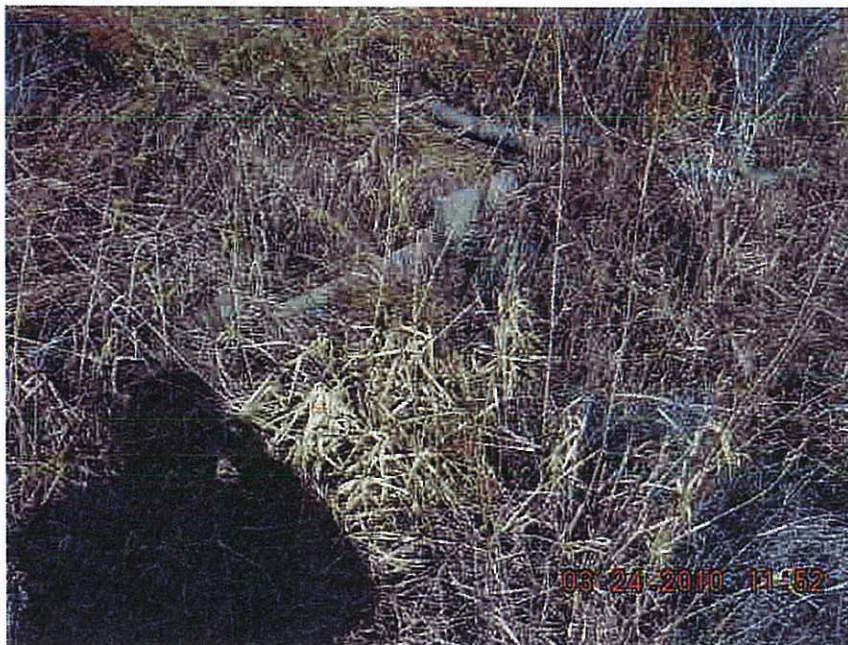
Eastside Canal  
Larry Jensen (North)  
41"

Active headgate is adjustable and lockable. No measuring device.  
Canal approach to gate is extremely obstructed.

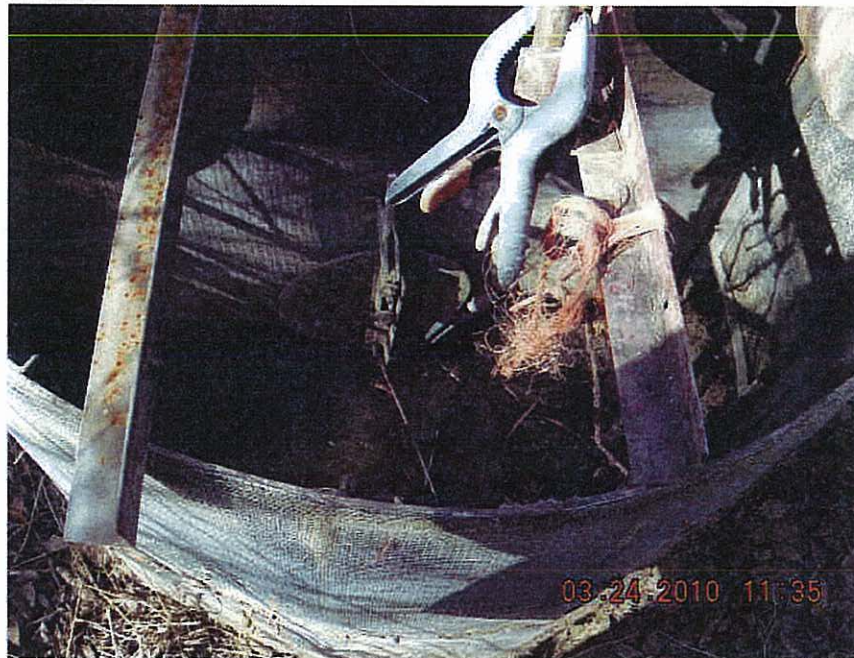
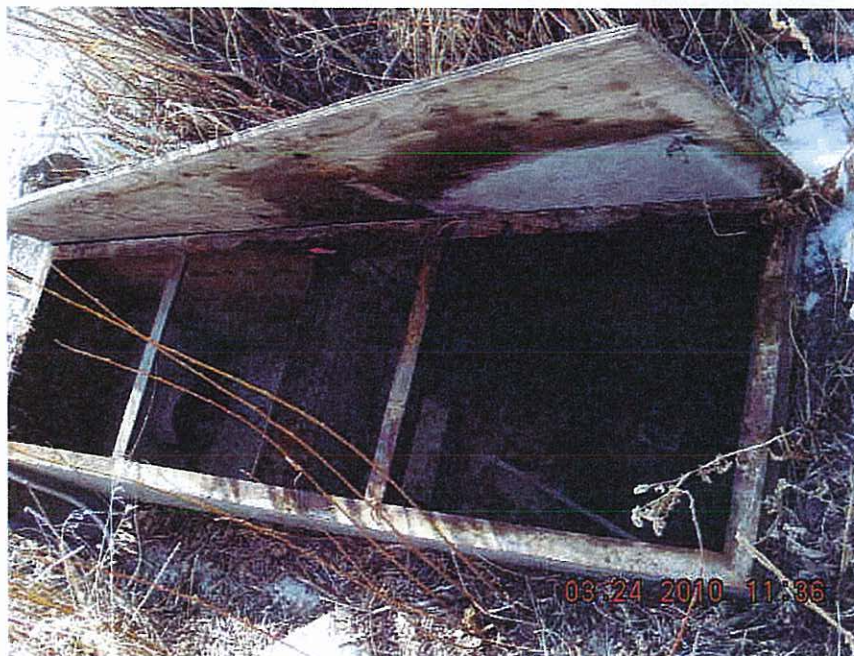
Eastside Canal  
Larry Jensen (South)  
41"

Active station. No adjustable or lockable control. No measuring device. Orifice plate has not been in place for many years.

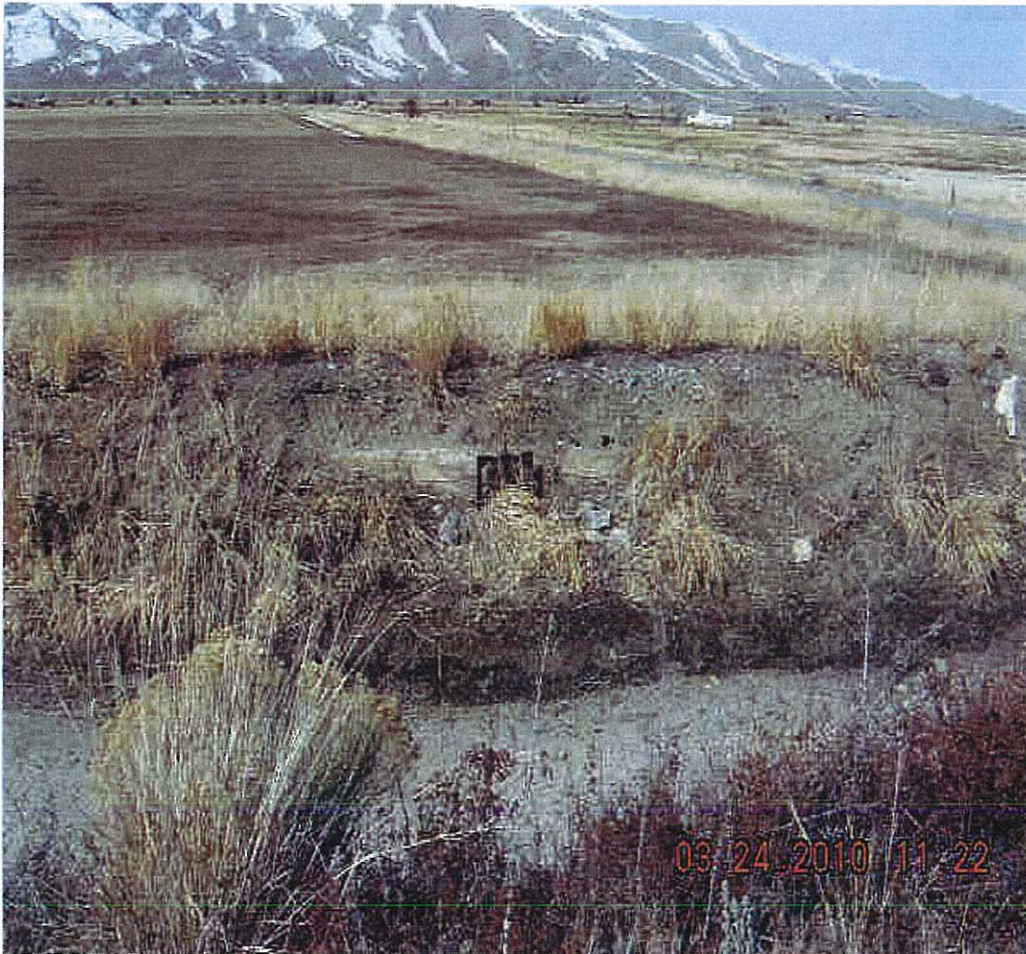
Eastside Canal  
South of 3200  
35"

Inactive headgate.

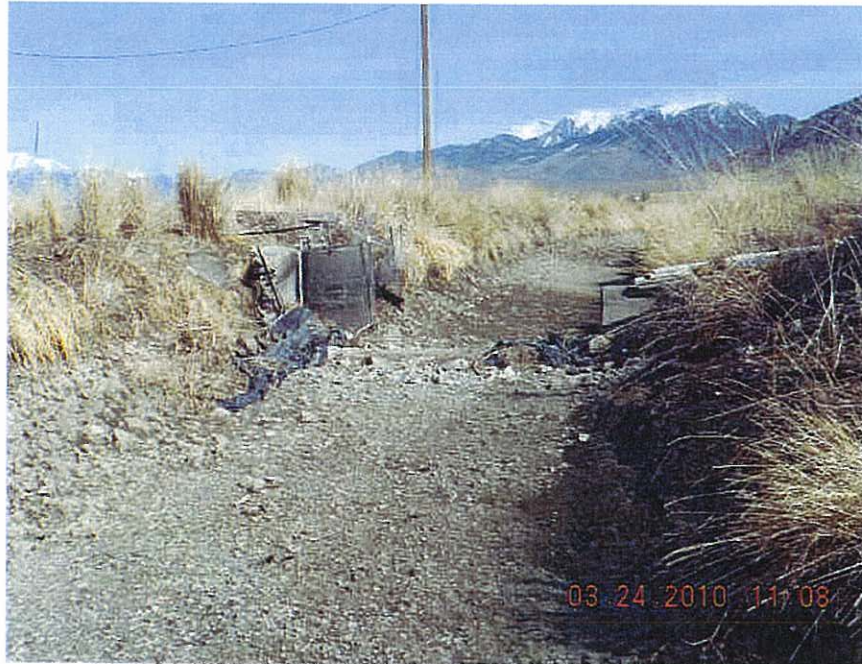
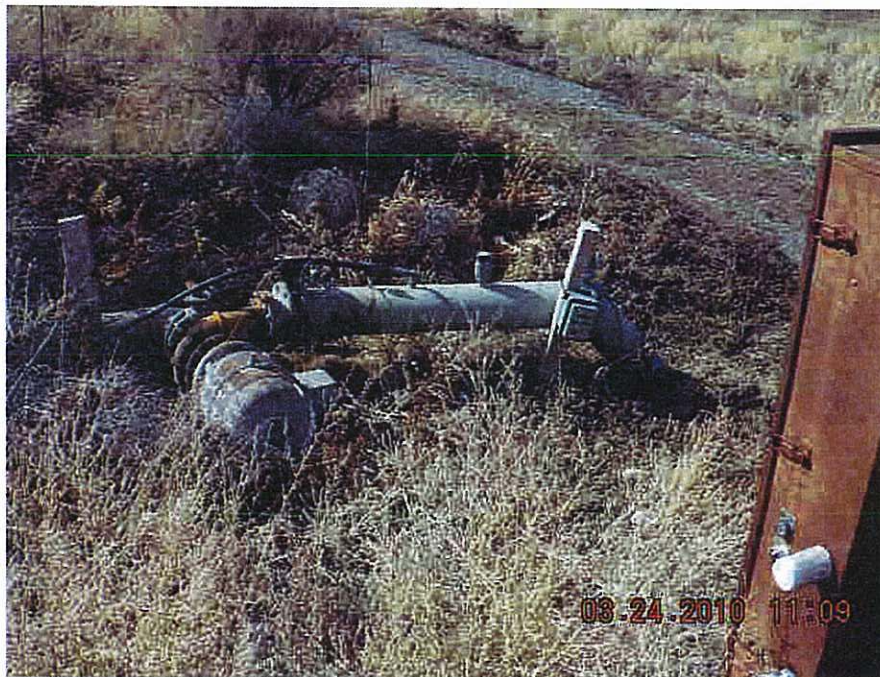
Eastside Canal  
Moore Ward Farm  
44"

Active station. EFC 1000 flow meter. Adjustable and lockable control.

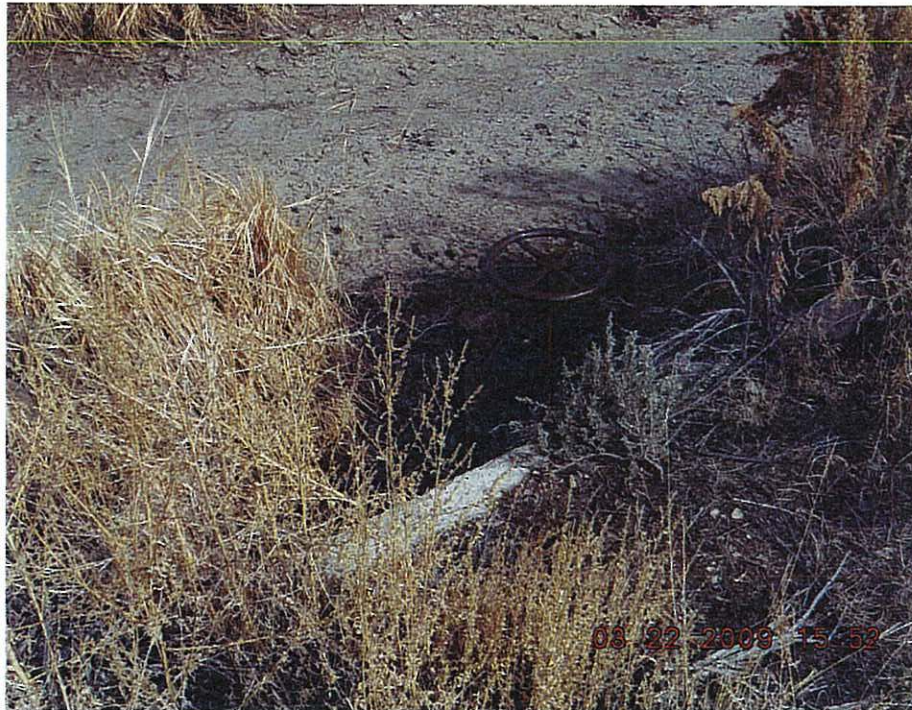
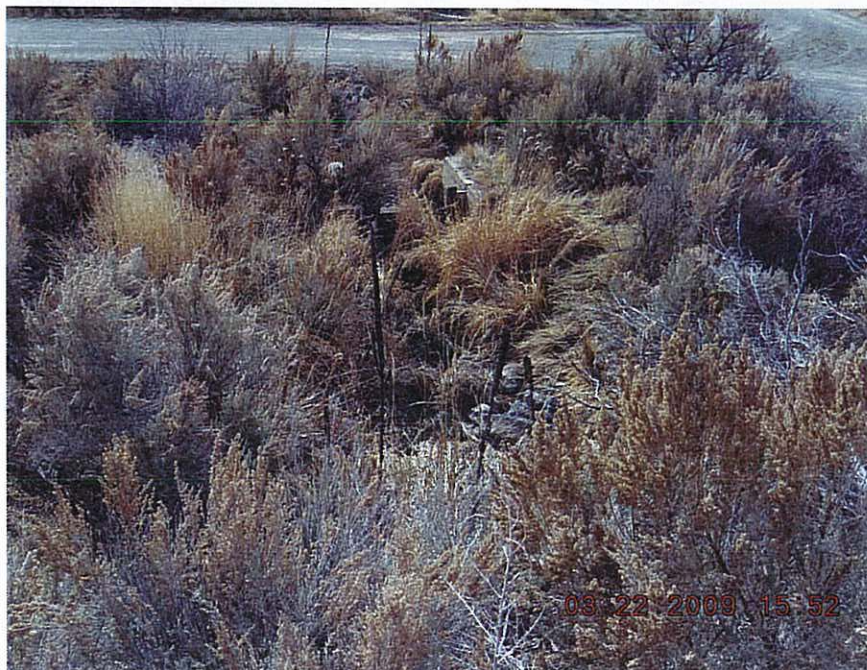
Eastside Canal  
Ray Boyack (North)  
42"

Active headgate. 3 ft. rectangular weir is not acceptable due to excessive obstruction at both ends. Control device is adjustable and lockable.

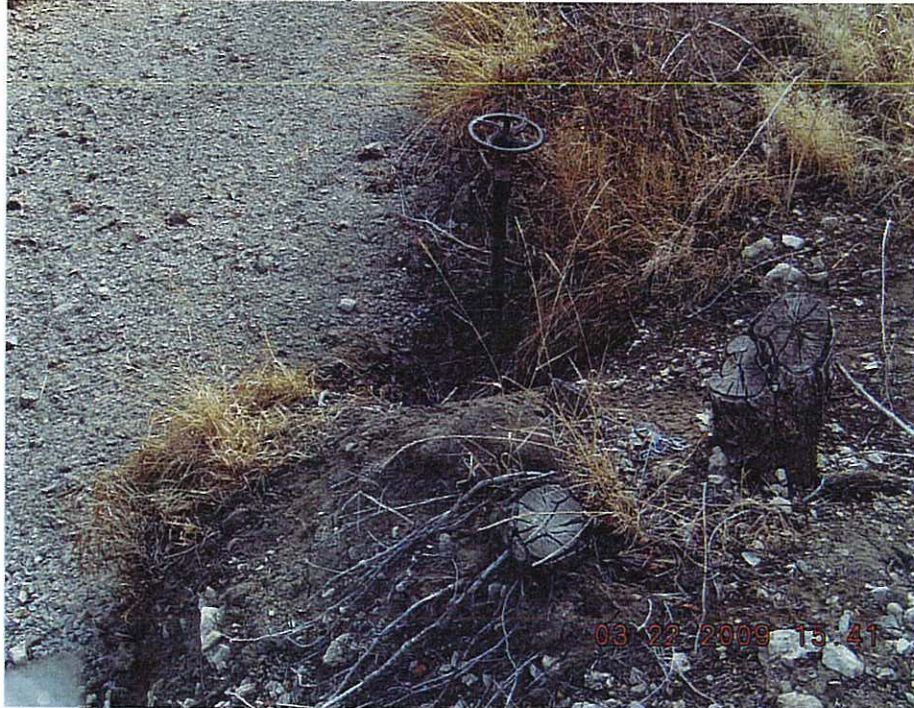
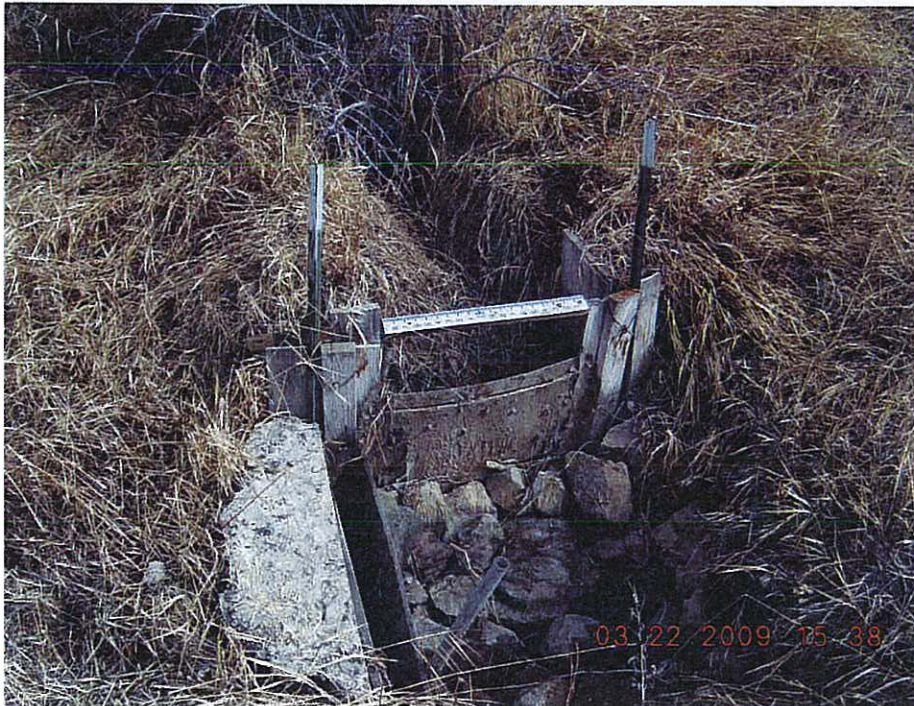
Eastside Canal  
Ray Boyack (South)  
19' 44"

Active headgate. 2 ft. rectangular weir is not acceptable because of debris. Control device is adjustable and lockable.

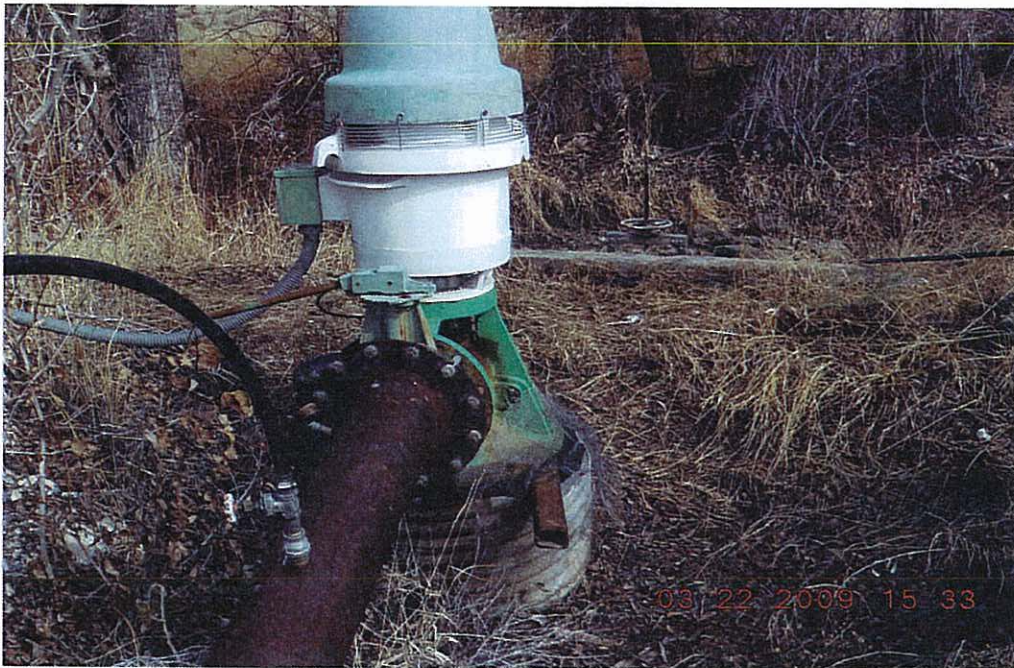
Eastside Canal  
Dennis Moss  
55"

Active station. Magnetic flow meter. No adjustable and lockable control valve.

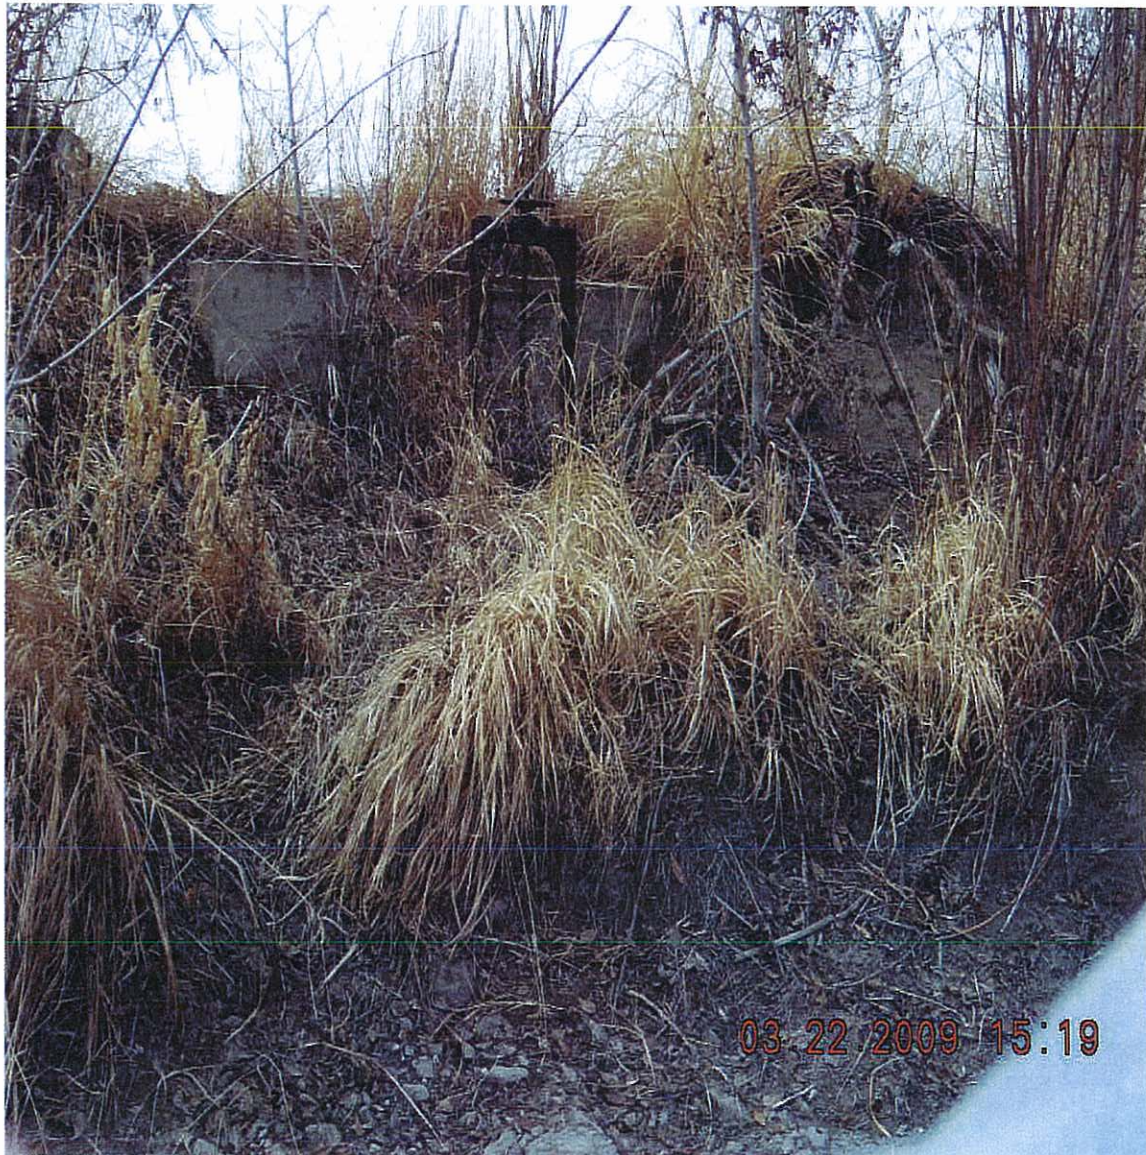
Eastside Canal  
South of Morgan Lane

Inactive headgate.

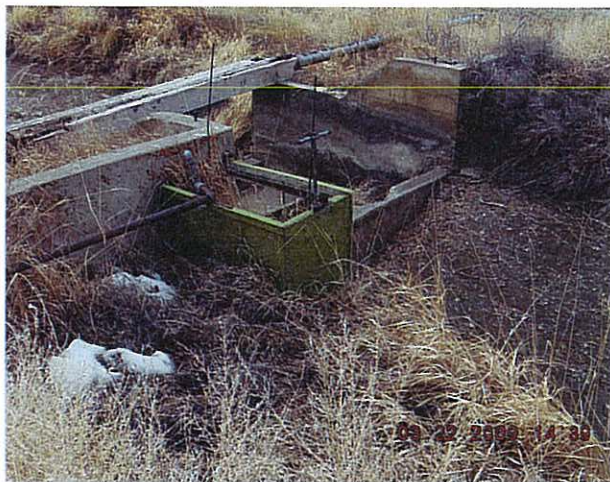
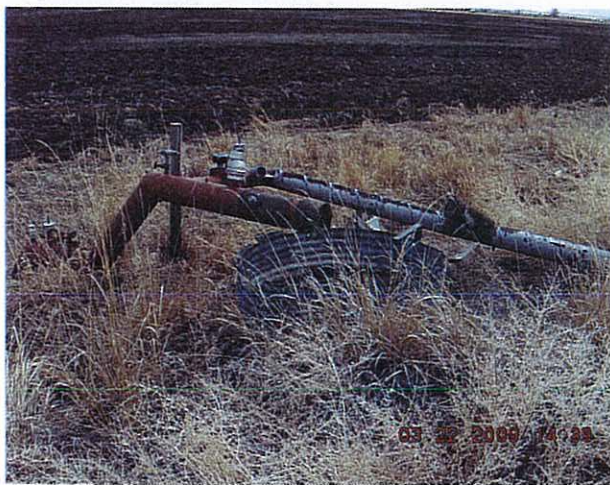
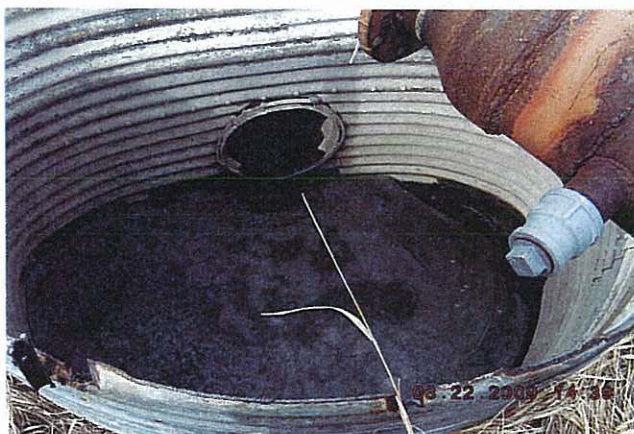
Eastside Canal  
Tyler Felton  
41"

Inactive station. No control gate.

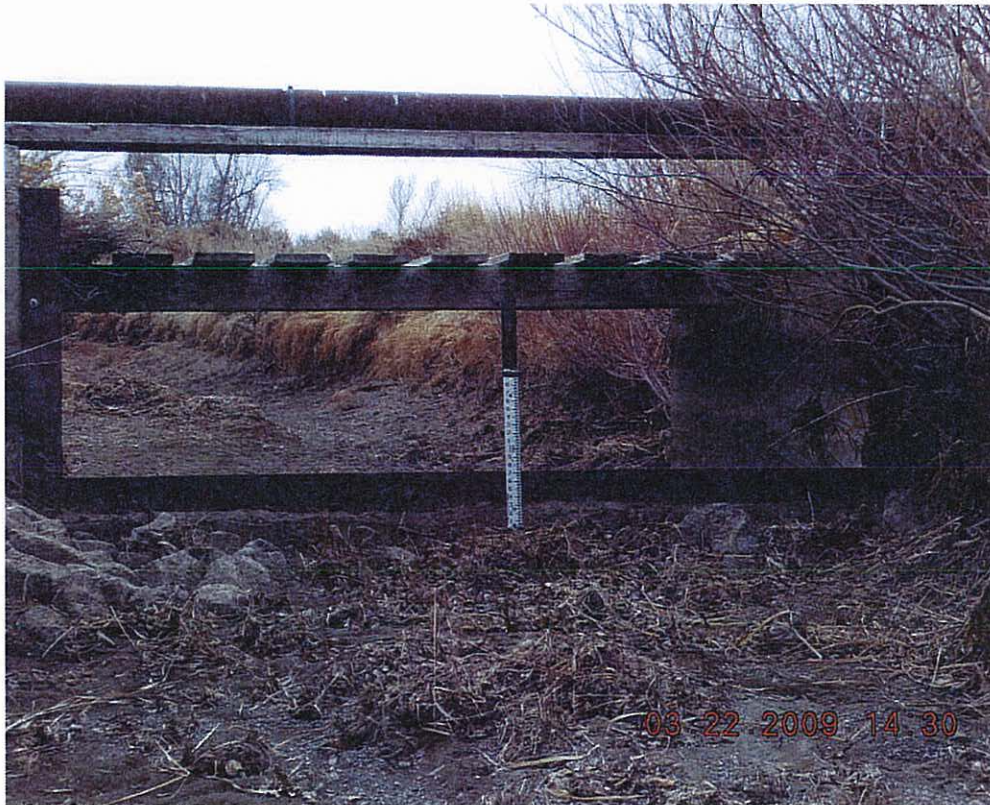
Eastside Canal  
Tyler Felton

Inactive.
