RE: Water District 34 Water Measurement Matters.

# **EIM CANAL PRESEASON COMPLIANCE REPORT**

RE: Compliance Report Notification

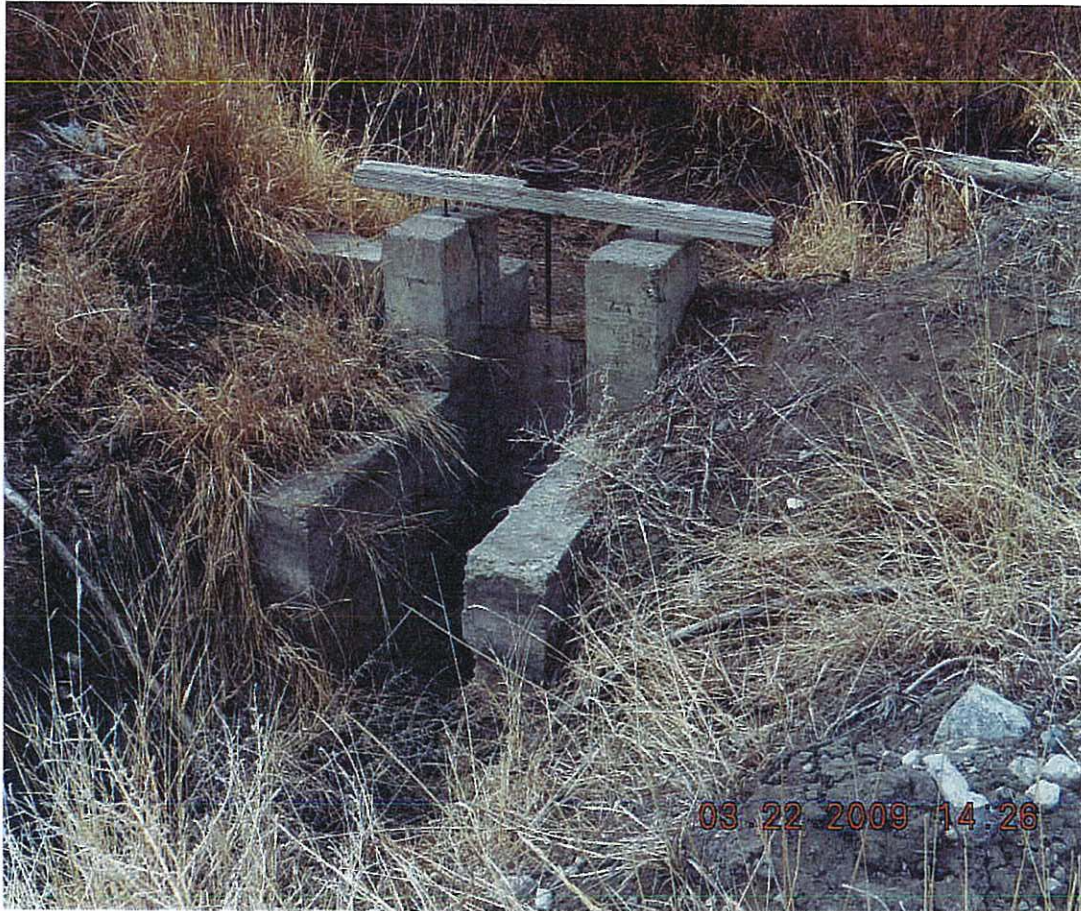
Eastside Canal  
Into James Creek  
43"

Two (2) control gates into James Creek that are adjustable and lockable. No measuring device.

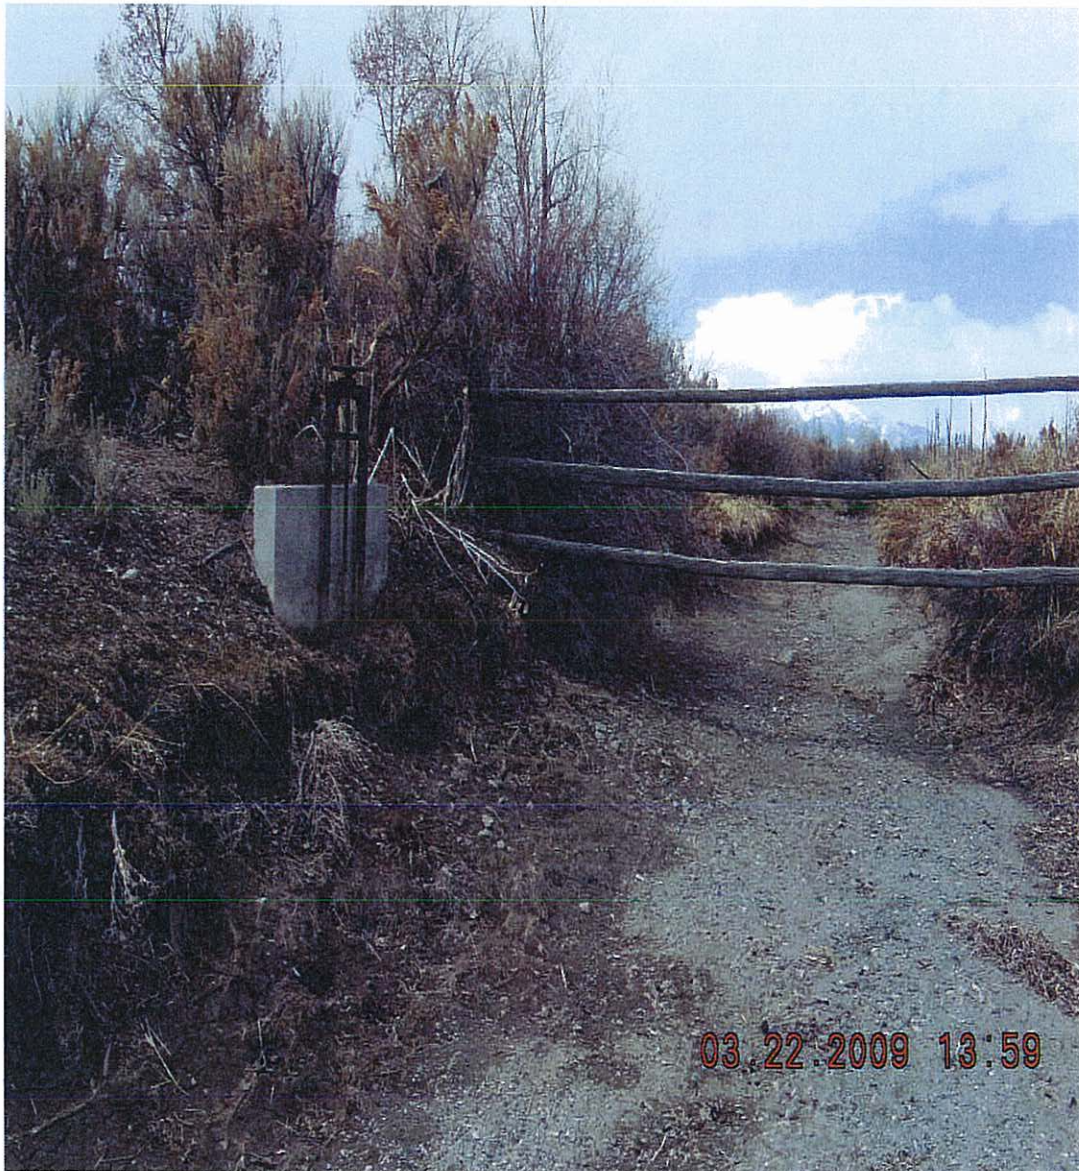
Eastside Canal

Canal North of Doug Schureman's well. Note the pile of debris in the middle of canal channel causing bank erosion.

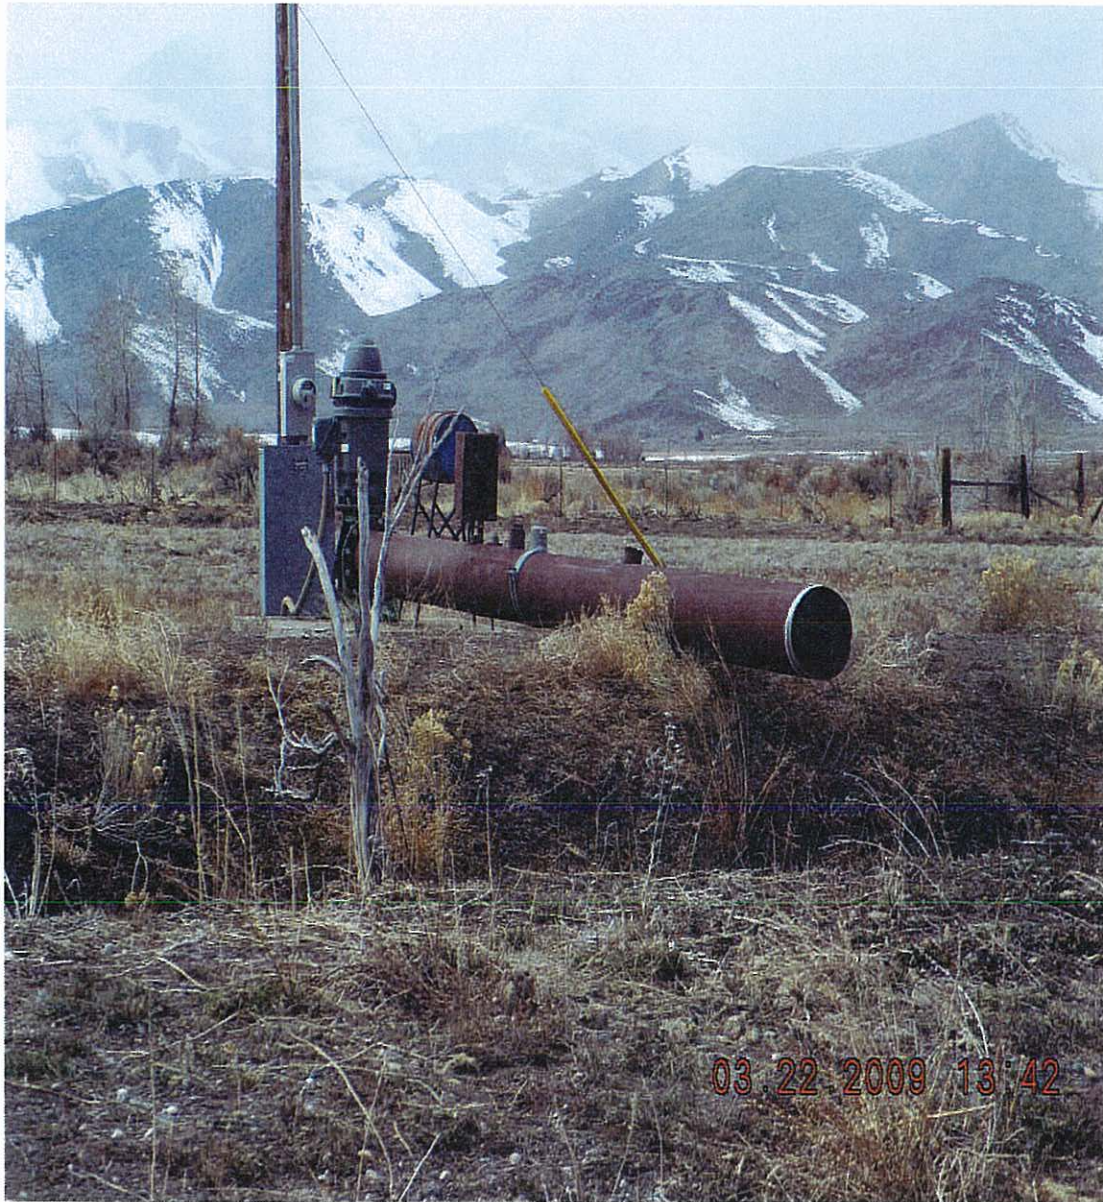
Nolan Beard

Active. Adjustable and lockable headgate. 3 ft. Cipolletti weir.

Measuring device needs repair due to bent edge that allows water to go under it.

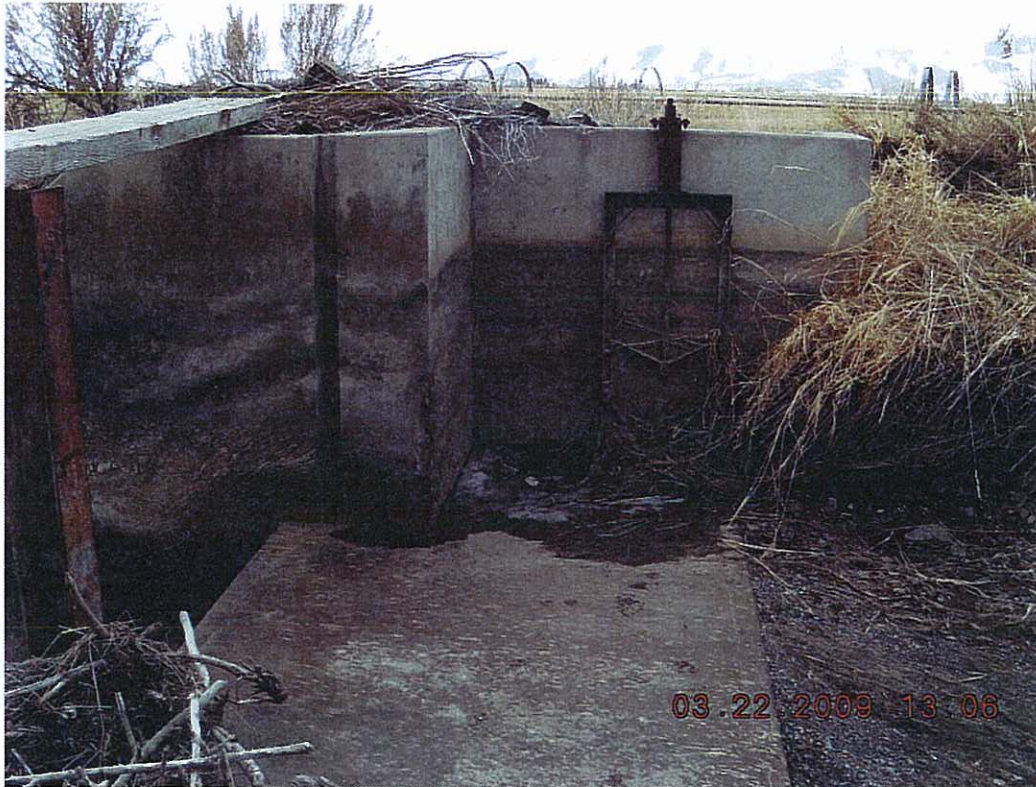
Eastside Canal  
Mary Leo Felton  
21"

Active station. Magnetic Flow Meter. Control is adjustable and lockable. System appears to be poorly designed.

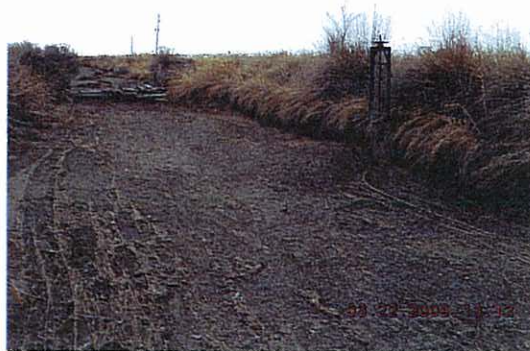
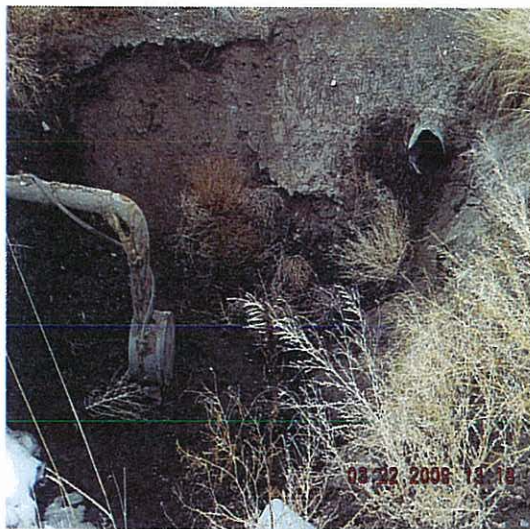
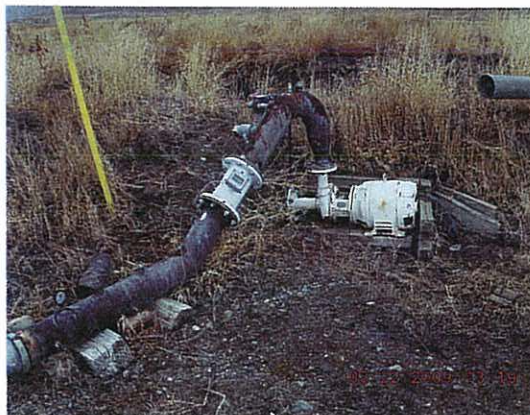
North West of Mary Leo Felton's home

Inactive headgate with control device.

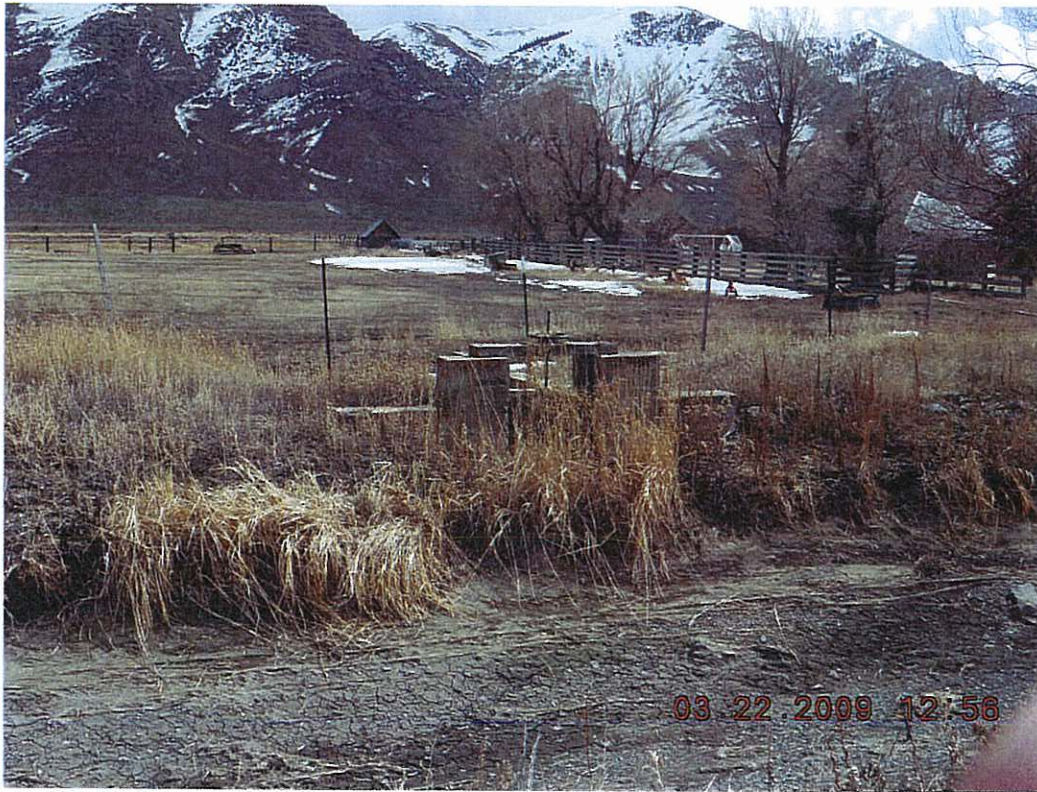
Eastside Canal  
Reva Walker

Active station with 1.5 ft. Rectangular measuring device. Adjustable and lockable control device. Approach needs to be cleaned to make device accurate.

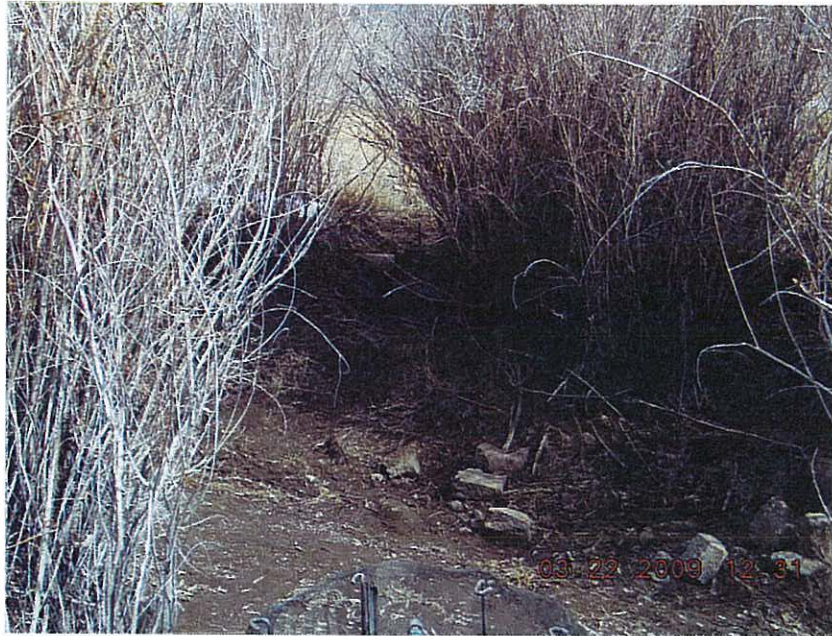
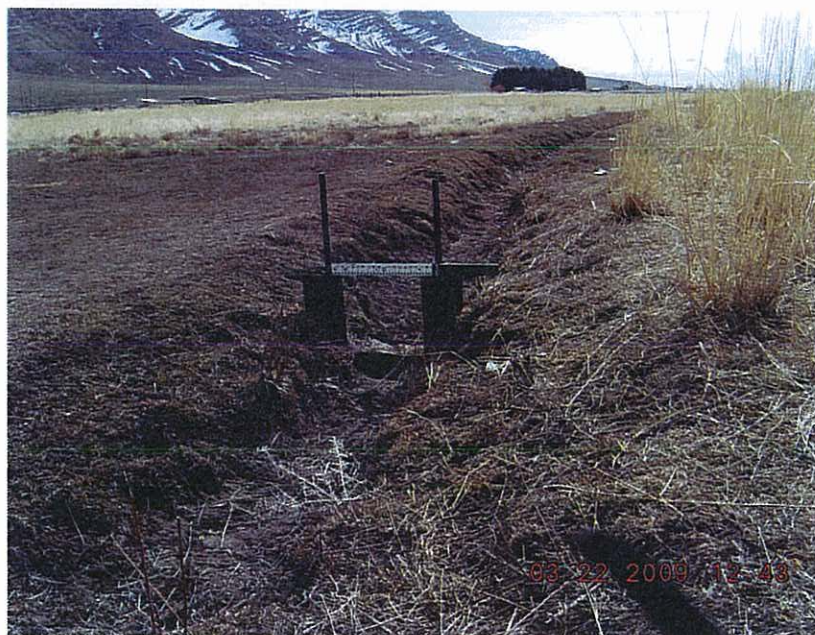
Eastside Canal  
Richard Reynolds

Active station. No measuring device, although there is a port for a flow meter. There is not enough straight unobstructed pipe up-stream or down for any type of flow meter to operate correctly. There is an adjustable and lockable control.

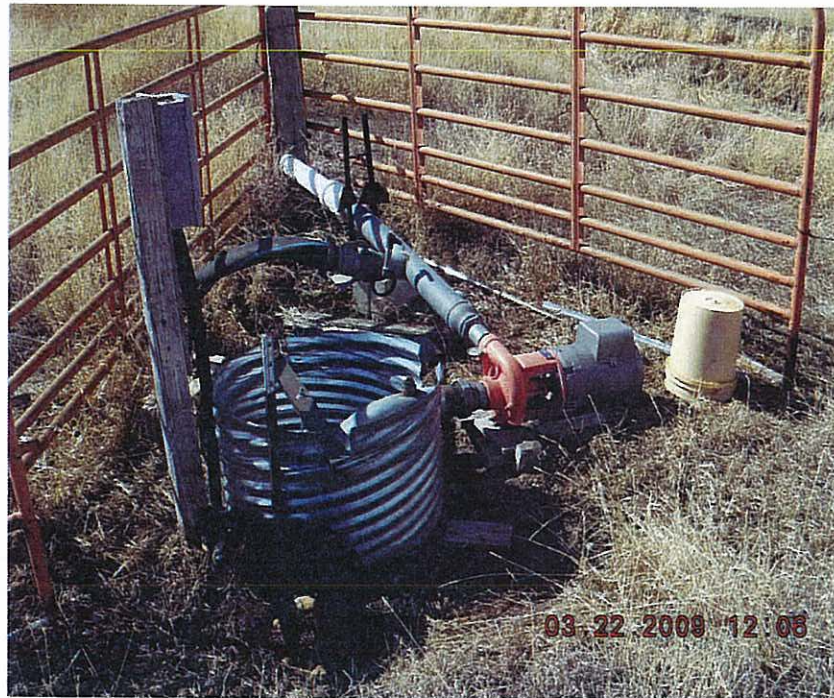
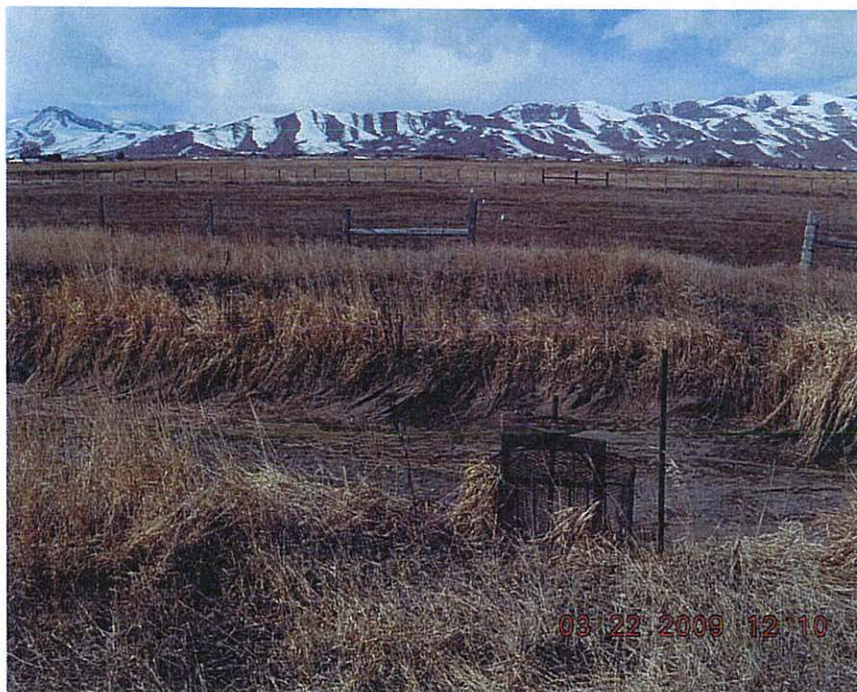
Eastside Canal  
Tony Madson

Active station. No measuring device. Control is adjustable and lockable.

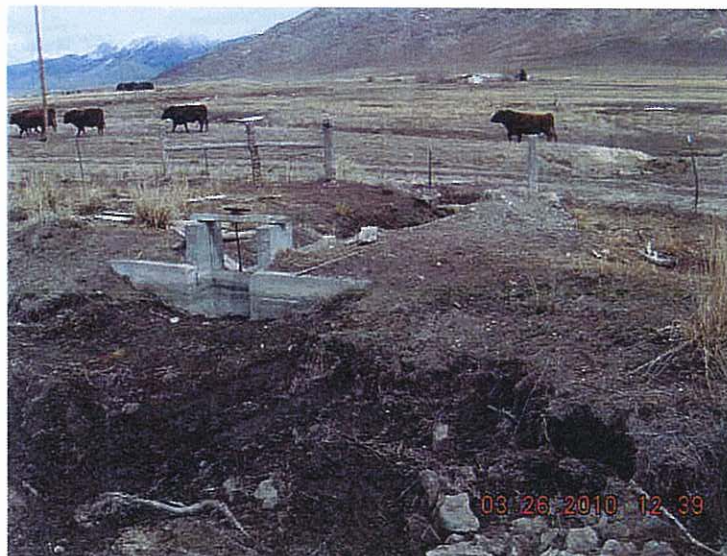
Eastside Canal  
PU Ranch  
02"

Active station. No measuring device. Two (2) adjustable and lockable control devices.

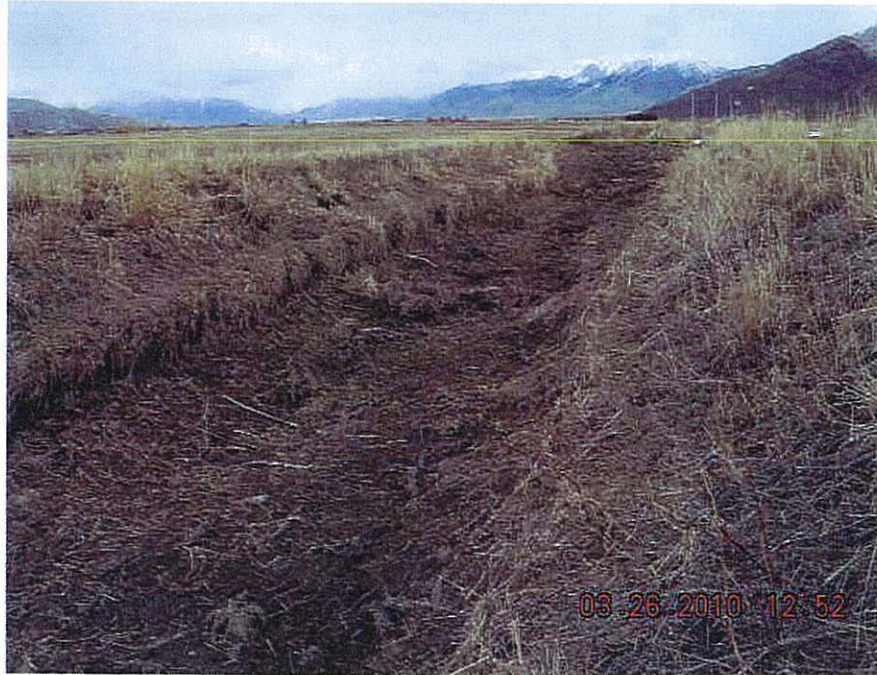
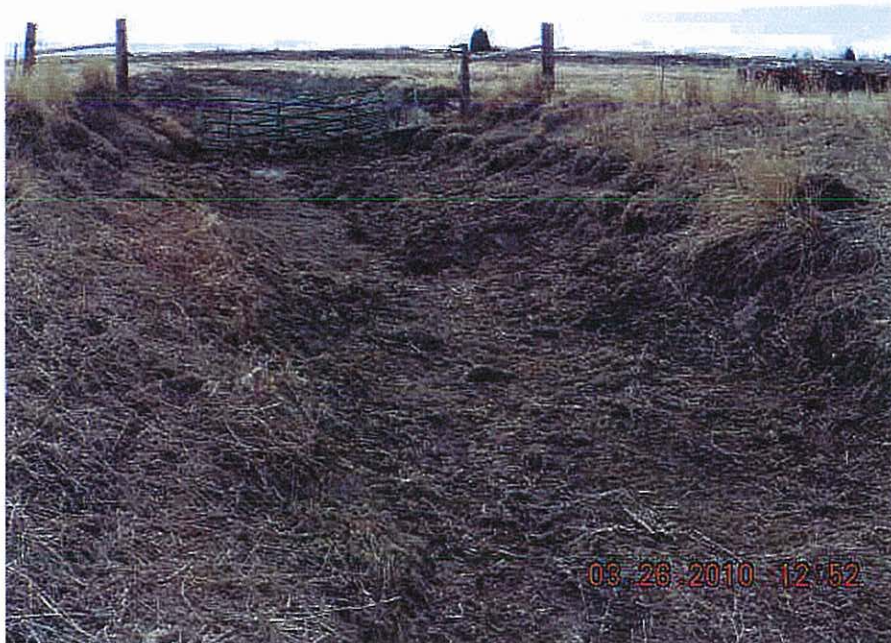
BLRID crew scraped sides but left sago pond grass and sediments un-disturbed. Water will flow around pond grass and erode banks.

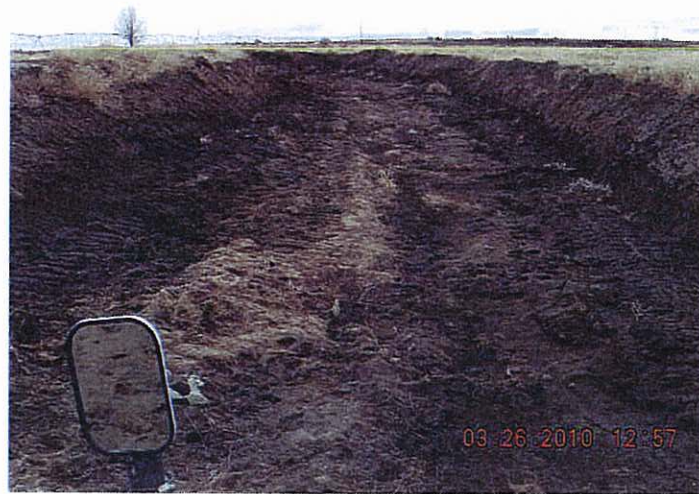
BLRID crew scraped sides but left sago pond grass and sediments un-disturbed. Water will flow around pond grass and erode banks.

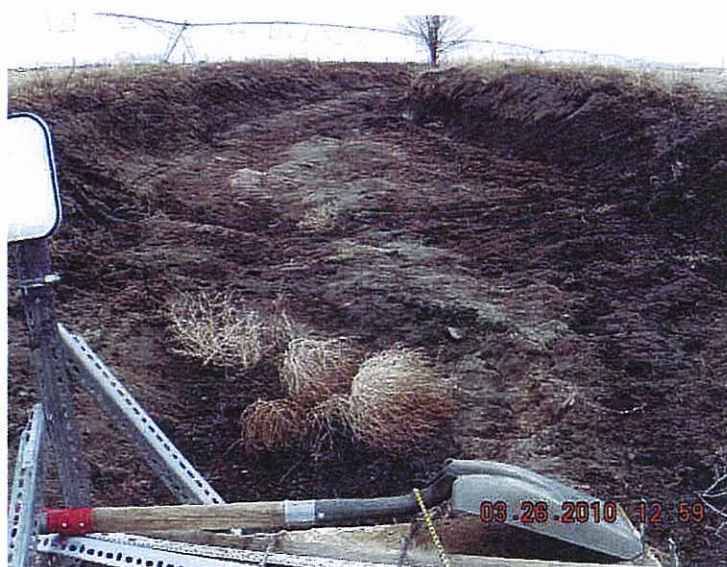
Eastside Canal  
North of Eastside Out  
03"

BLRID crew did not clean the pond grass out of the channel. When the grass grows the water will go around the side and cut the banks.

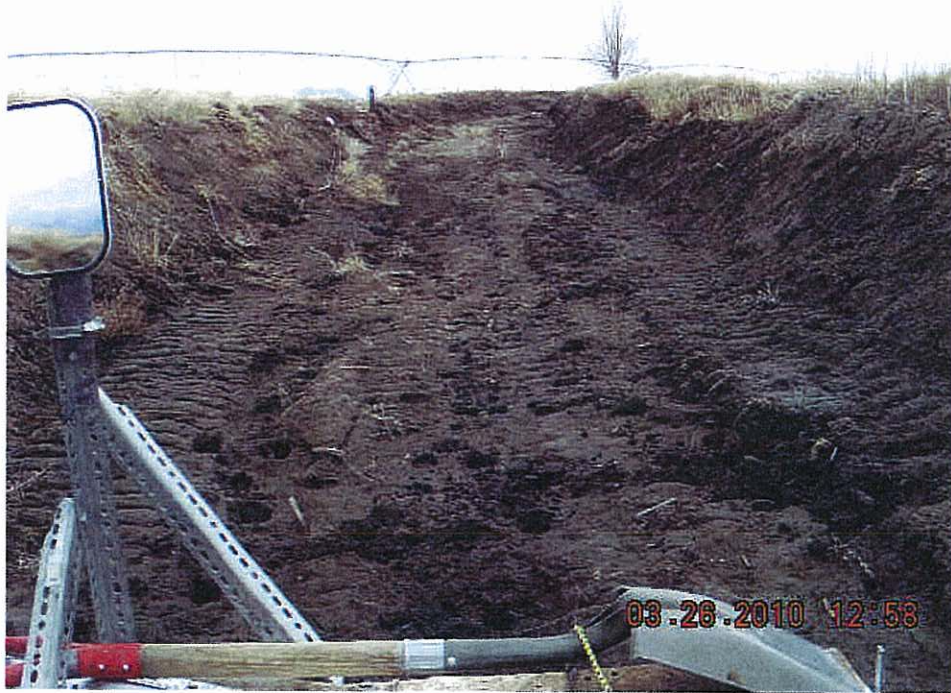
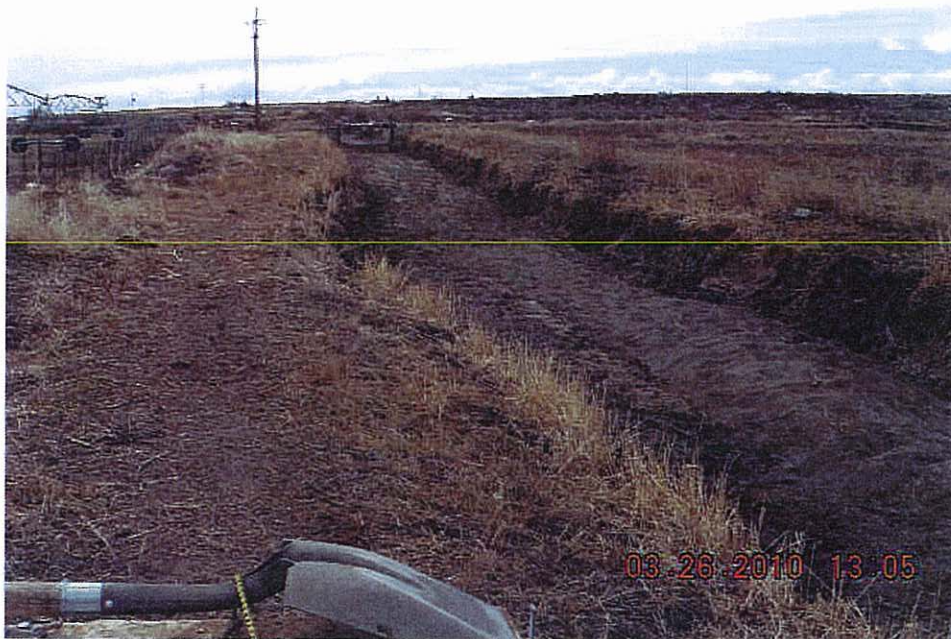
Eastside Out

11 ft. is not a standard rectangular weir. A data logger will be installed at this location.

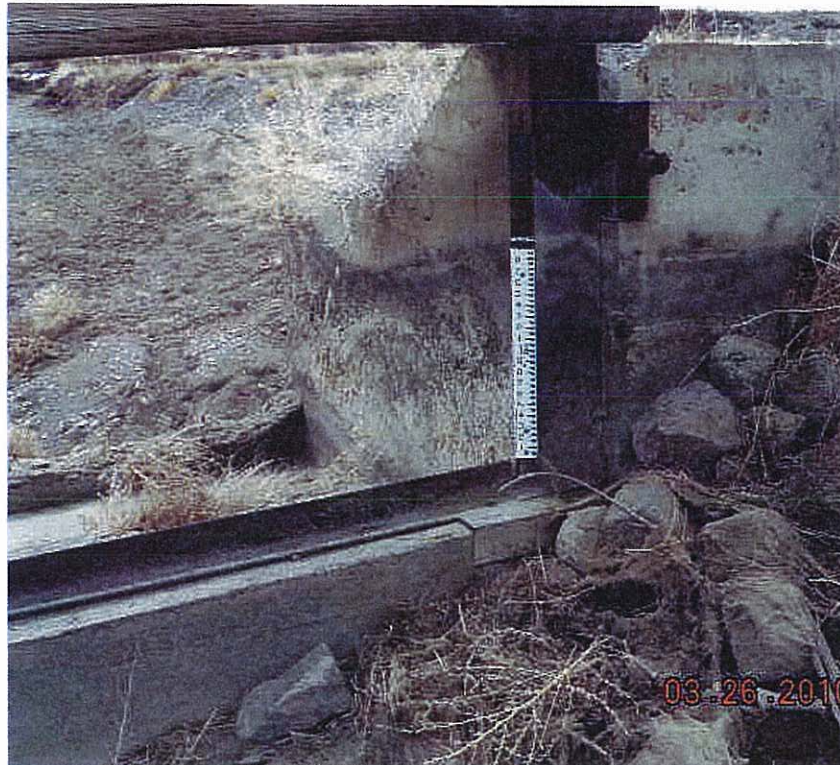
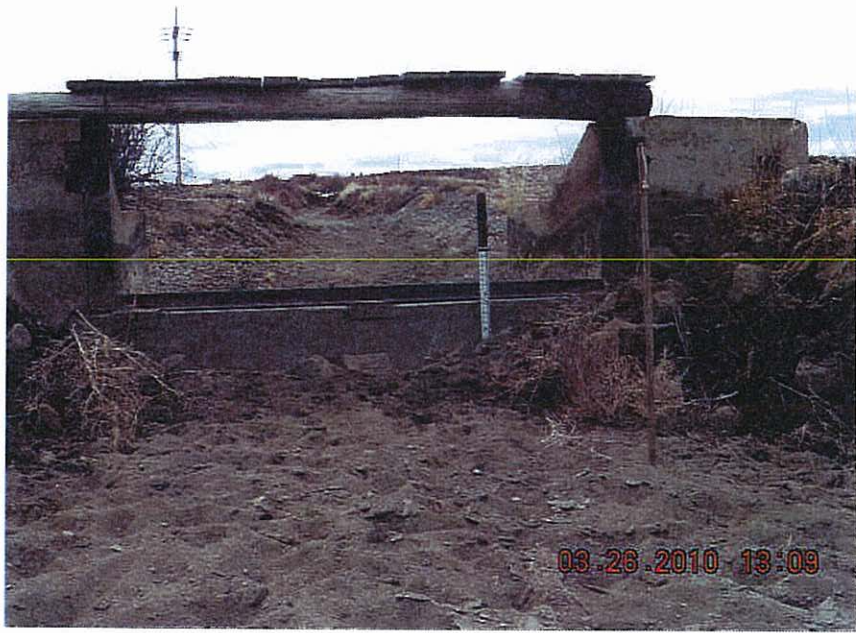
Arco Canal Heading Weir  
00"

Arco Canal Heading gates are adjustable and lockable. As discussed on the symposium tour, the measuring device is not adequate due to design. There is not enough elevation drop or contraction especially from the bottom and water does not have a straight shot at the weir. A data logger will be installed at this site.

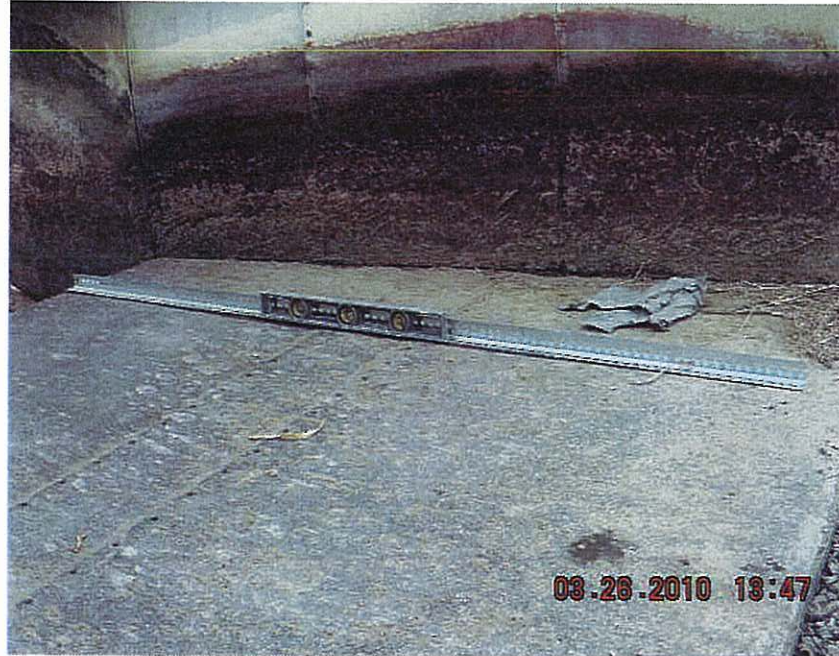
The East Side

The measuring device is a 5 ft. Parshall flume. Please note the front to back on East and West sides are nearly level. The East side of the floor is 1.25 in. lower than the West side of the floor. The gauge is 3/100 short and is mounted on the low side.

The bottom of the flume box is not level side to side. Note the difference of approx. 1.25 in. This device will need to be reset or recalibrated to achieve an accurate reading. This site will also include a data logger.

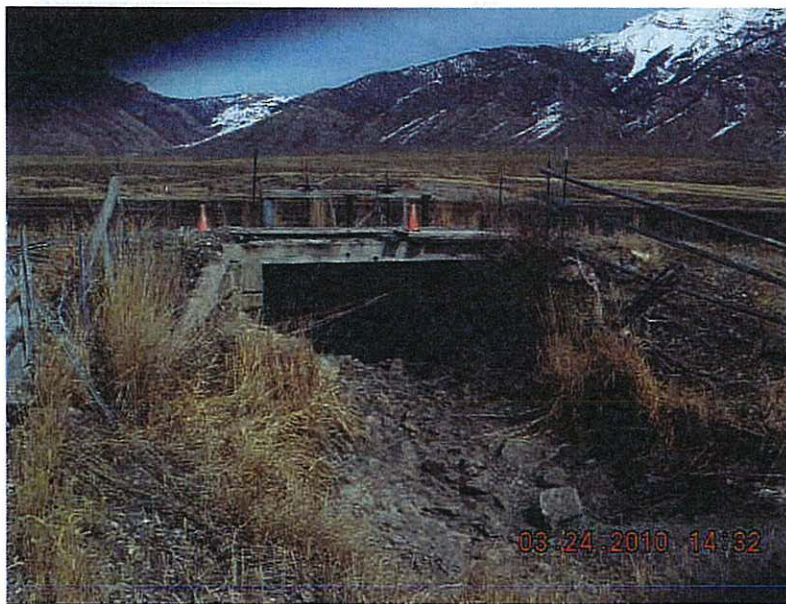
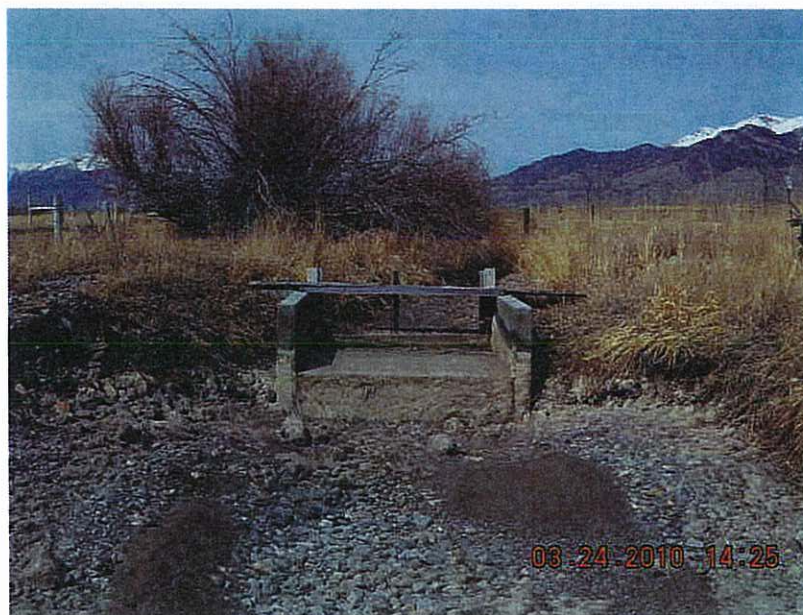
Active canal heading. Adjustable and lockable control. 7 ft. rectangular measuring device. Not acceptable because the device lacks adequate contraction and the water flow does not have a straight approach to the weir. A data logger will be installed at this location to assist in accurate calibration.

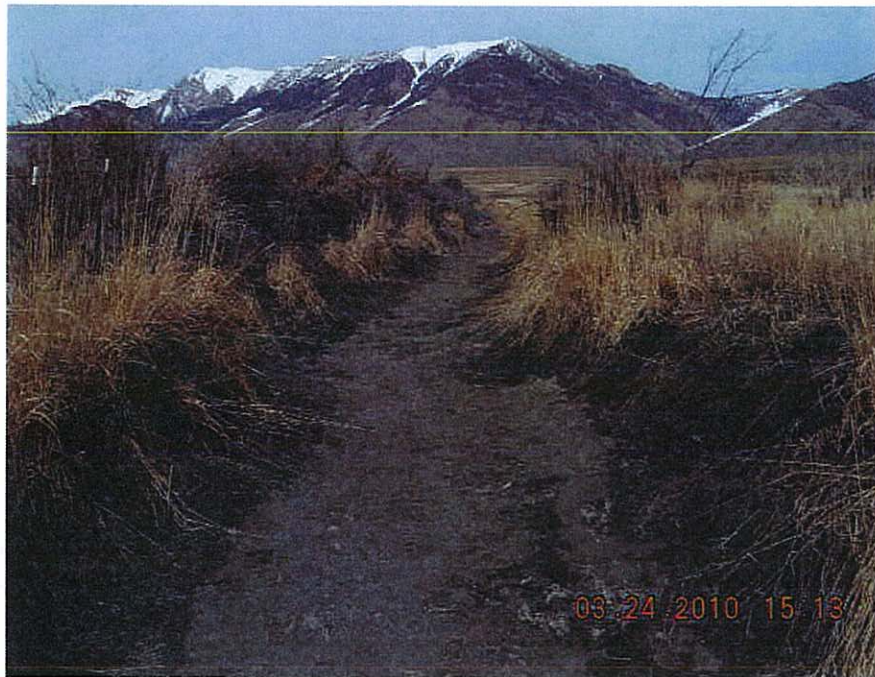
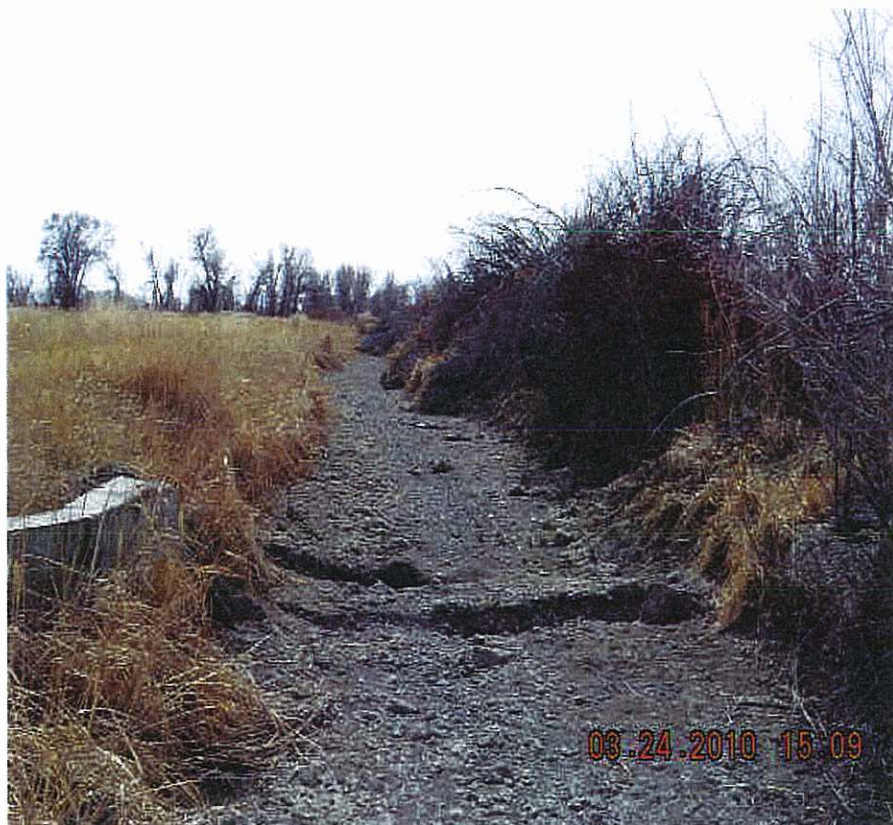
Inactive headgate. The 8 in. lip in the check structure should be removed to reduce water stacking which causes excessive shrink.

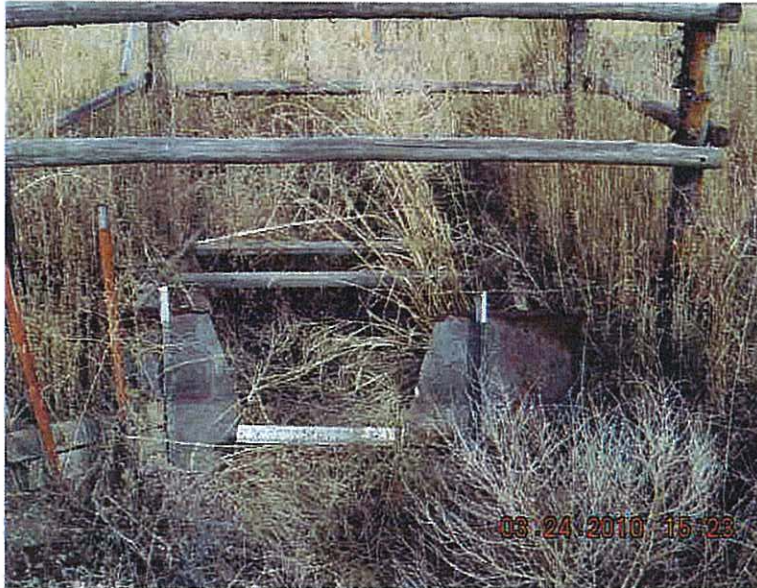
Active station. Adjustable and lockable control. 2 ft. Cipolletti weir.  
The area around the weir needs to be cleaned.

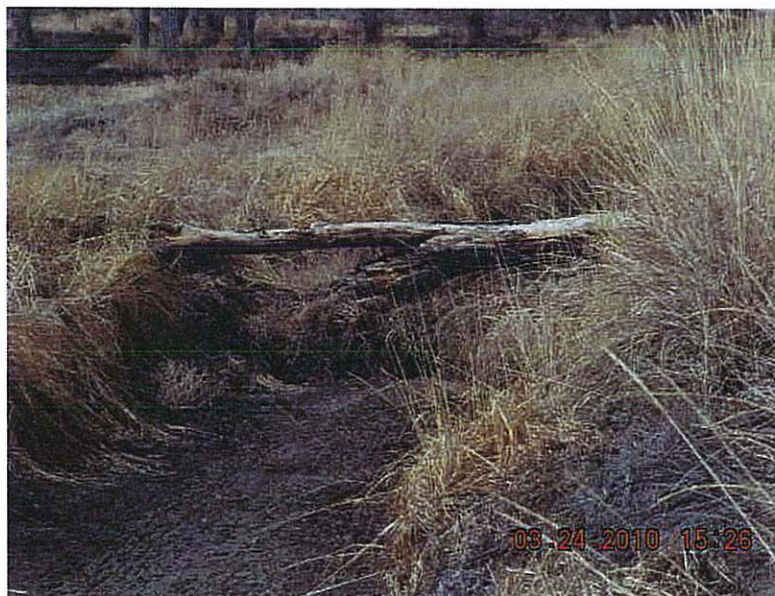
Up stream in Island 100 feet. The tree limb has caught some debris and is causing canal flows to be reduced and shrink to increase.

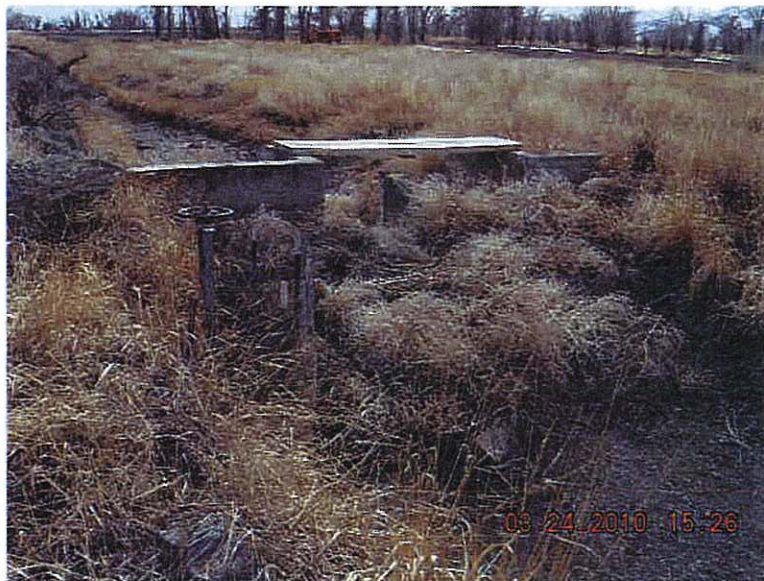
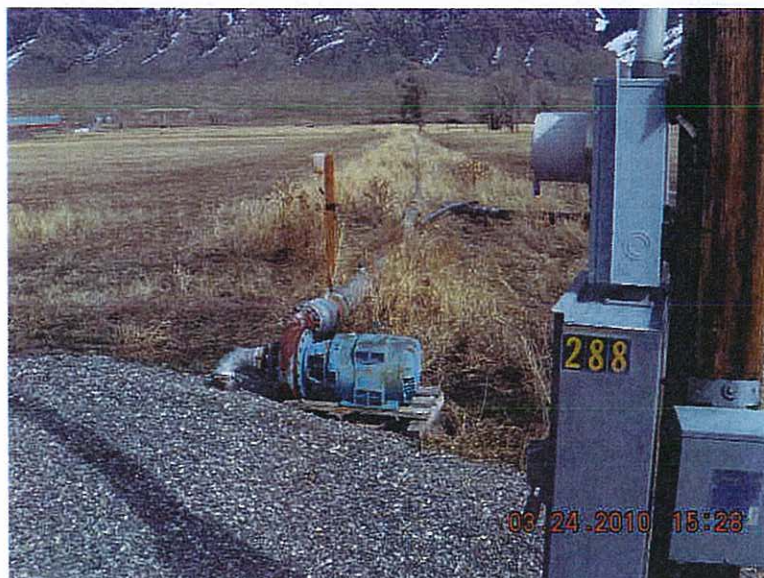
Active headgate. Adjustable and lockable control. The measuring device is a flow meter located in the discharge pipe.

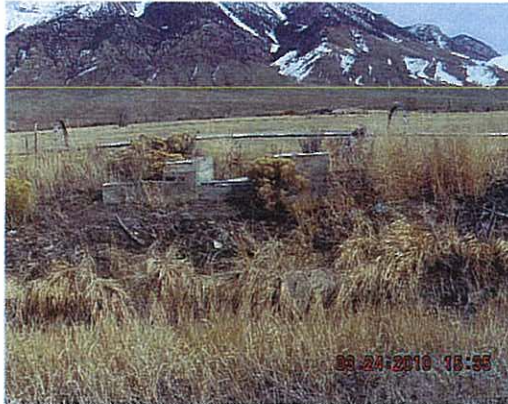
North of 3400  
side

Island Canal  
(3) Inactive headgates.

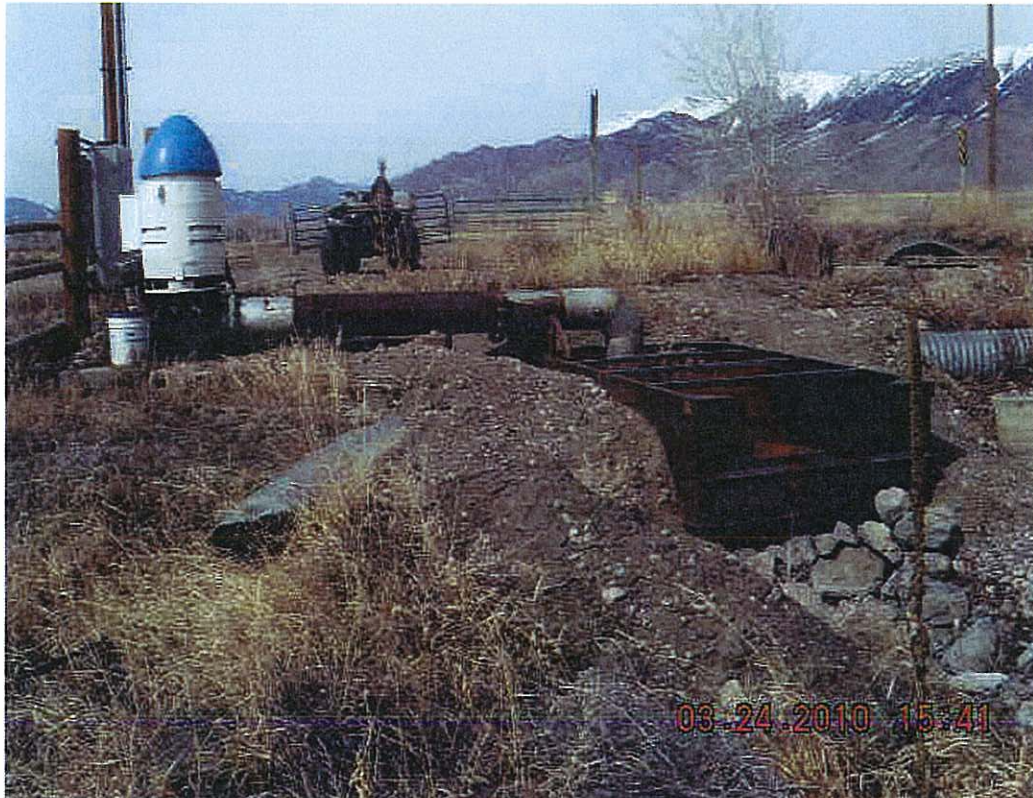
Island Canal  
Leon Folkman (Deep Well)  
04"

Active well. 3 ft. Cipolletti weir and stilling box.

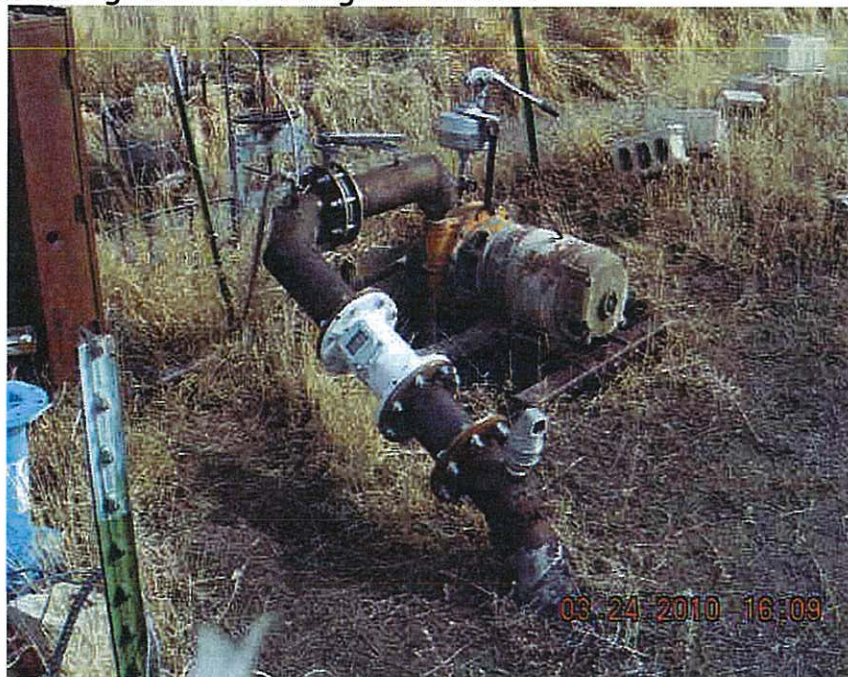
Island Canal  
Kevin Pearson  
01"

Active station. Adjustable and lockable control.  
The measuring device is a Magnetic meter.

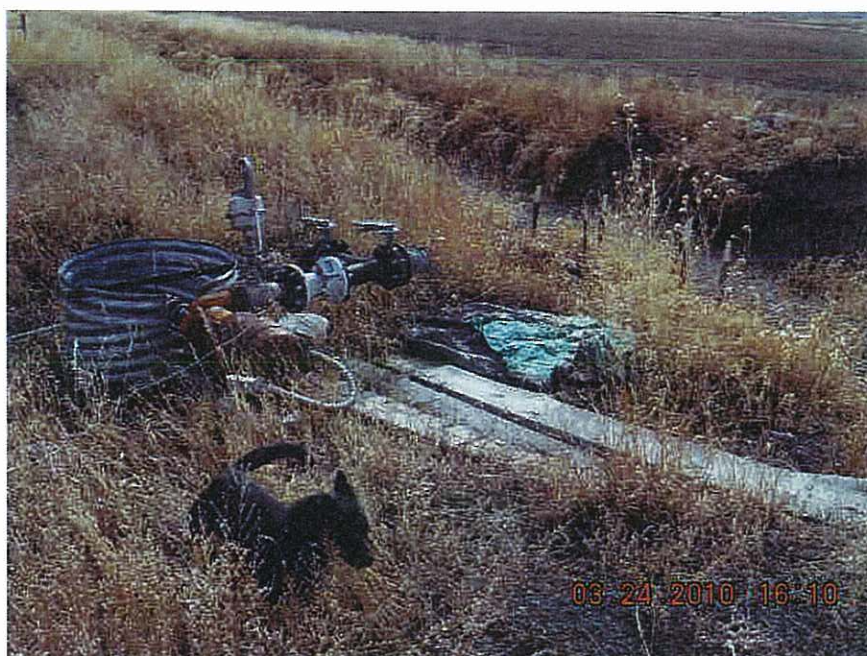
Mike O'Neal - Active station with Magnetic meter.

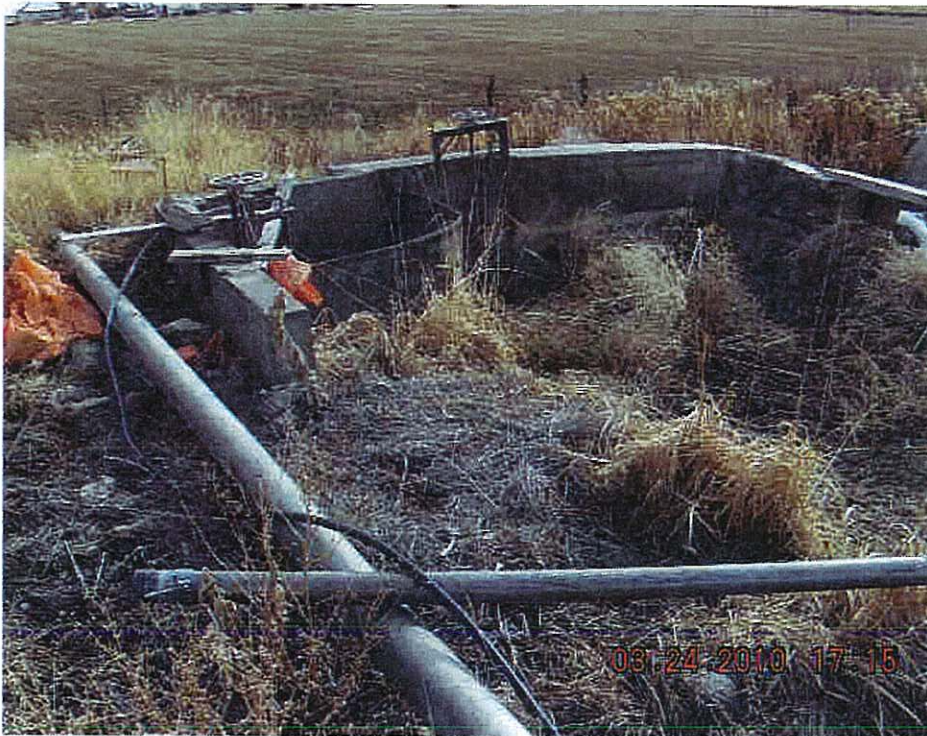
Island Canal  
King and Beaverland Gates  
58"

Active stations for Stephen King with a submerged rectangular orifice, and Beaverland Ranch which does not have a measuring device. Station should be cleaned to improve efficiencies. Both stations have adjustable and lockable controls.

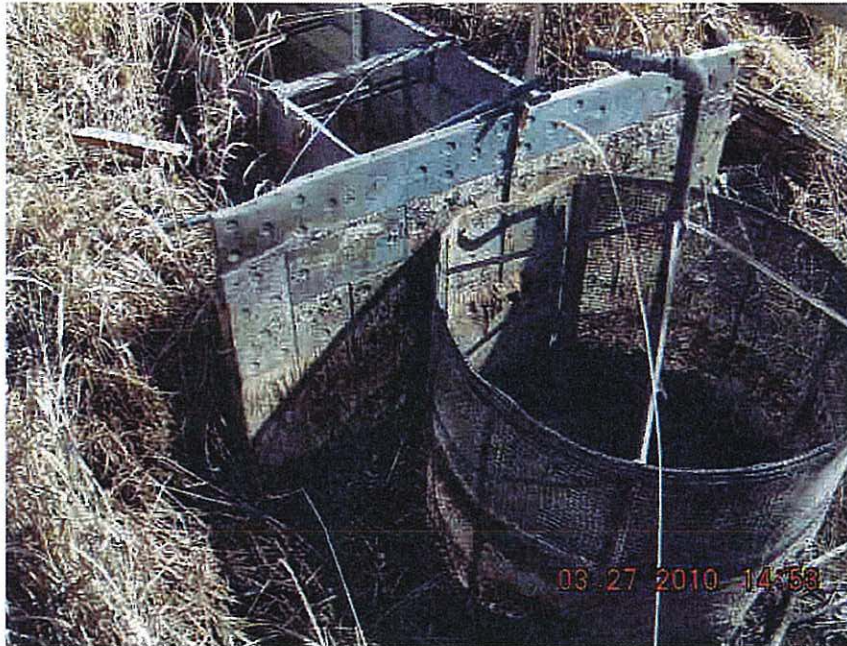
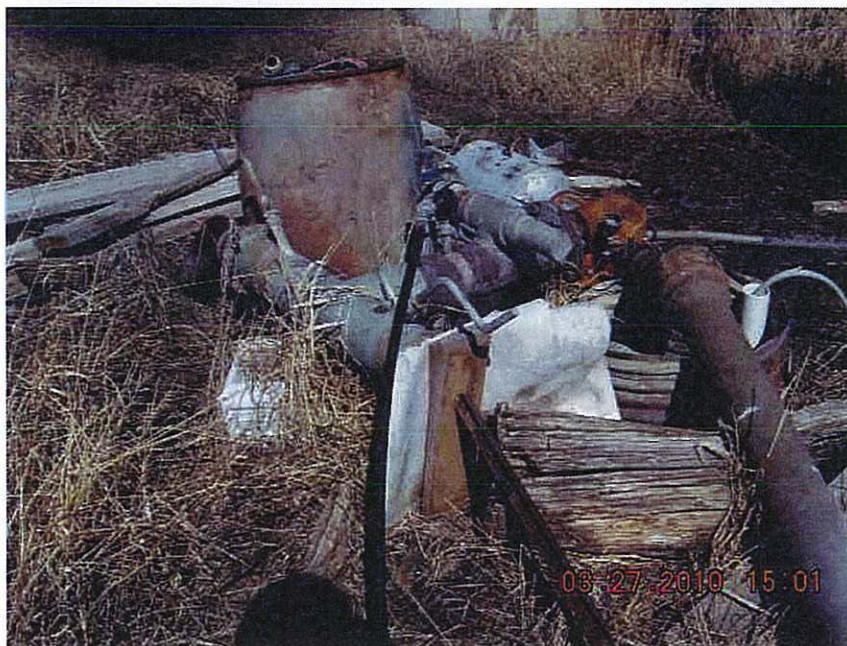
Island Canal  
Stephen King (South)  
10"

Active station. Adjustable and lockable control.  
The measuring device is a submerged orifice.
