RE: Water District 34 Water Measurement Matters.

# **EIM CANAL PRESEASON COMPLIANCE REPORT**

RE: Compliance Report Notification

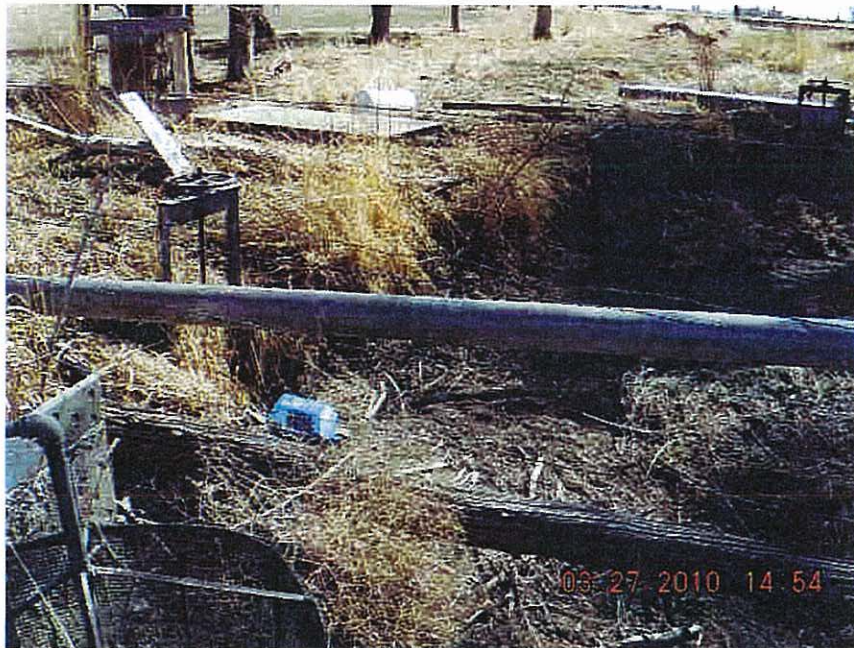
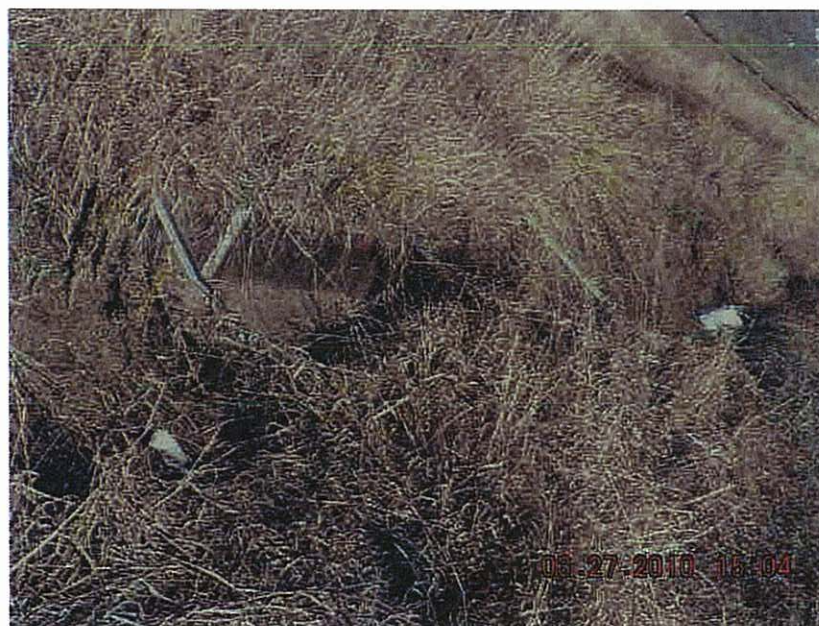
Island Canal  
Alvin Wheeler (North)  
10"

Active station. Adjustable and lockable control. 18 in. Parshall flume.  
The flume will need to be cleaned to achieve an accurate measurement reading.

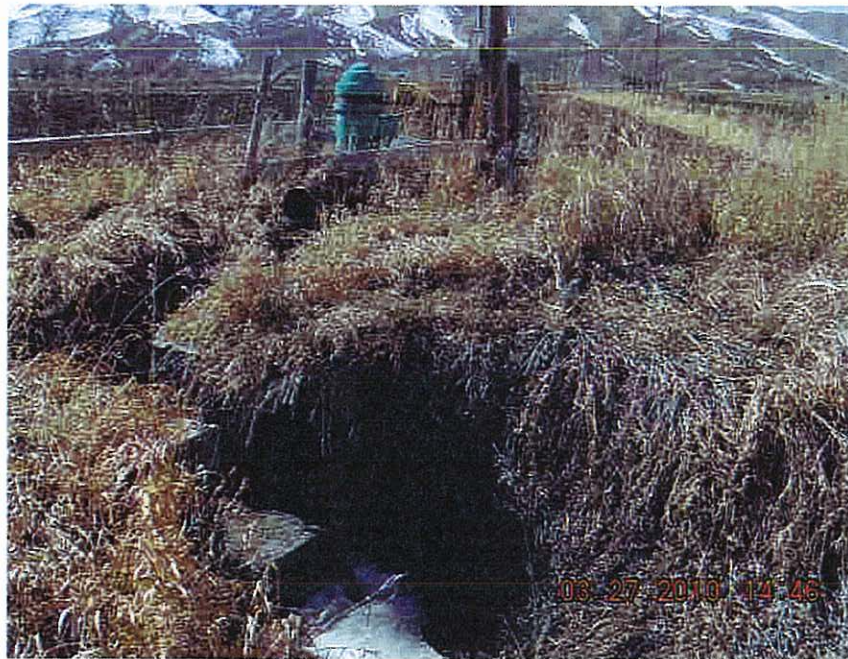
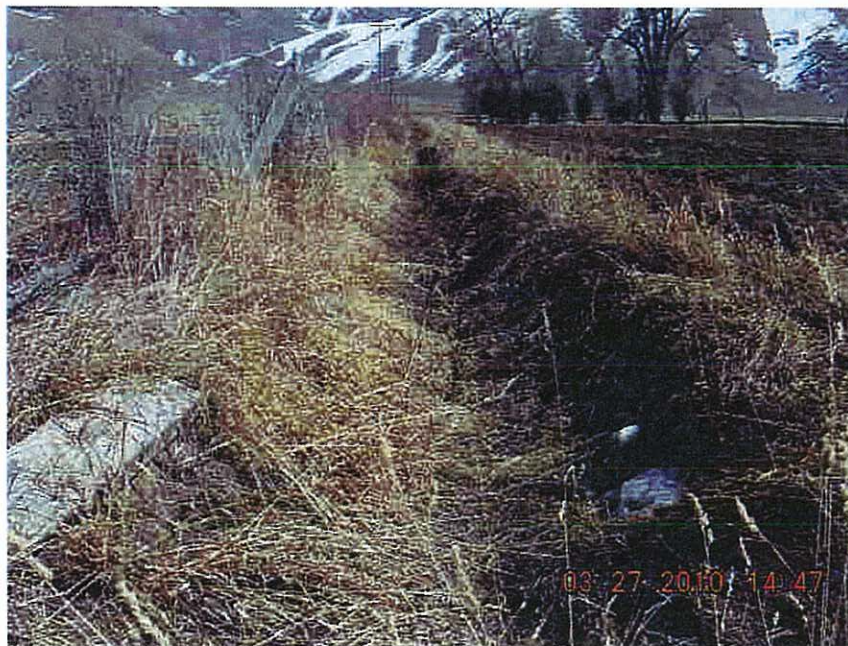
Island Canal  
Larry Jensen (well)  
15"

Active well. No measuring device.

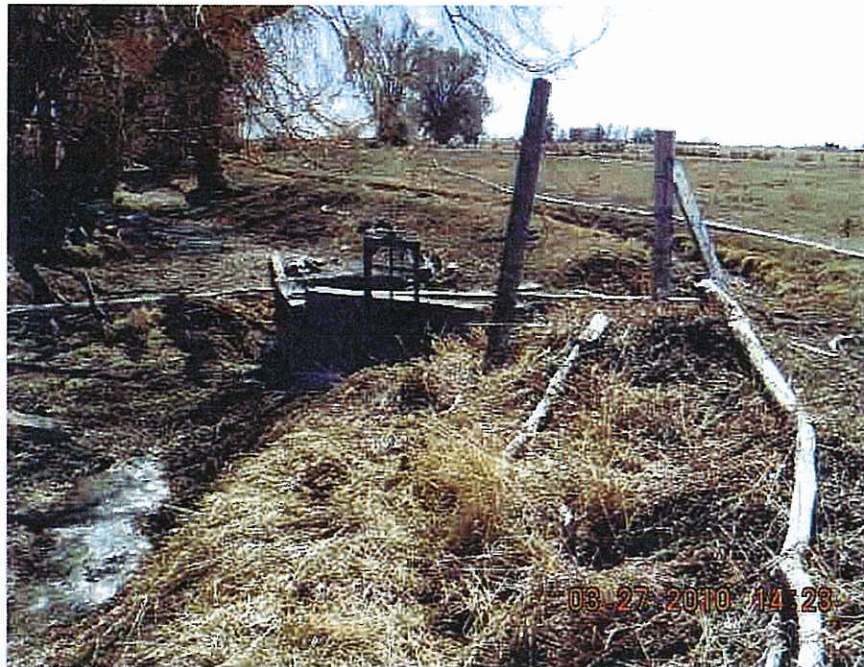
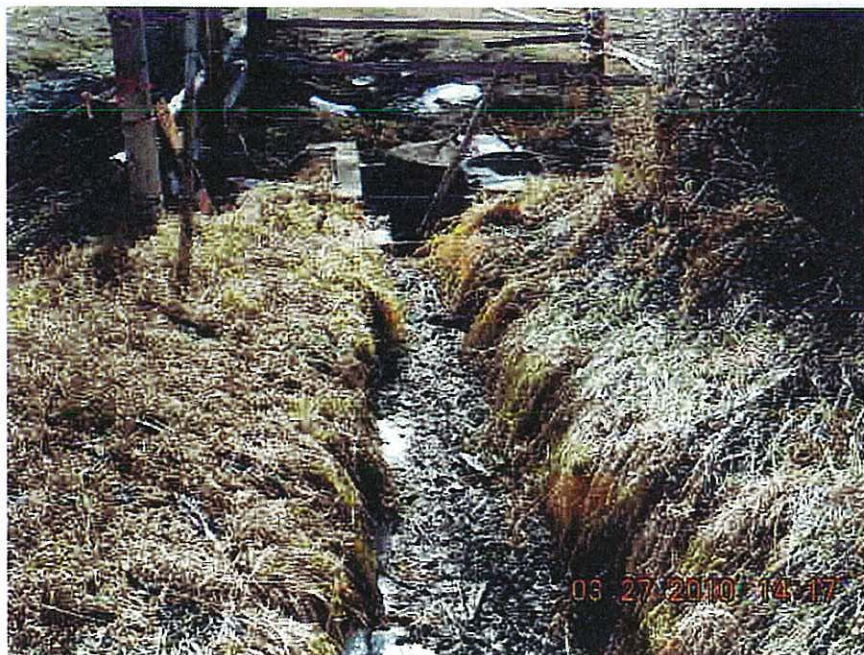
Island Canal  
Larry Jensen (South)  
06"

Active headgate. Adjustable and lockable control. No measuring device.

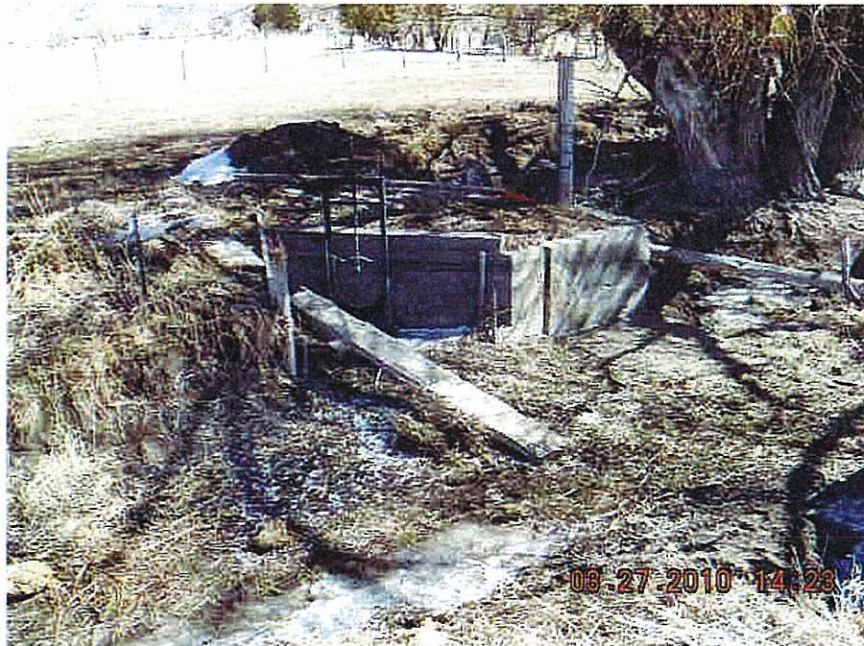
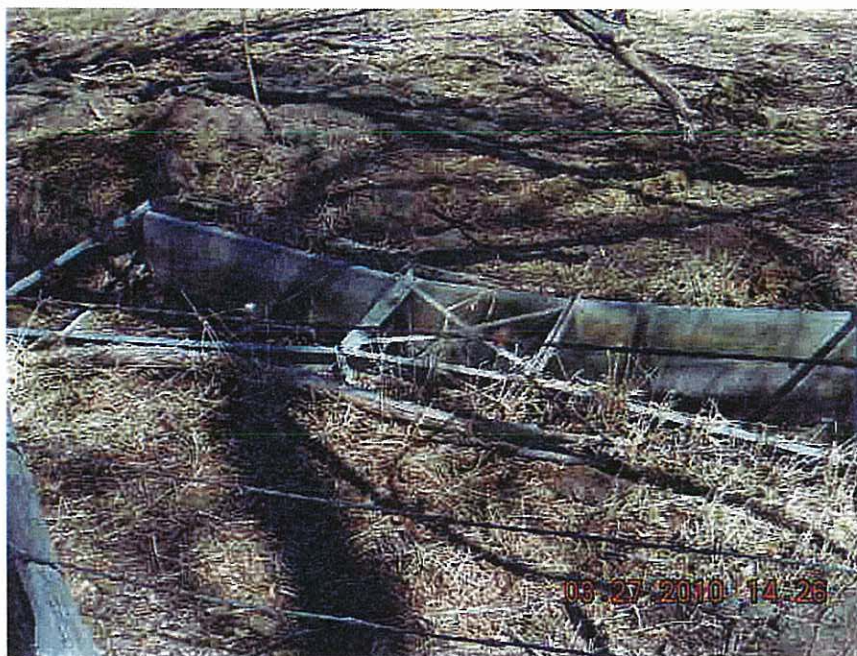
Island Canal  
Penny Hawkins  
06"

Active headgate. Adjustable and lockable control. The measuring device is a Parshall flume.

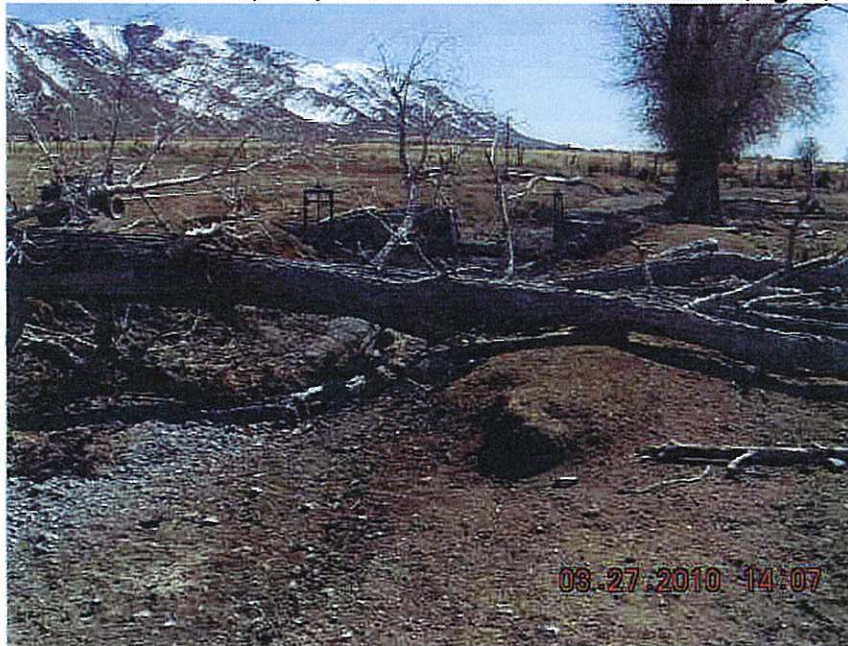
Island Canal  
A. Wheeler & E. Zediker  
09"

Active headgates. Adjustable and lockable controls. 3 ft. rectangular weir and a 18 in. Parshall flume (front 1.0 in. high). Note the fallen tree in canal.

Alvin Wheeler (left)

Ernest Zediker (right)

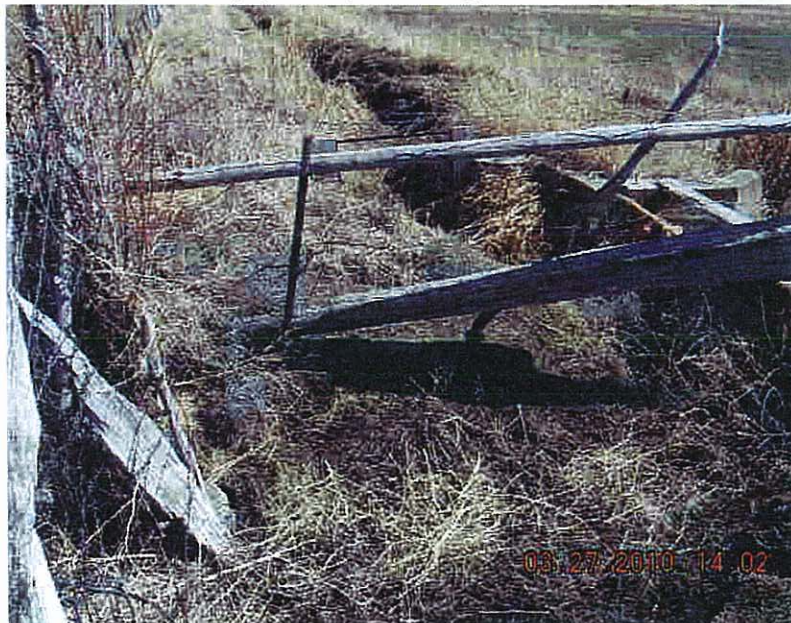
Alvin Wheeler 3 ft. Rect.

E. Zediker 18 in. Parshall

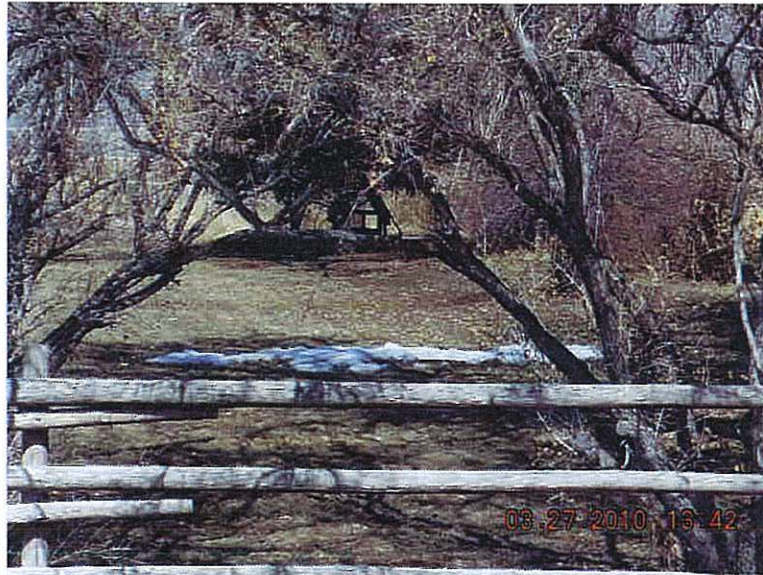
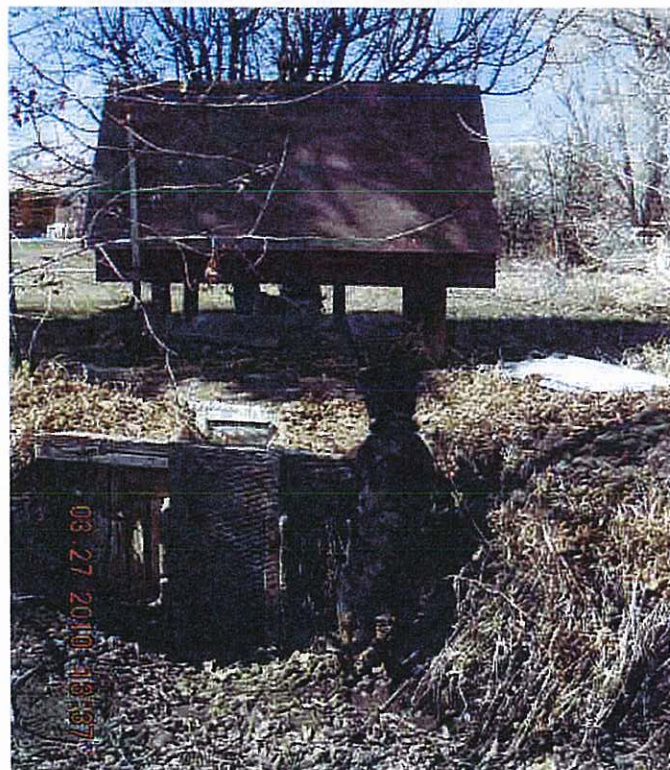
Island Canal  
Richard Keller  
14"

Active headgate. No adjustable and lockable controls. No measuring device.

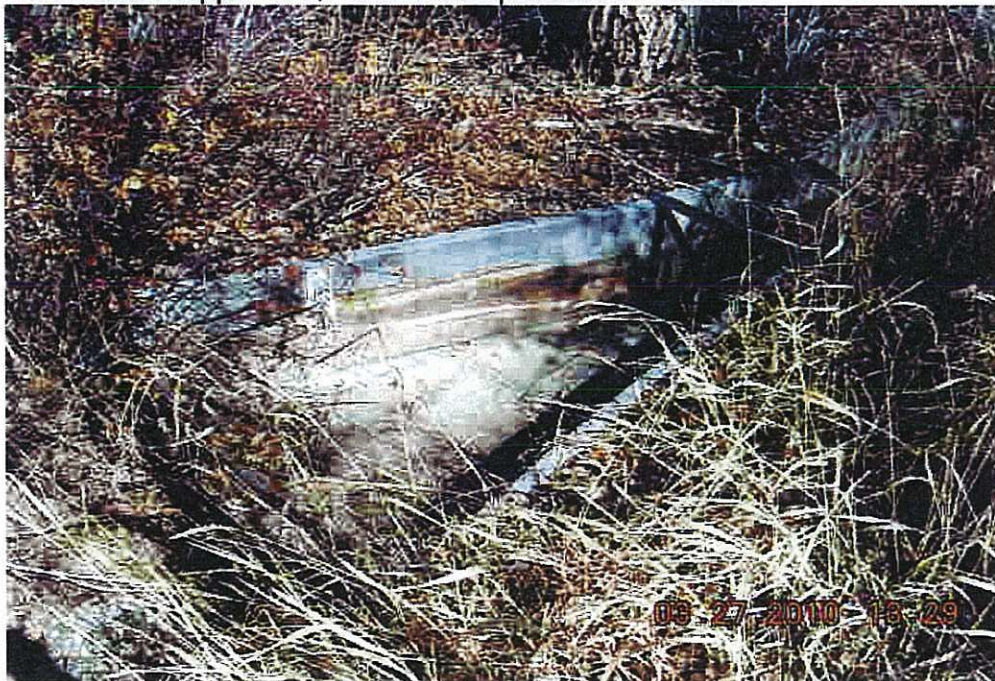
Tree roots in approach, roots have pushed sides in.

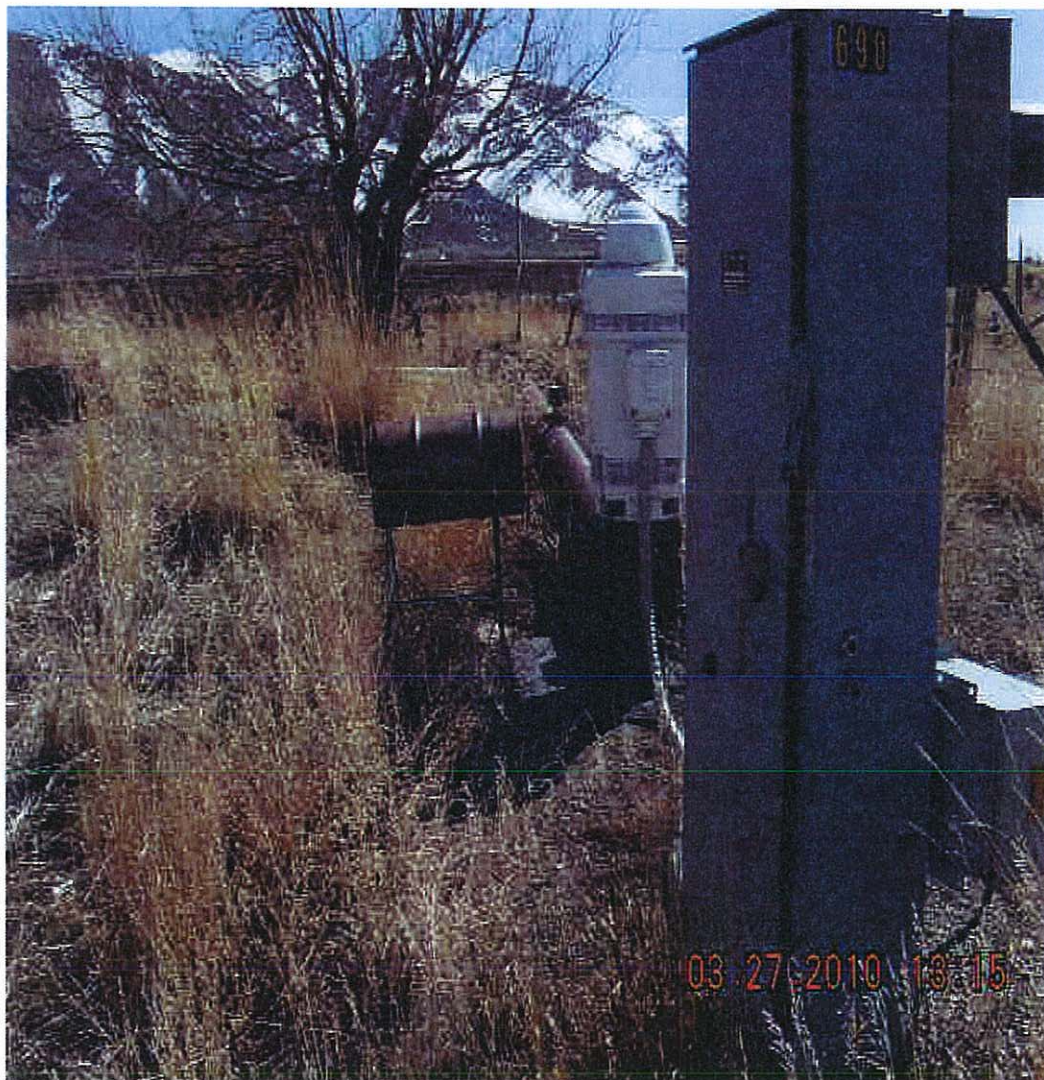
Island Canal  
Jay Jensen Well  
14"

Active well with 10 in. restricted orifice on 12 in. discharge pipe.

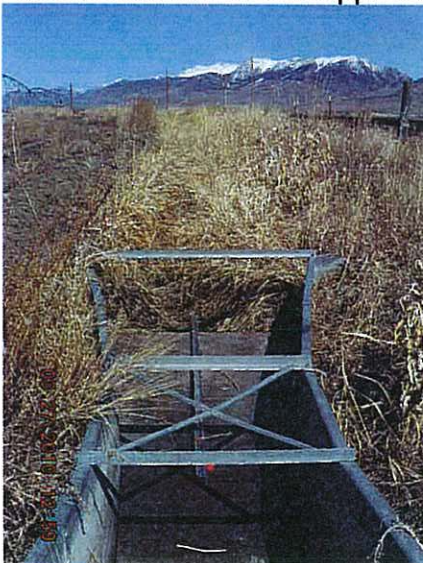
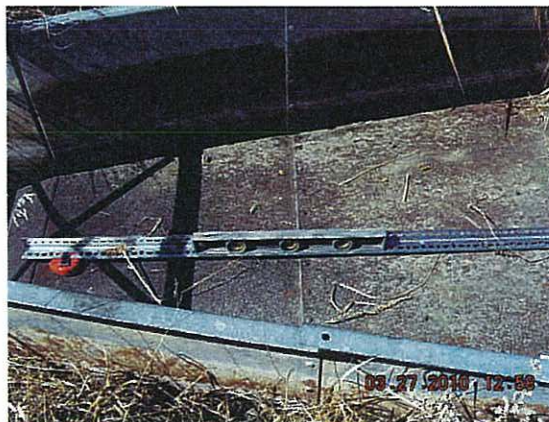
Island Canal  
Jim Babcock  
05"

Active headgate. Adjustable and lockable control. 2 ft. Parshall flume. The flume needs to be leveled and vegetation removed prior to being acceptable.

Grass sediments block approach and front end is 1.0 in. high

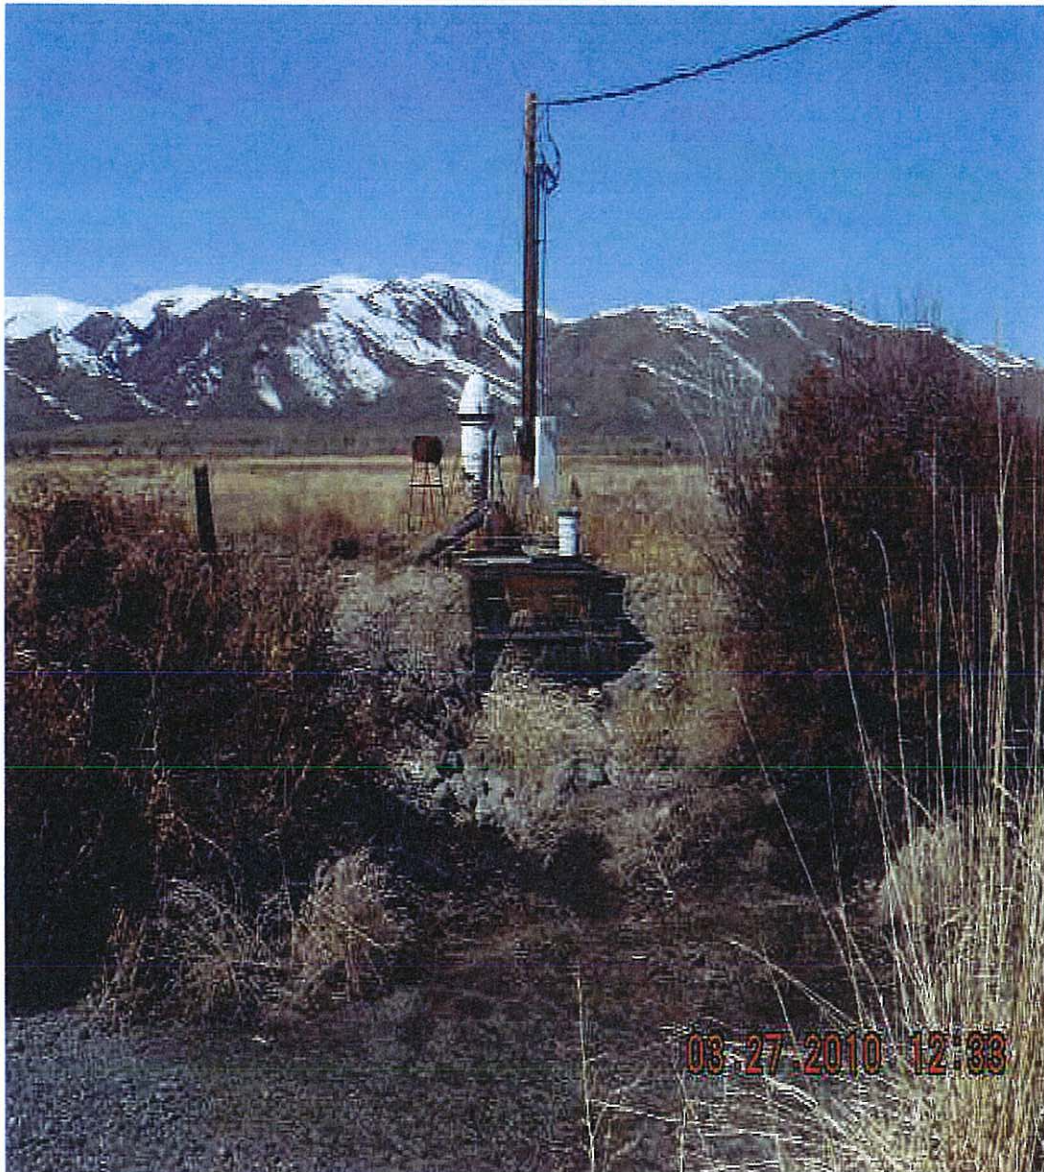
Island Canal  
Isom # 1 Well  
04"

Active well. 3 ft. Cipolletti weir and stilling box.

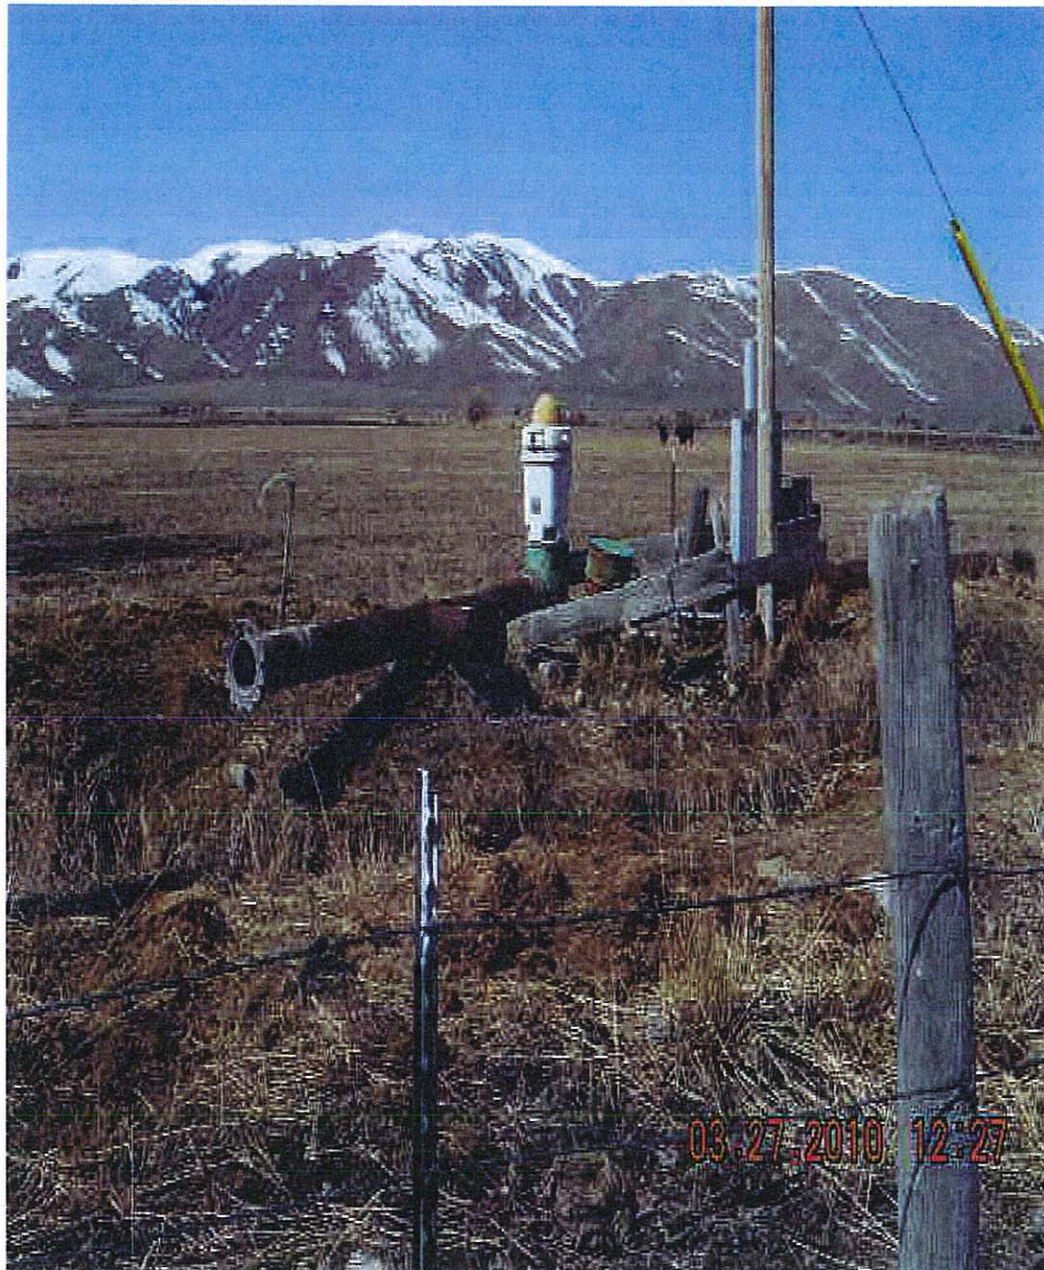
Island Canal  
Darrel McDonald Well  
47"

Active well. 10 in. restricted orifice. 12 in. discharge pipe.

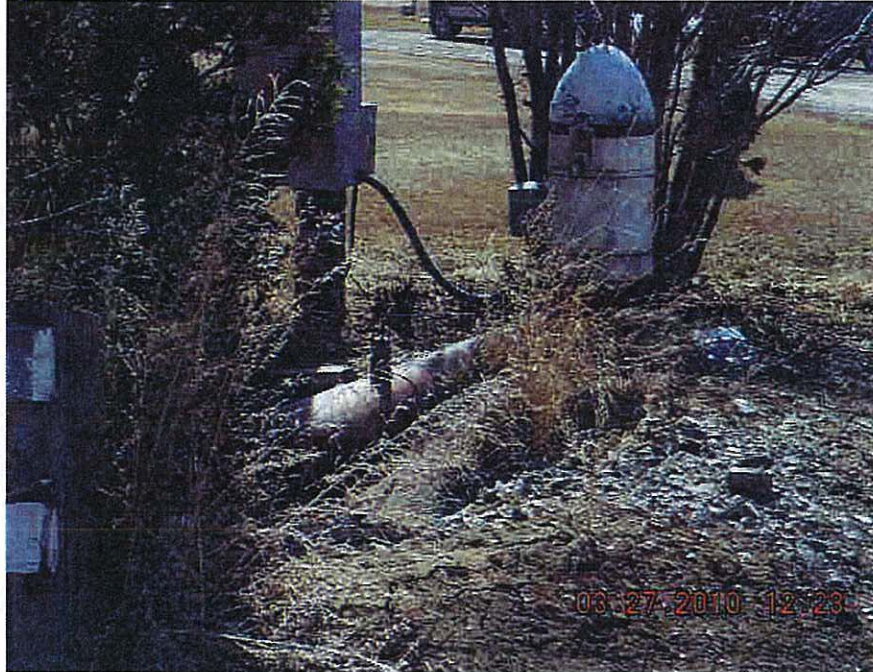
Island Canal  
Hendricks/Felton Well  
46"

Active well. Flow meter in discharge pipe. Pipe sizes vary on both sides of meter. Closer inspection will be required to verify calibration readings.

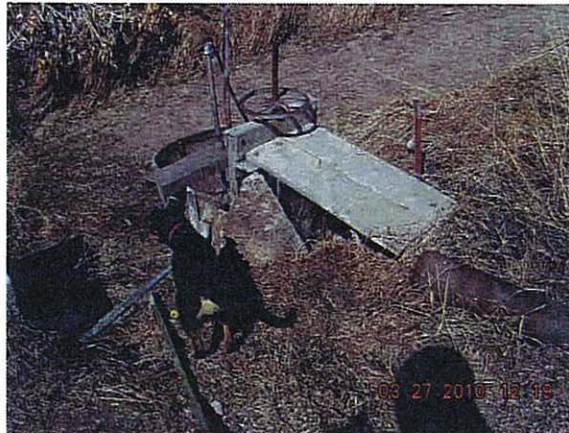
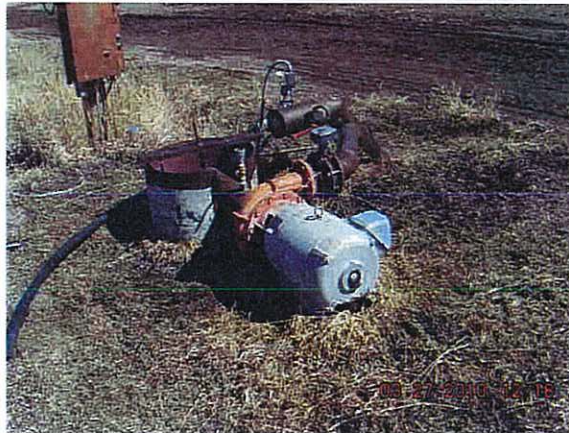
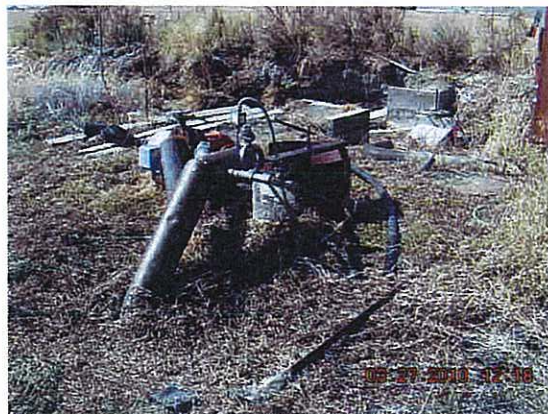
Island Canal  
Doug Hendricks  
46"

Active headgate. Adjustable and lockable control. No measuring device on pumping station. Measuring device is required for system to be in compliance.

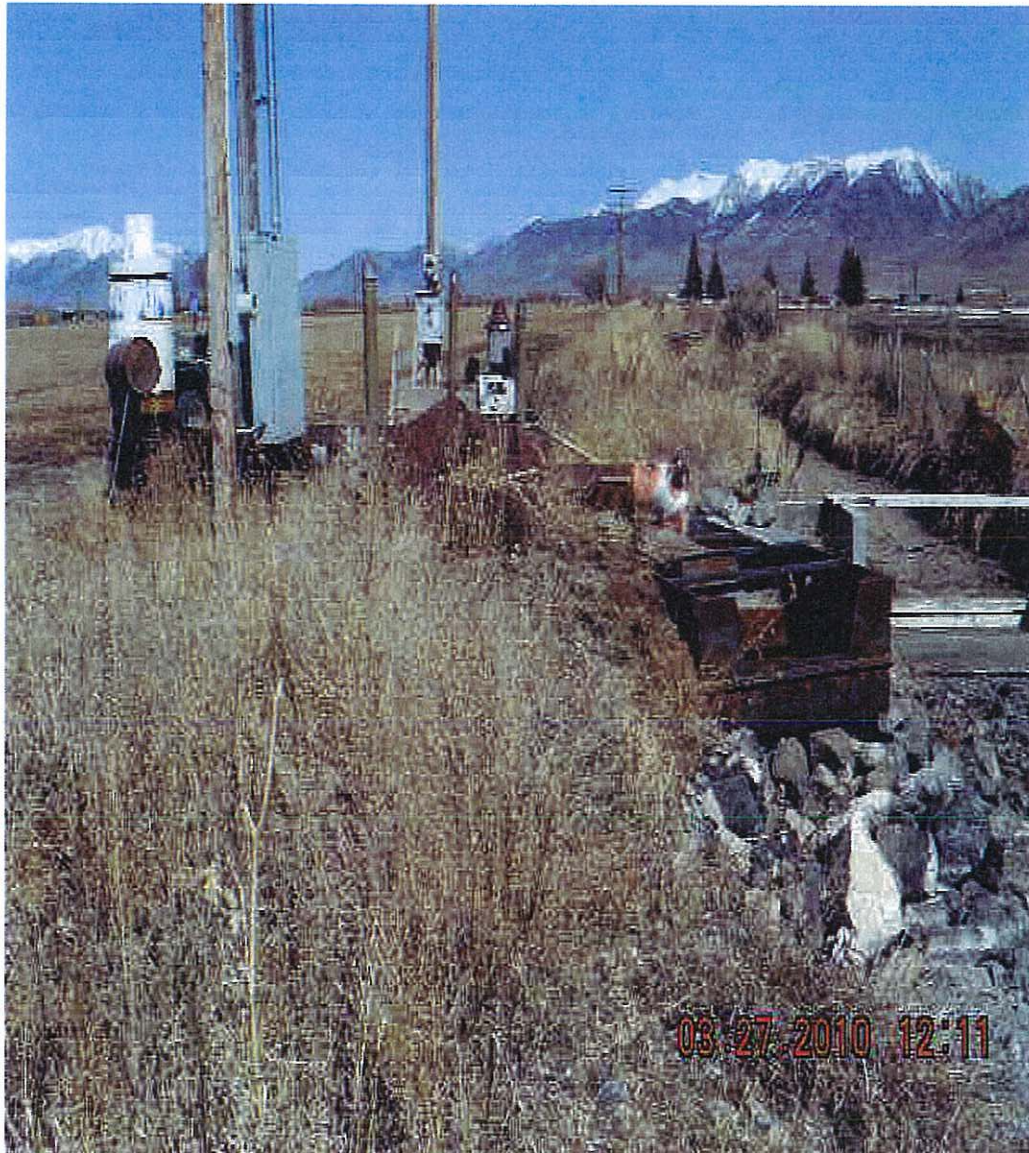
Island Canal  
Isom # 2 Well  
47"

Active well. 3 ft. Cipolletti weir and stilling box.

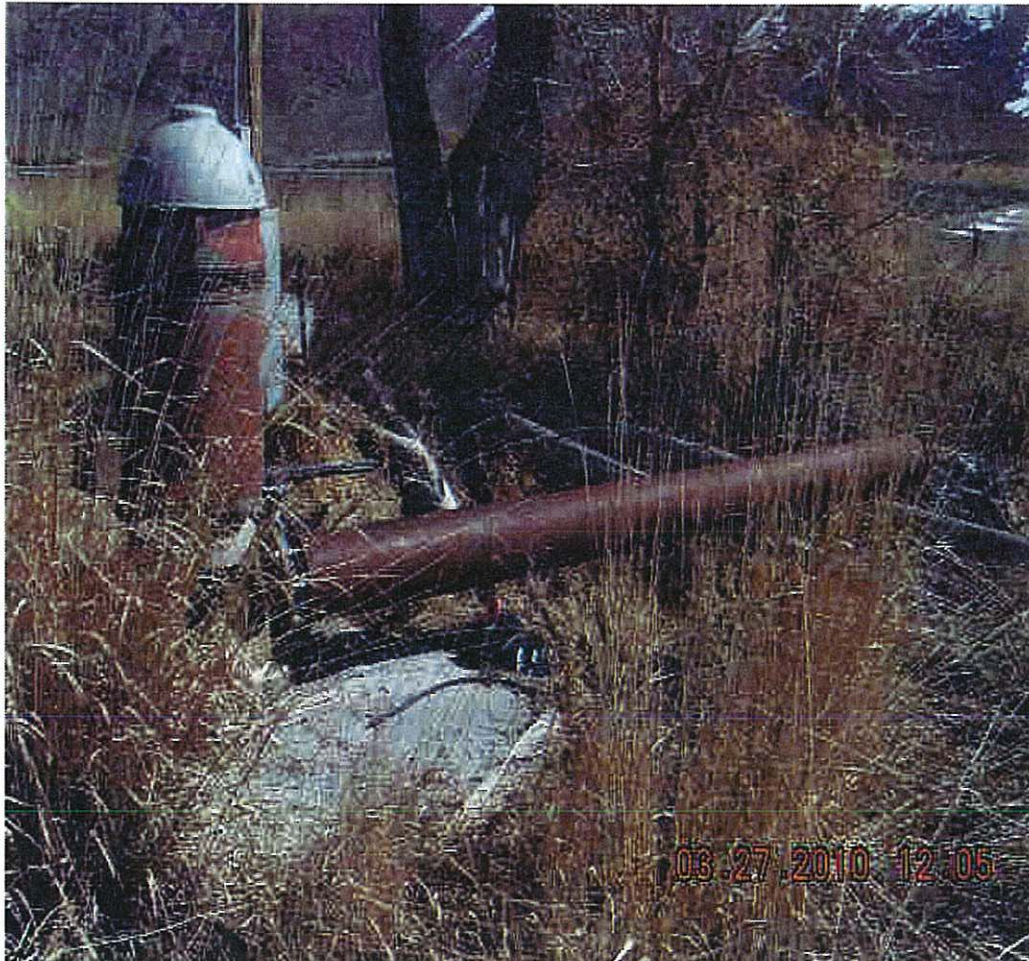
Island Canal  
Larry Quist Well  
47"

Active well. 10 in restricted orifice in 12" discharge pipe. The discharge also has an adjustable valve.

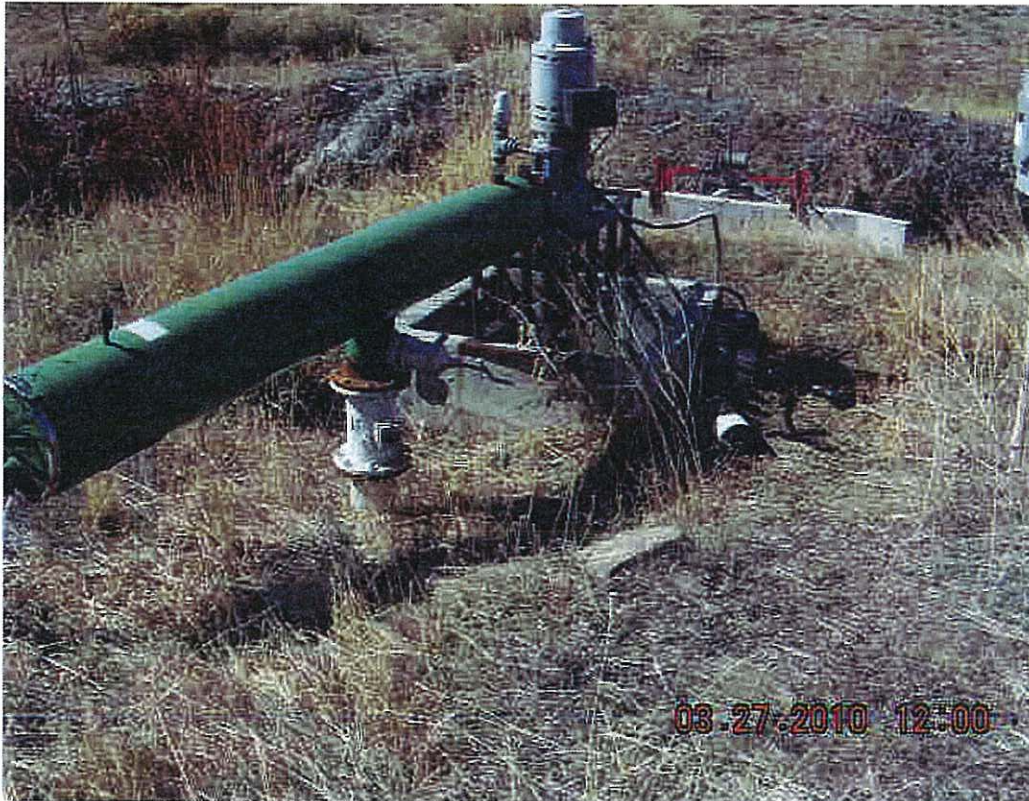
Island Canal  
Tyler Felton  
44"

Active station. Adjustable and lockable control. Magnetic flow meter.

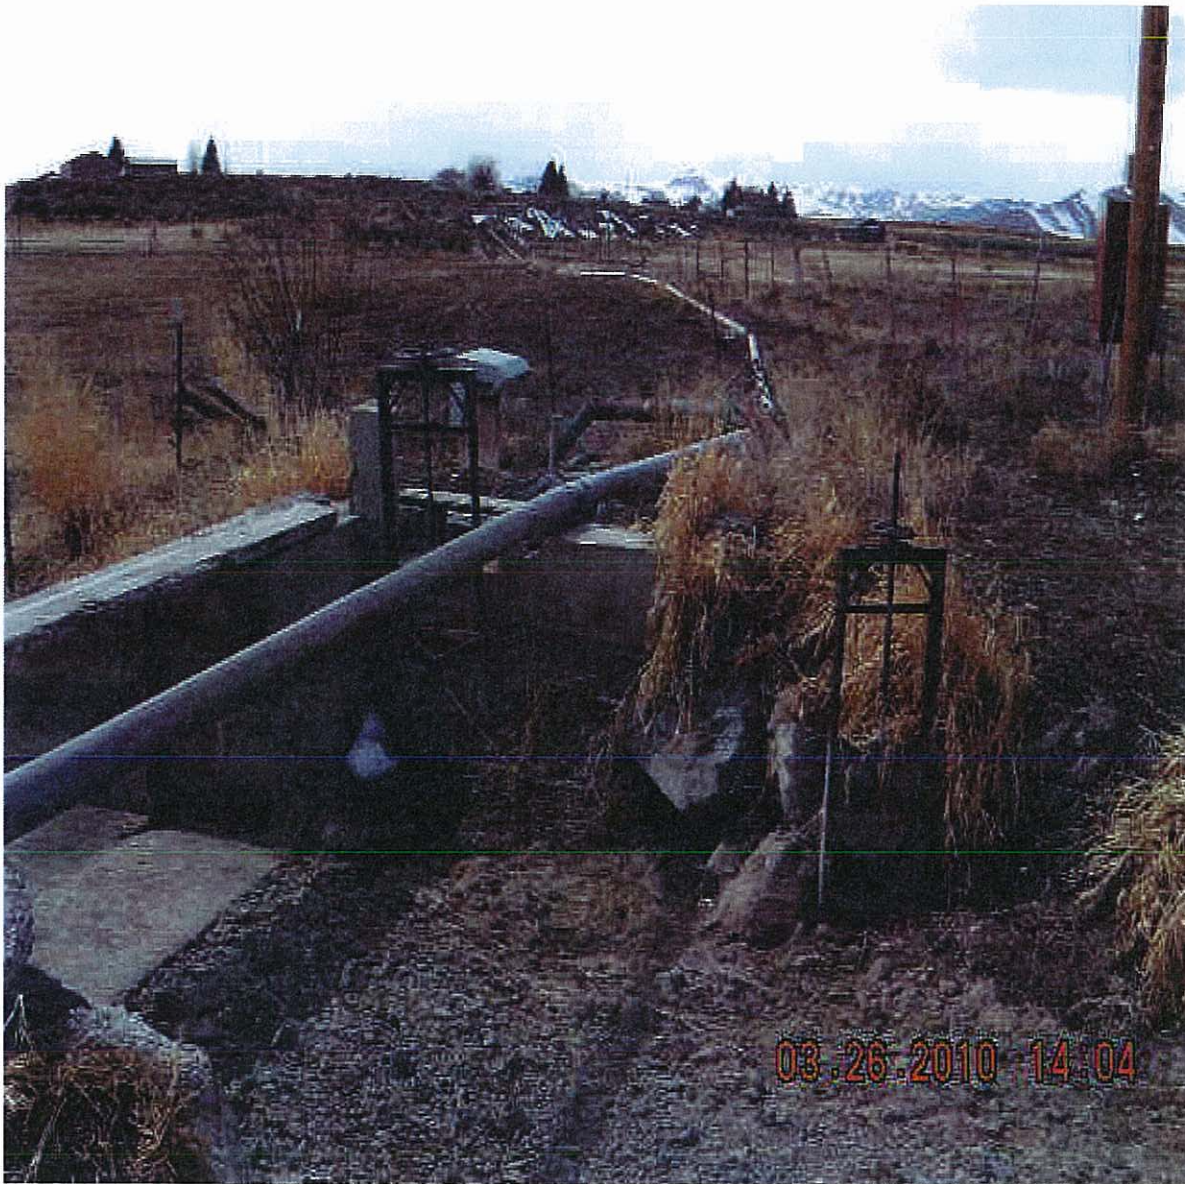
Munsey Canal  
Brook Casper

MIC flow meter (unknown if it works).  
Adjustable and lockable control.

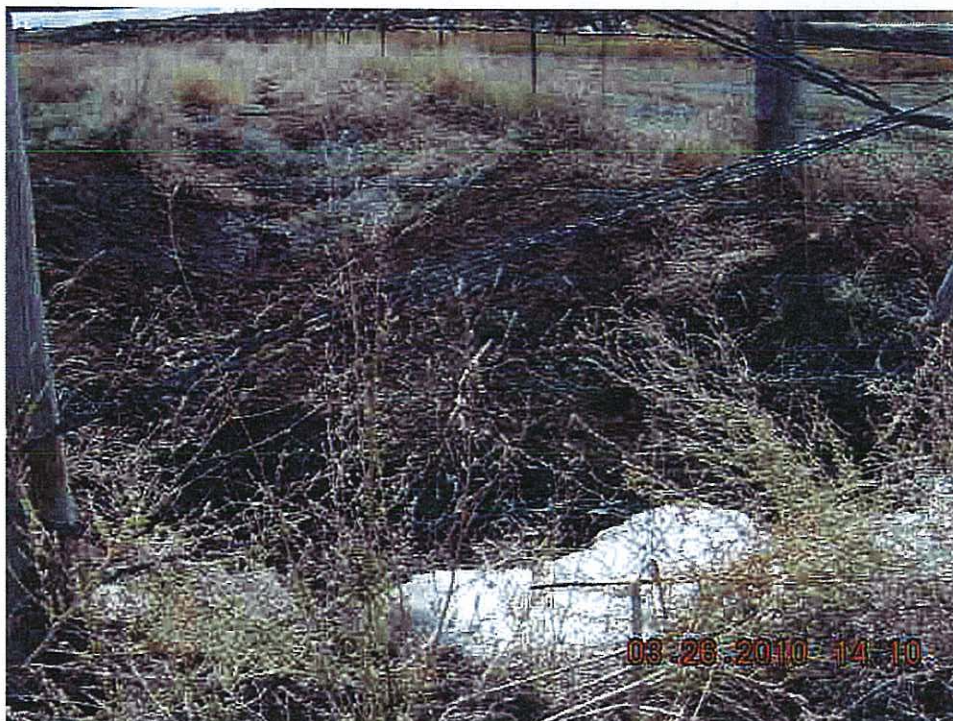
Adjustable and lockable control. Parshall flume does not work because of trash and sediments in approach.

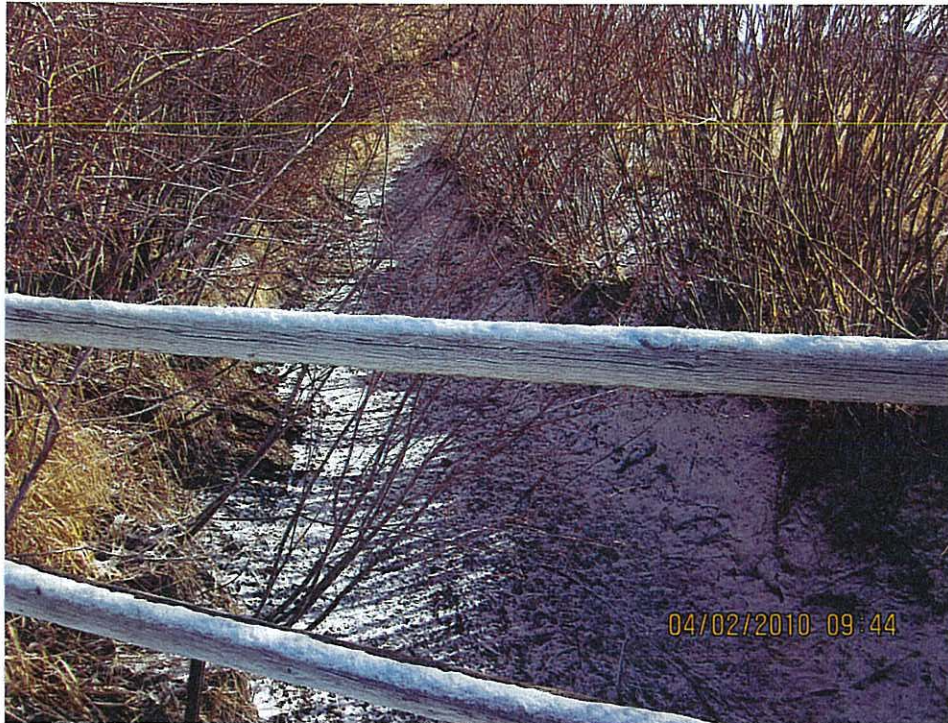
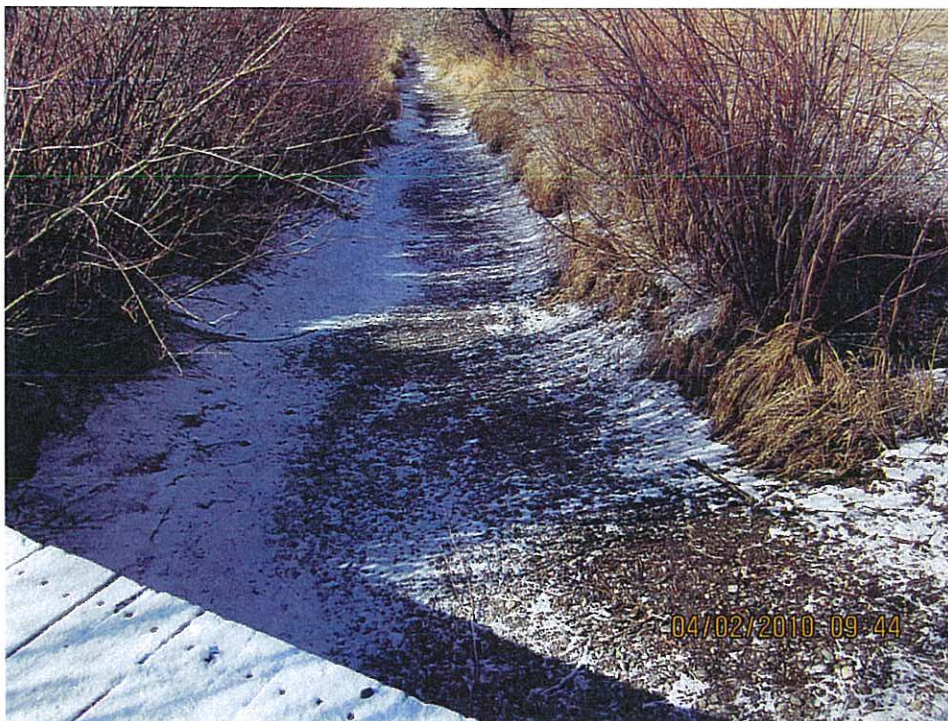
Munsey Canal  
Brian Anderson

Adjustable and lockable control. 18 in. Parshall flume. Vegetation and trash need to be removed before device will measure accurately.

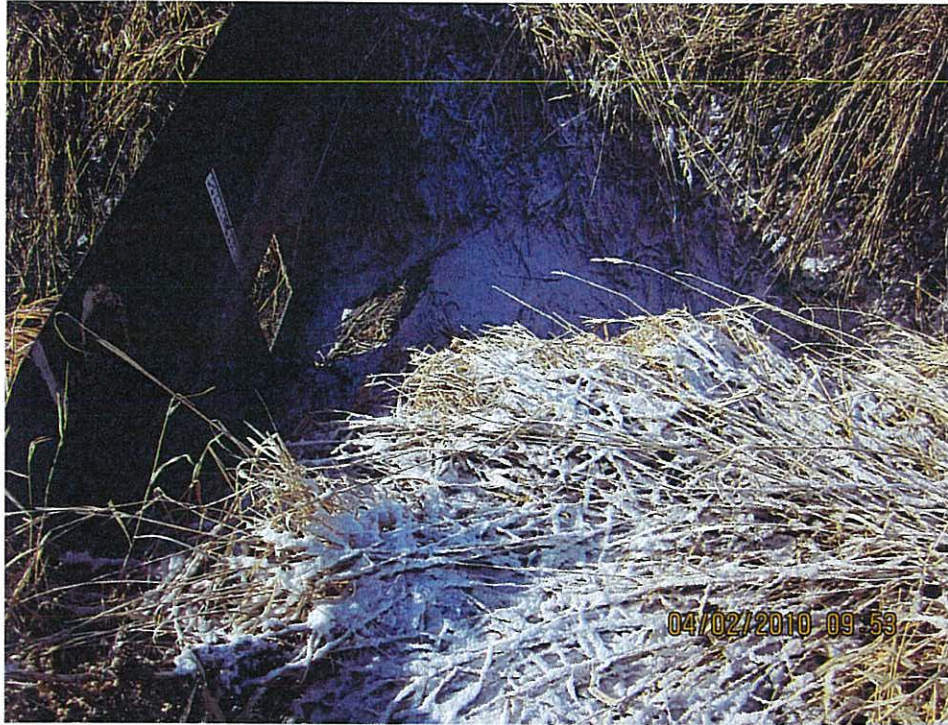
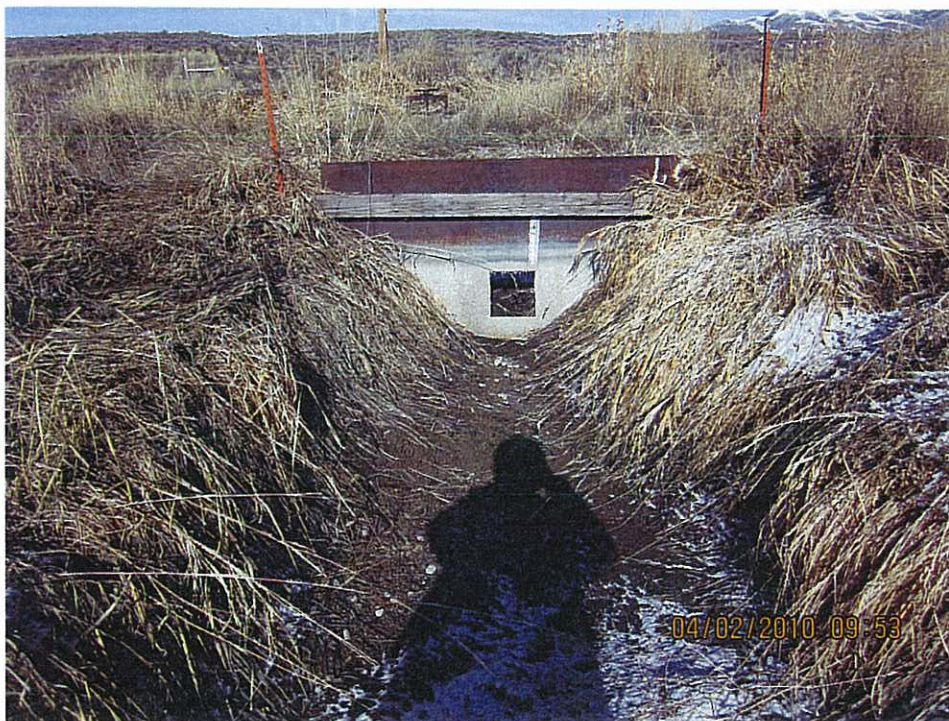
Munsey Canal  
Jay Andersen

Adjustable and lockable control. 12 in. x 12 in submerged orifices. Sediment needs to be removed from the up stream side of the plate.

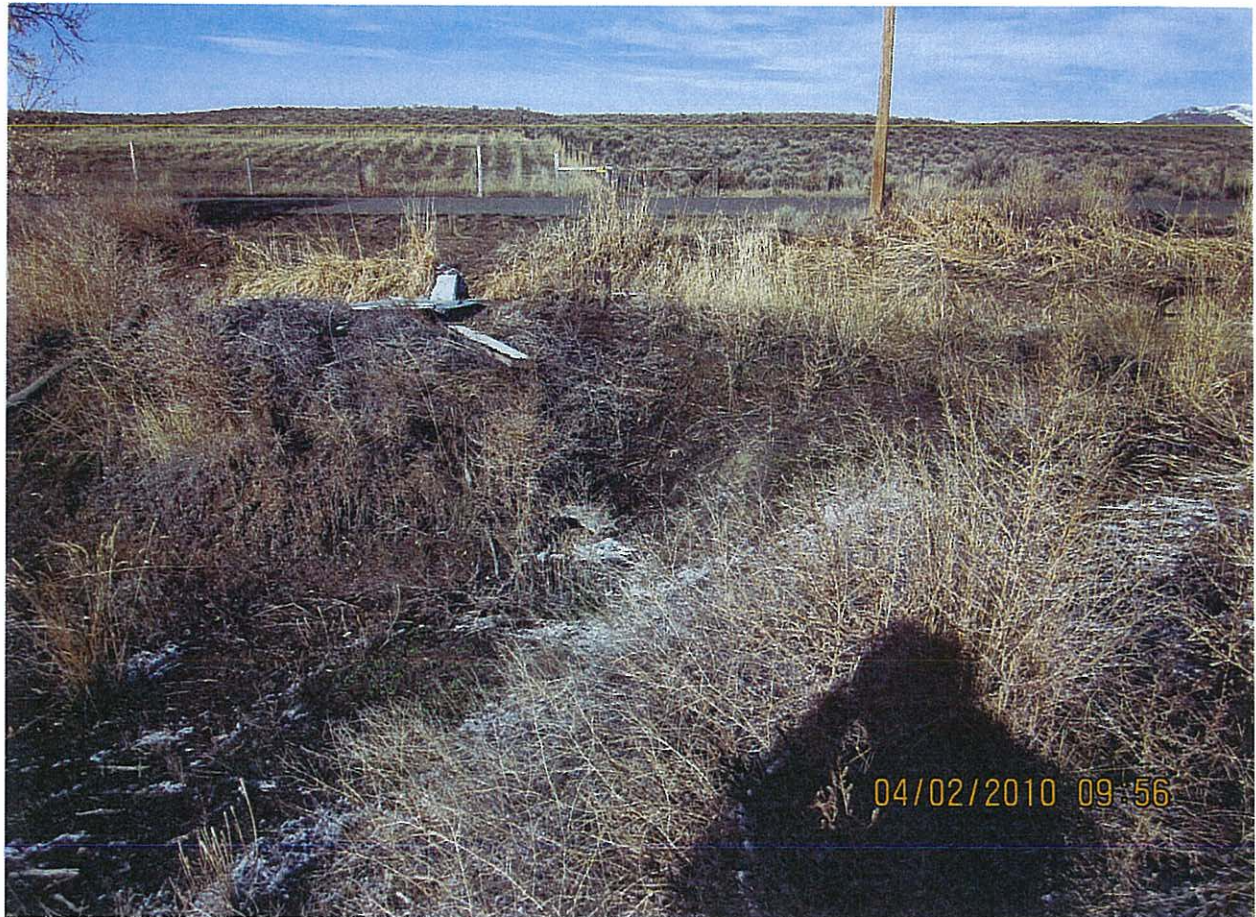
Munsey Canal  
Jay Andersen

Inactive headgate.

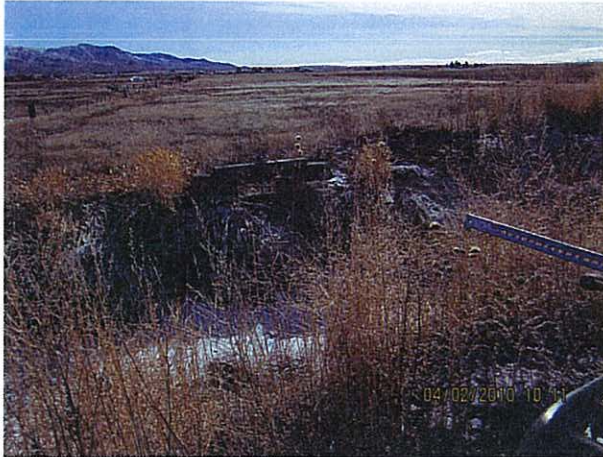
( # 1 ) N 43° 37' 00"    W 113° 19' 23"  
19' 17"

Six (6) inactive headgates south of Ted Sluder and North of Kenneth Bell. Please note the excessive vegetation in canal channel.
