RE: Water District 34 Water Measurement Matters.

# **EIM CANAL PRESEASON COMPLIANCE REPORT**

RE: Compliance Report Notification

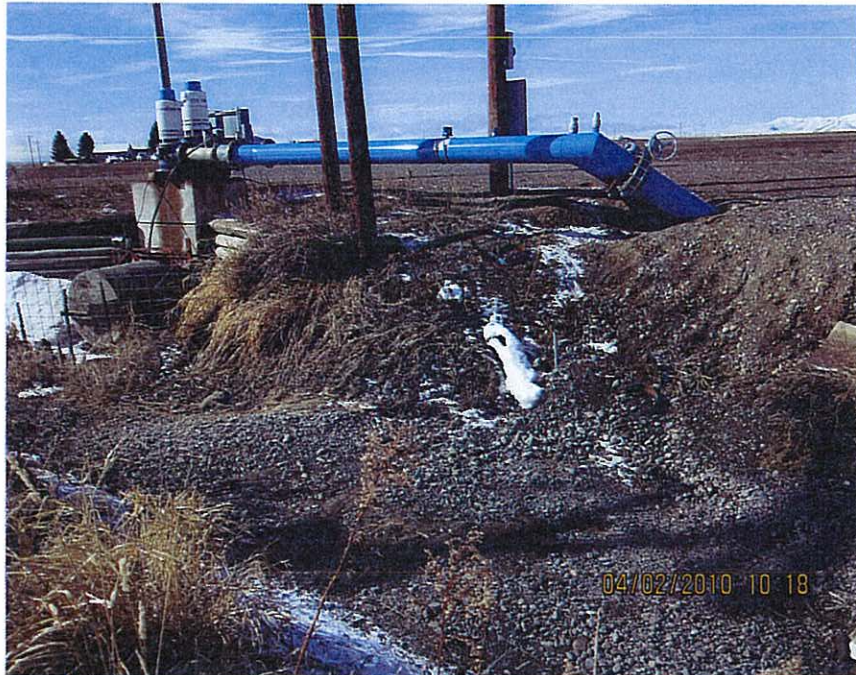
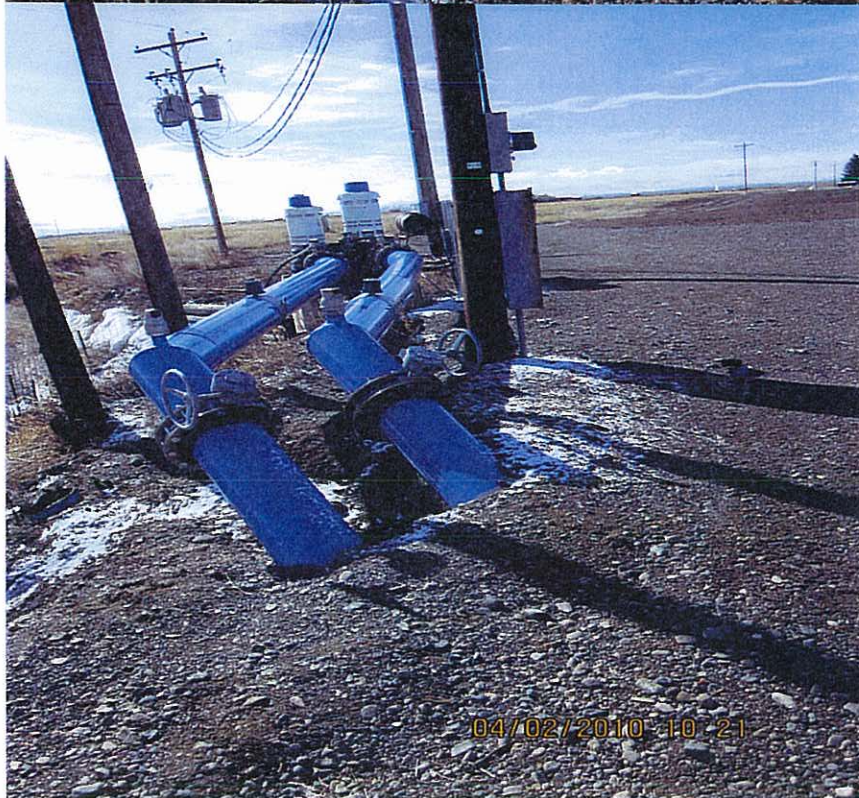
Munsey Canal  
Upper Isom & Leon Folkman Lift Pumps

Two (2) McCrometers installed with 15 ft. clean pipe diameters up stream and 5 ft. down stream. Water supplies can be measured a second time with Polysonic meter and a third time with a Parshall flume at end of discharge pipe. Each discharge pipe has an adjustable and lockable control valve.

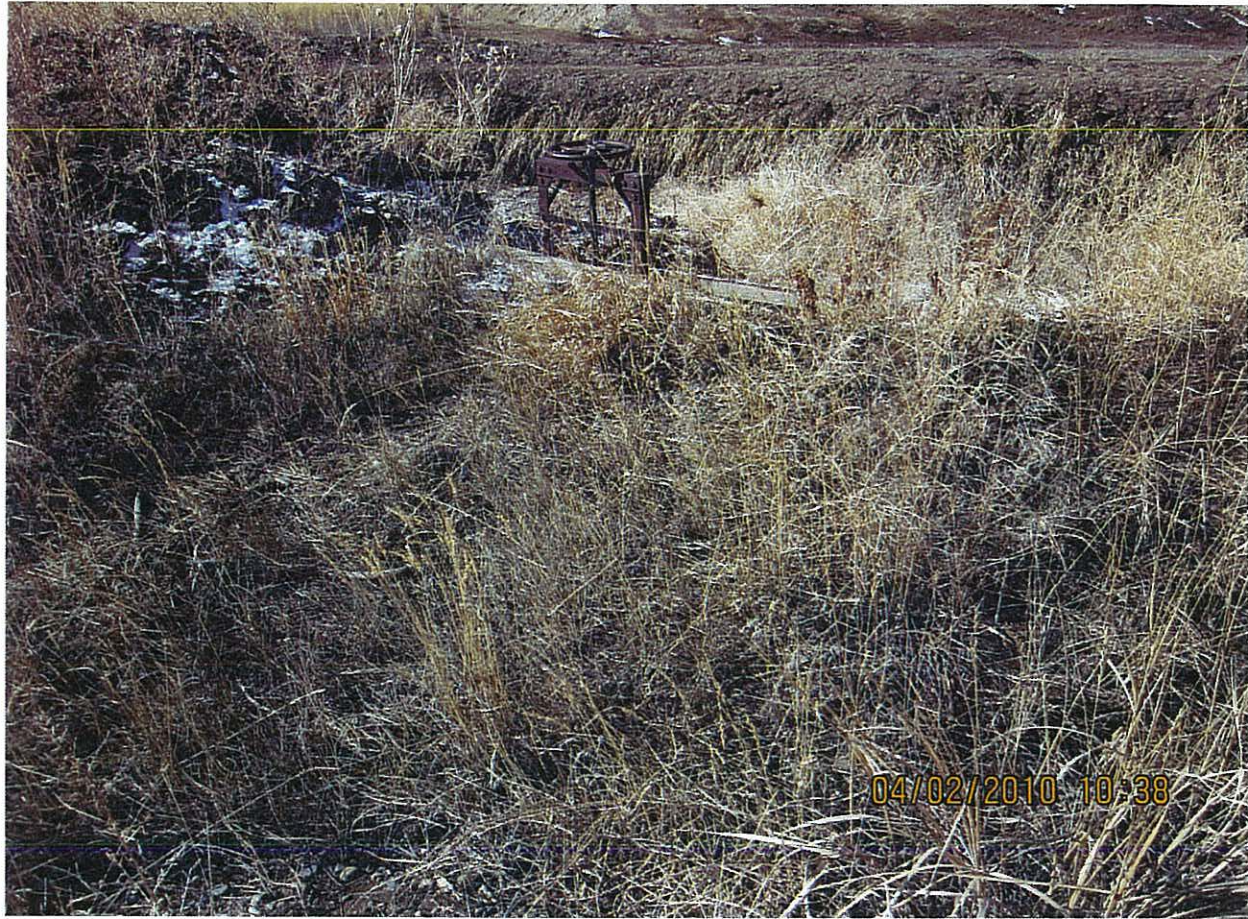
Munsey Canal  
Kenneth Bell

Adjustable and lockable control. No measuring device.

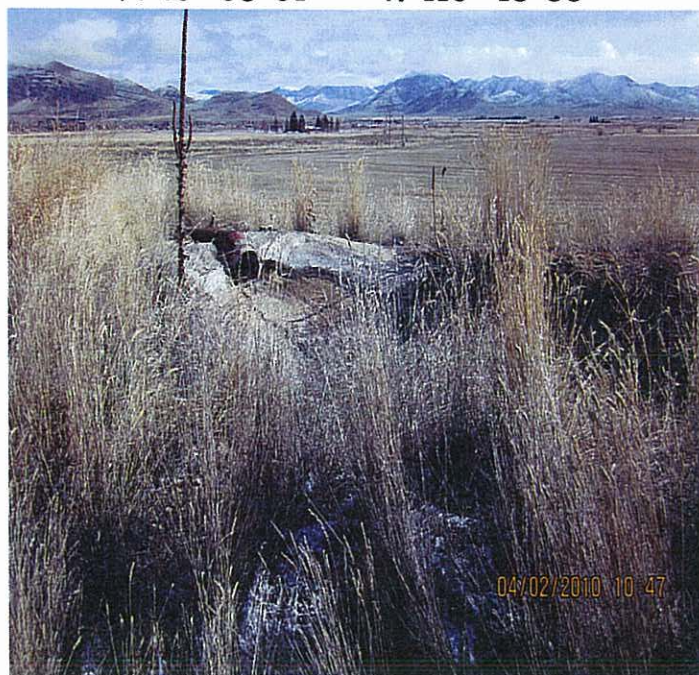
N 43° 36' 31"    W 113° 18' 58"

Neither the well water or the surface water from the Munsey Canal are measurable prior to being commingled, but are measured after being commingled. Surface water from the Munsey canal is controllable.

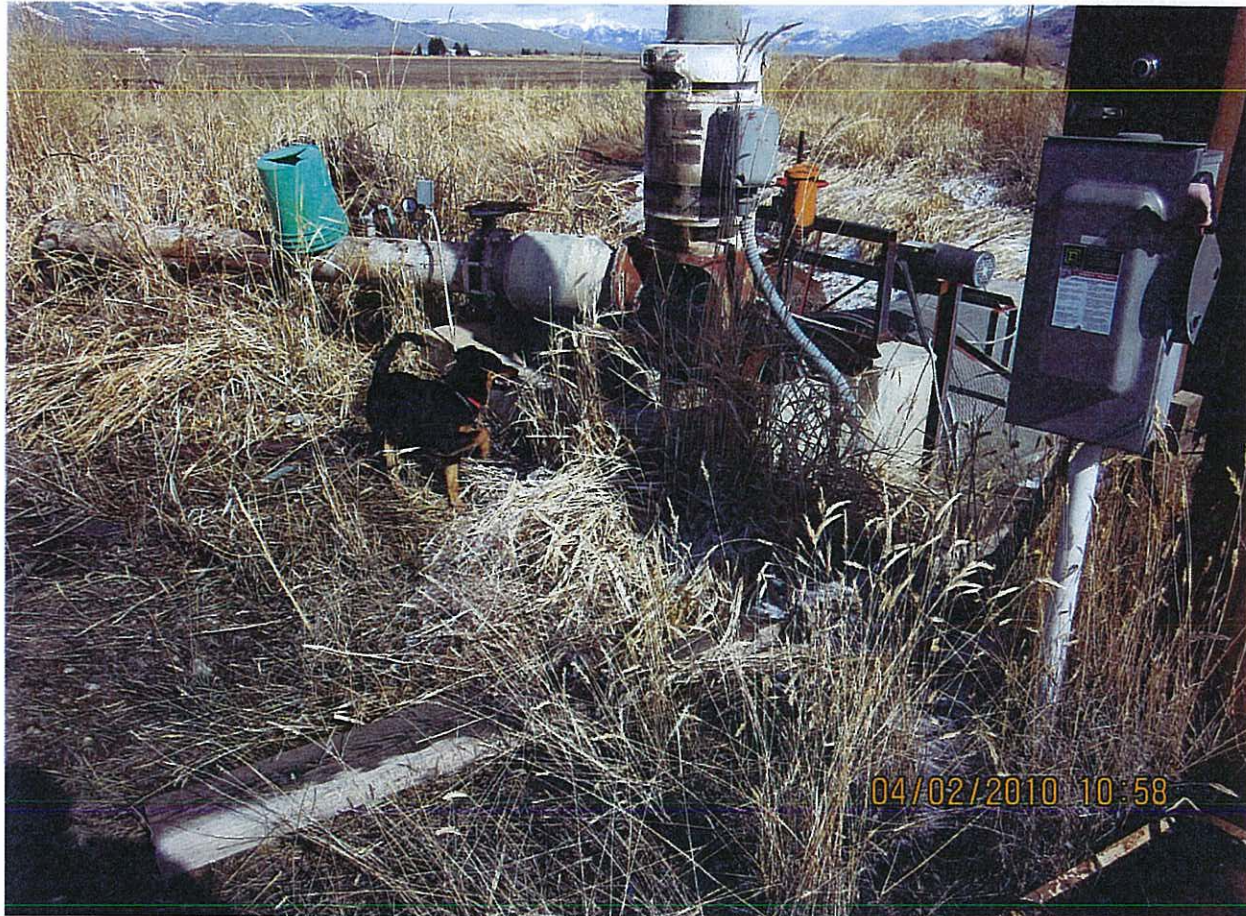
Munsey Canal  
Parkinson Farms (North station)

Measuring device has been removed for the winter. Adjustable and lockable control.

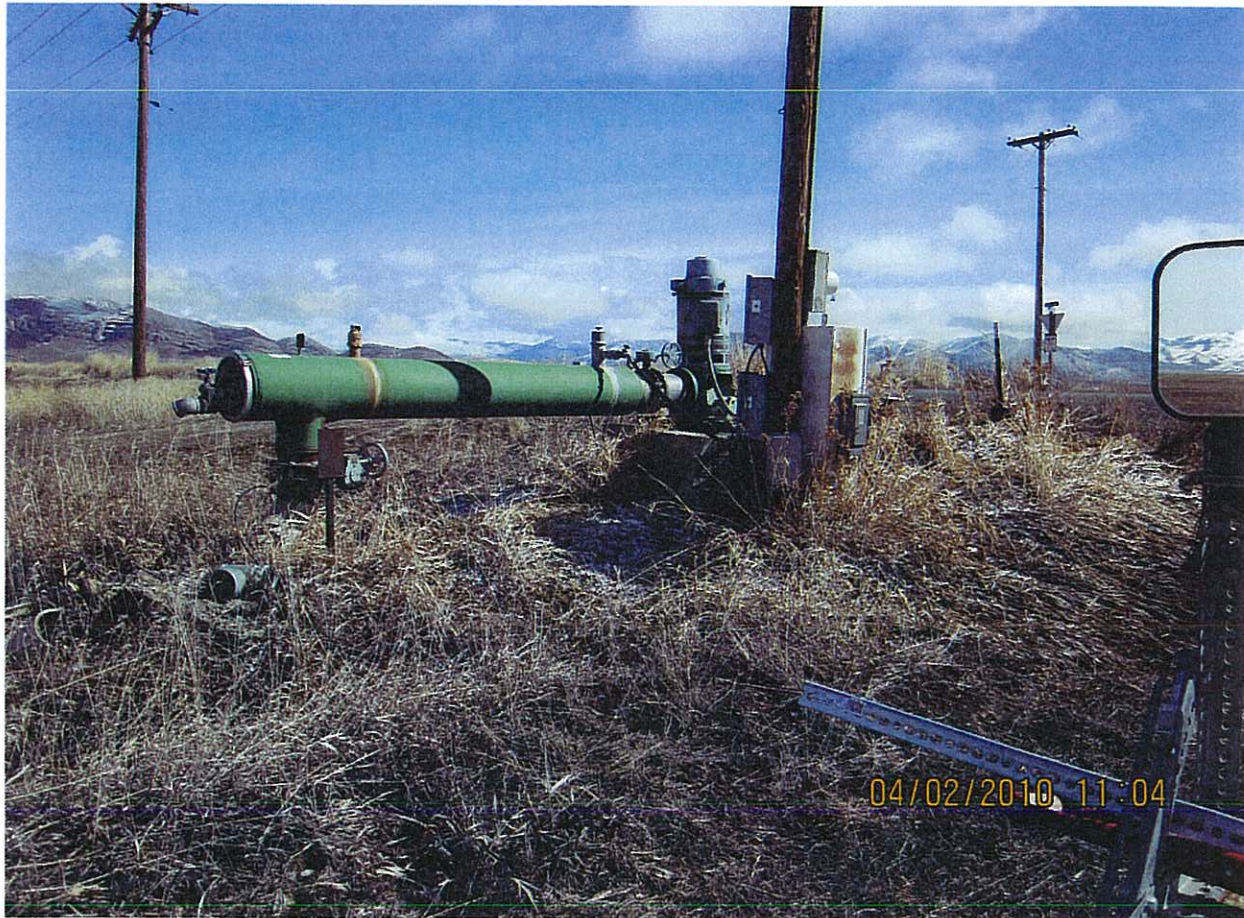
Munsey Canal  
Parkinson Farms (middle station)

Three (3) adjustable and lockable controls. The measuring device has been removed for the winter.

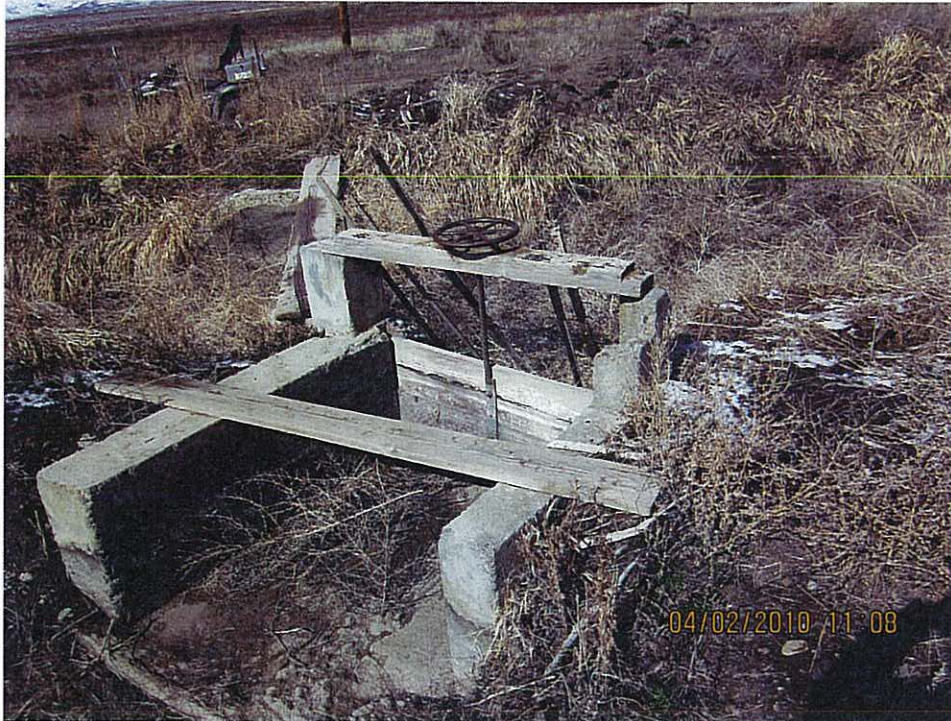
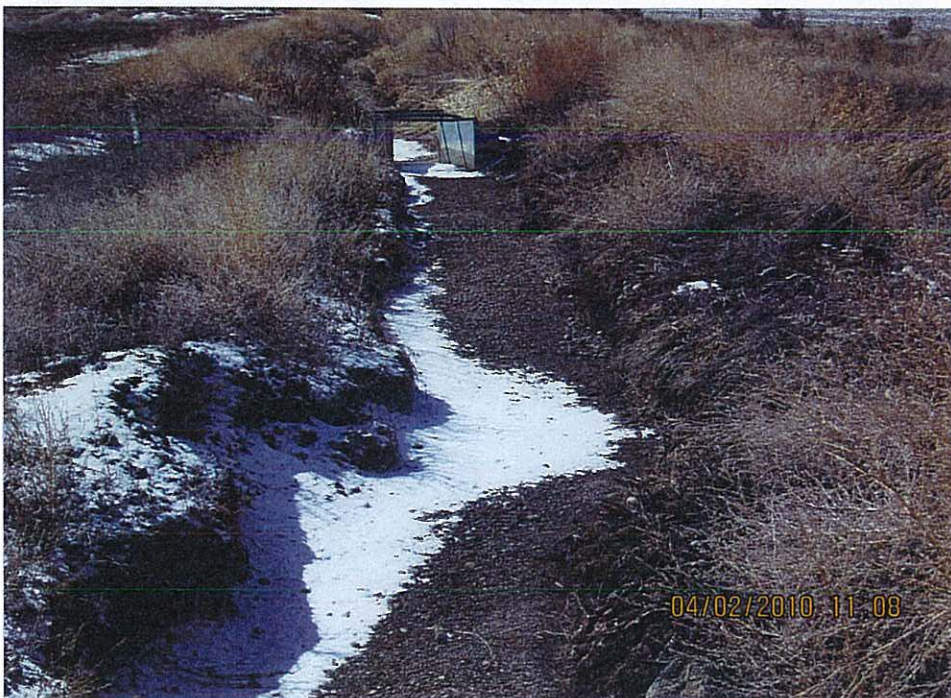
Doug Schureman

Adjustable and lockable control that is in need of repair. 24 in. Parshall flume.

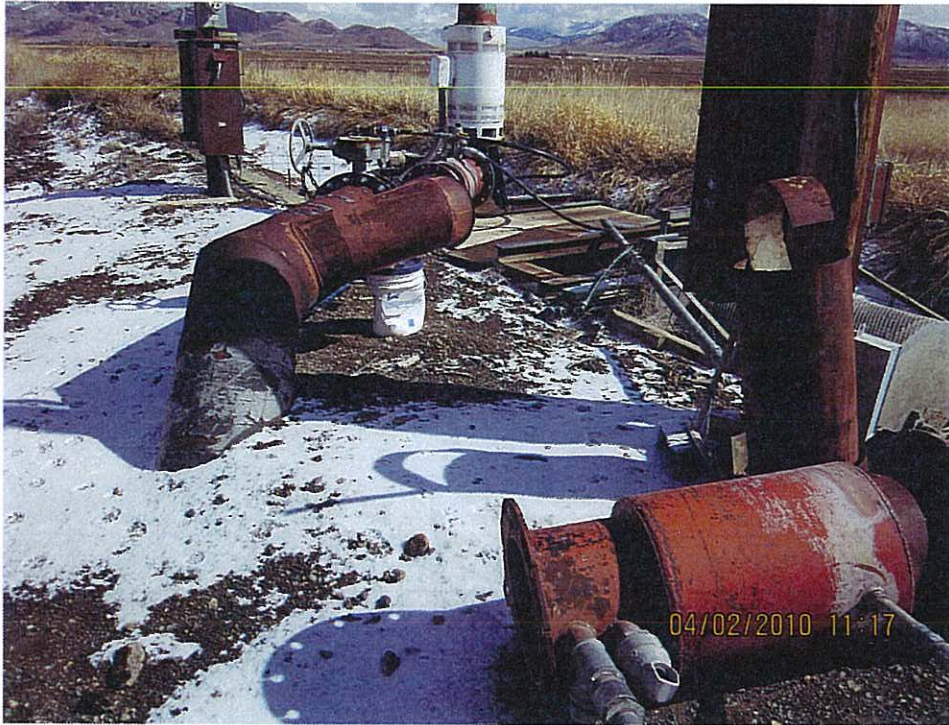
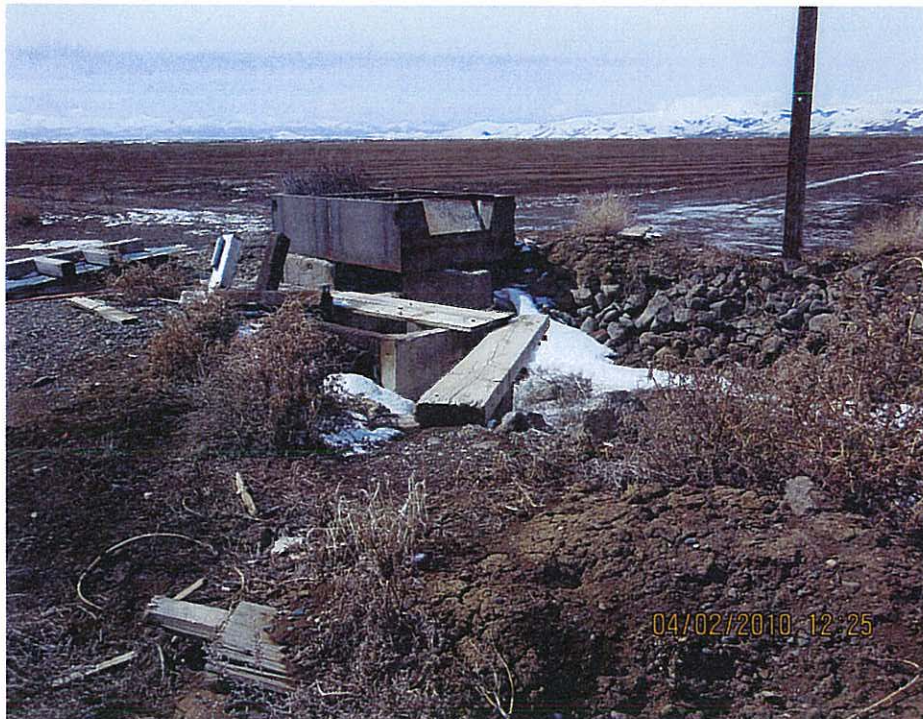
Munsey Canal  
Lower Isom Lift Pump

Adjustable and lockable control valve. 3 ft. Cipolletti weir with stilling box is located at the end of the discharge pipe.

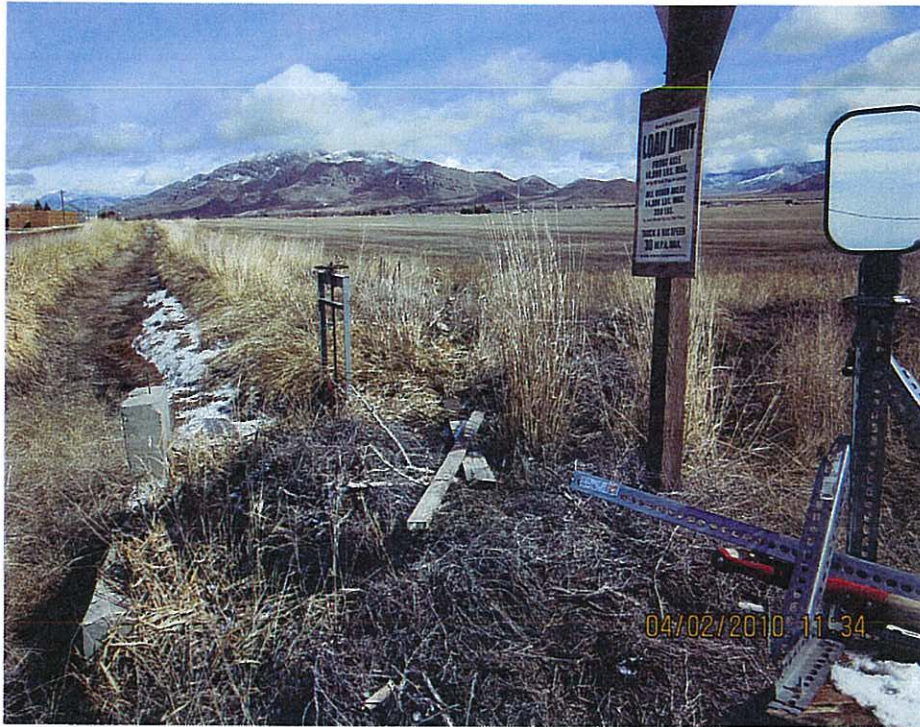
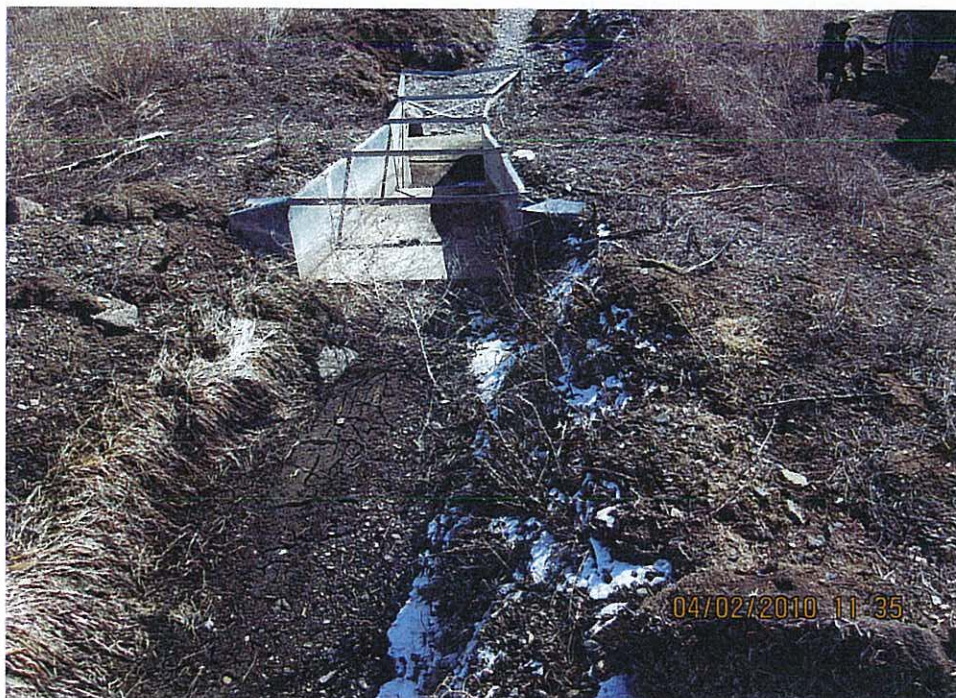
Munsey East Lateral  
Out of the Munsey Canal

Headgate is adjustable and lockable. 24 in. Parshall flume which needs approach cleaned prior to use.

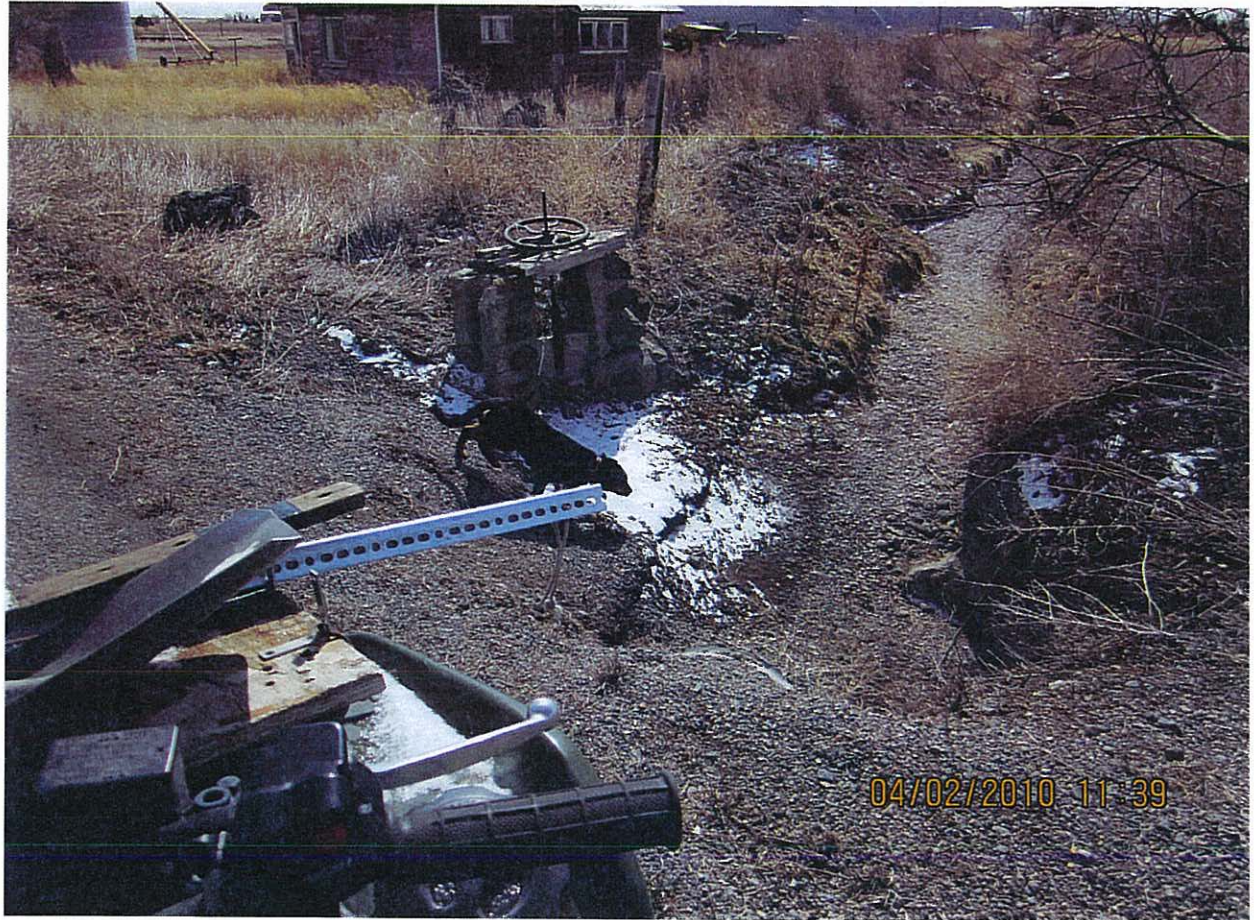
Munsey East Lateral  
Doug Schureman Home

Inactive headgate. Adjustable and lockable control.

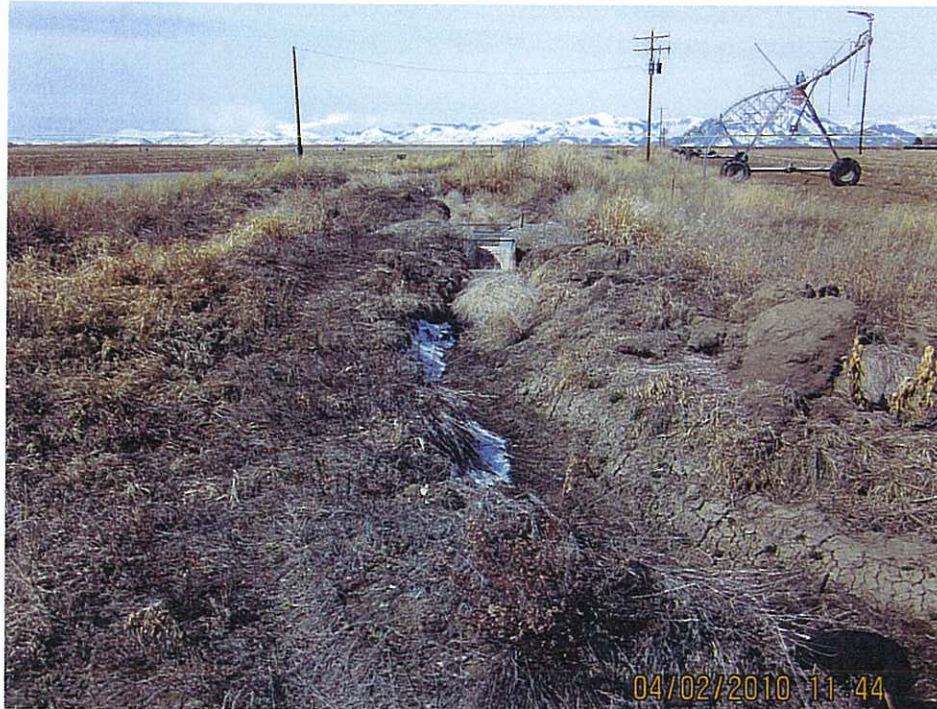
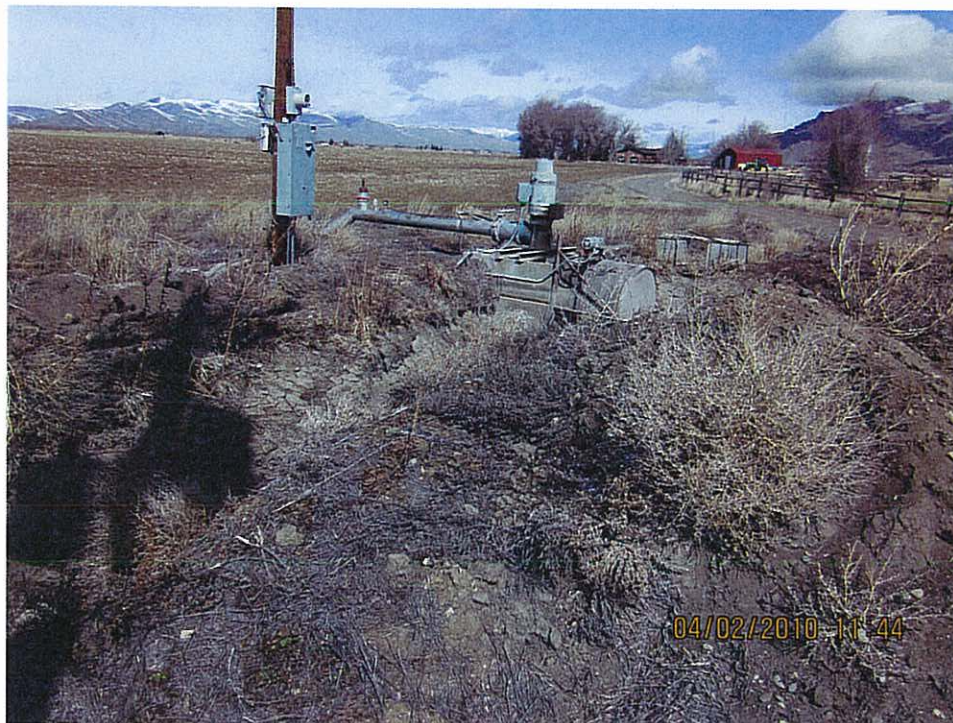
Munsey East Lateral  
Leon Folkman Pumping Station

Adjustable and lockable control. 18 in. Parshall flume.

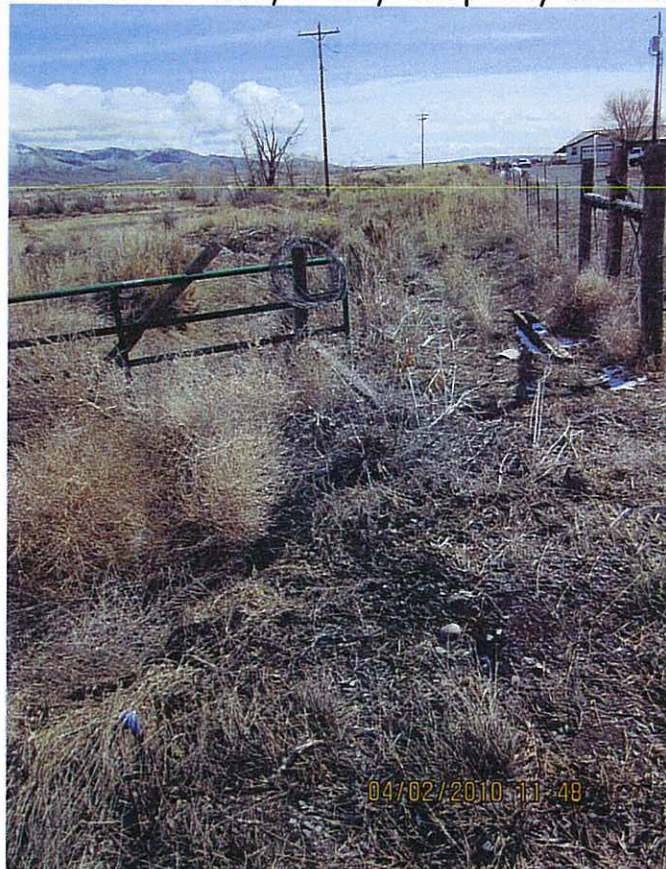
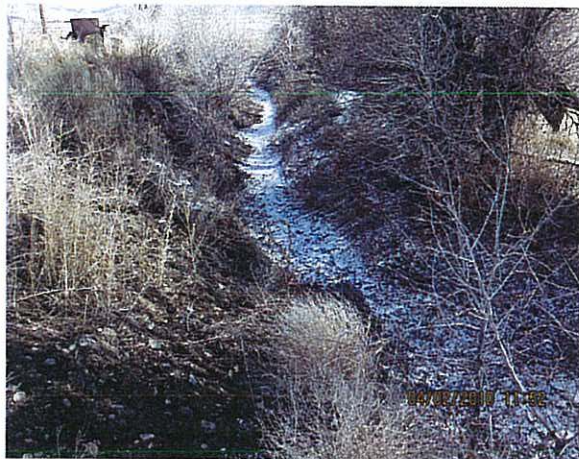
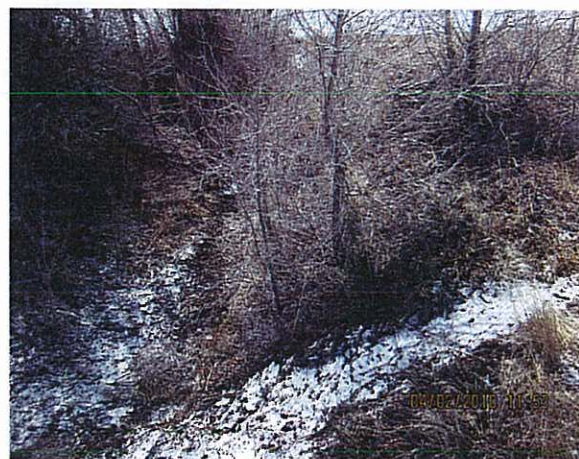
Munsey East Lateral  
North of Scot Parkinson home

This reach of the lateral is extremely trashy and poorly maintained. High loss area.

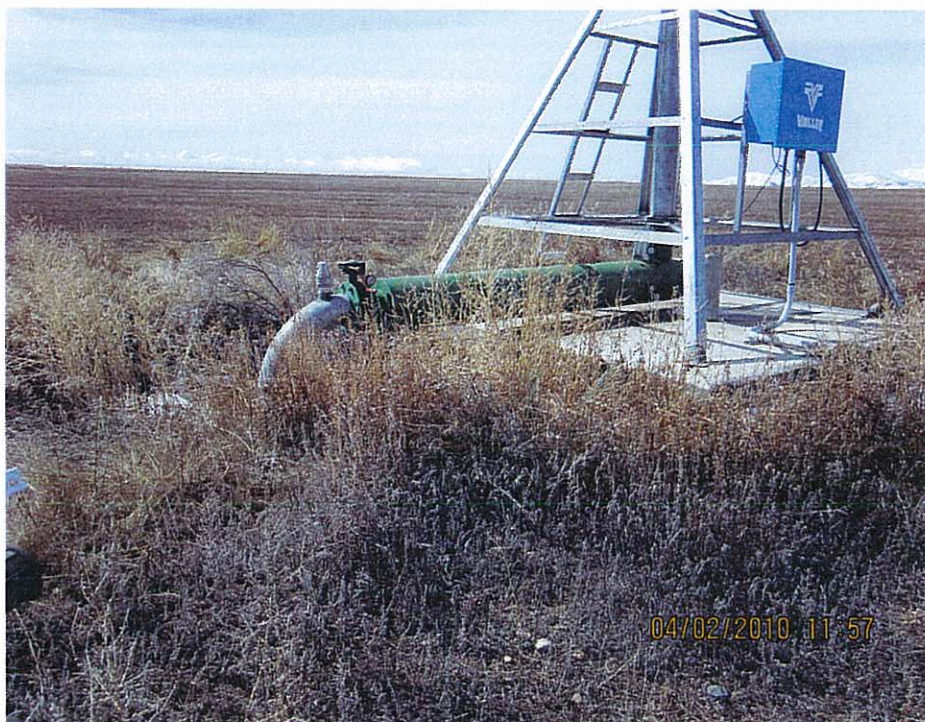
Munsey East Lateral  
Parkinson Farms (South pivot)

Adjustable and lockable control is located at the pivot point. It could not be determined if the flow meter is operational.

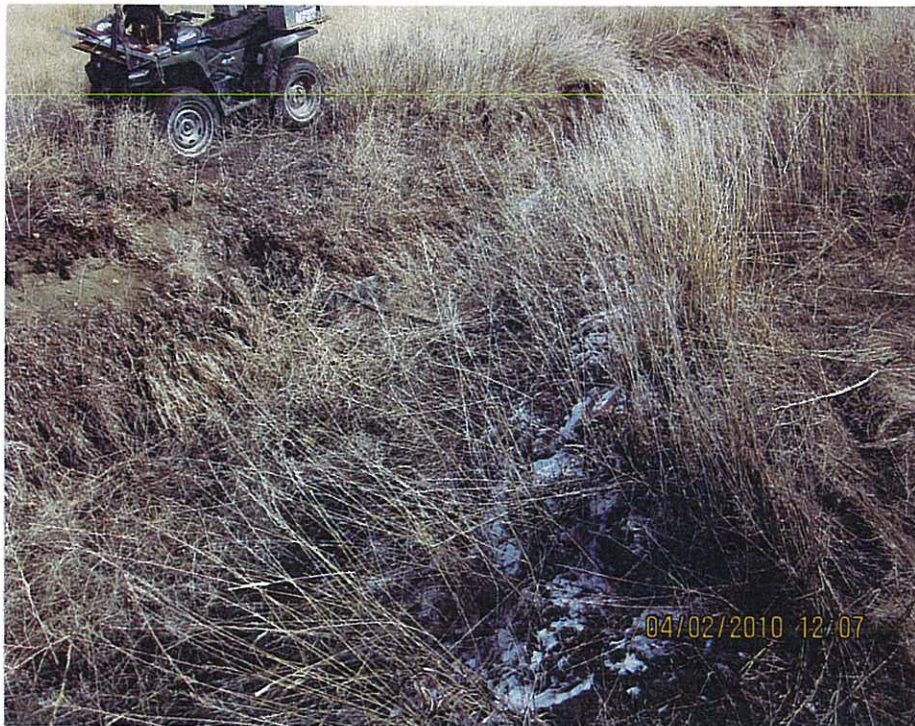
Munsey East Lateral  
Charles Huggins & Dennis Braswell

Headgate is adjustable and lockable. 18 in. Parshall flume will require approach cleaning to measure accurately.
