From: Skinner, Corey
Sent: Thursday, September 27, 2007 2:36 PM
To: Luke, Tim
Cc: Merritt, Allen; Cooper, Jeff
Subject: Results of Muldoon Creek Investigation

MEMORANDUM

SUBJECT: Field Visit and Inventory of Diversions

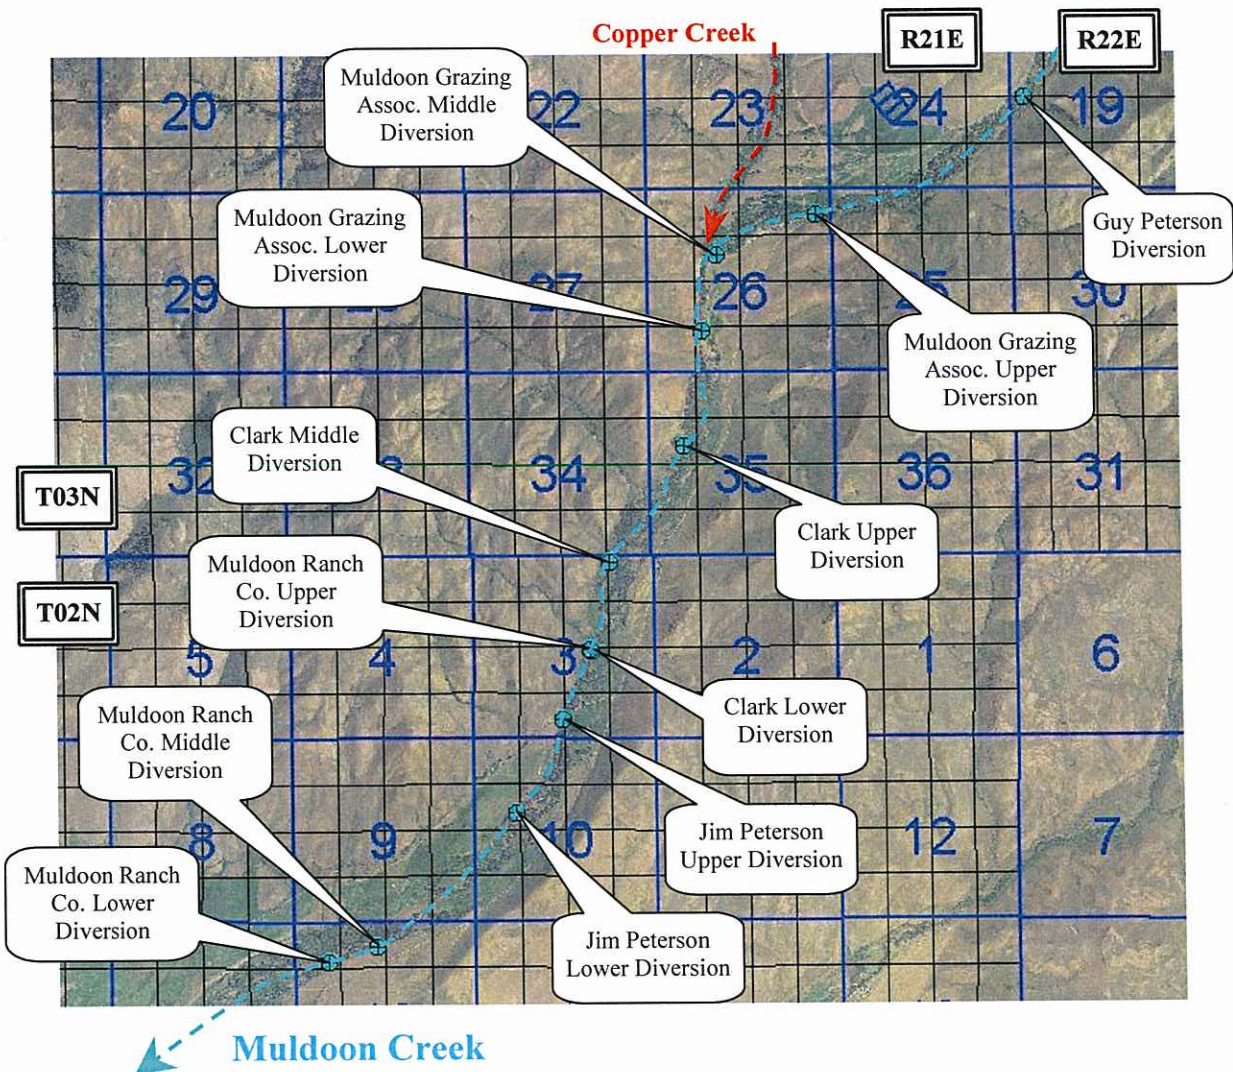
On September 5th and 6th, Jeff Cooper and I visited the Muldoon Creek area as a follow up to the August 10th water call filed by Gary Slette on behalf of his client, Muldoon Ranch Co LLC, and the August 16th response from IDWR (e-mail from Tim Luke). As part of our visit an inventory of the 12 diversions identified in the September 23, 2004 memo was conducted. Note that the September 23, 2004 memo detailed an inventory of the diversions and was prepared as a follow up to the Department's October 2003 order requiring the installation of control works and measuring devices. The following map provides an overview of the area and the locations of the various diversions detailed in the following pages of this memo....
