IDWR Adjudication Claims Investigation

## Claim Investigation Field Report

WR # 11-991A

WR # 11-8234

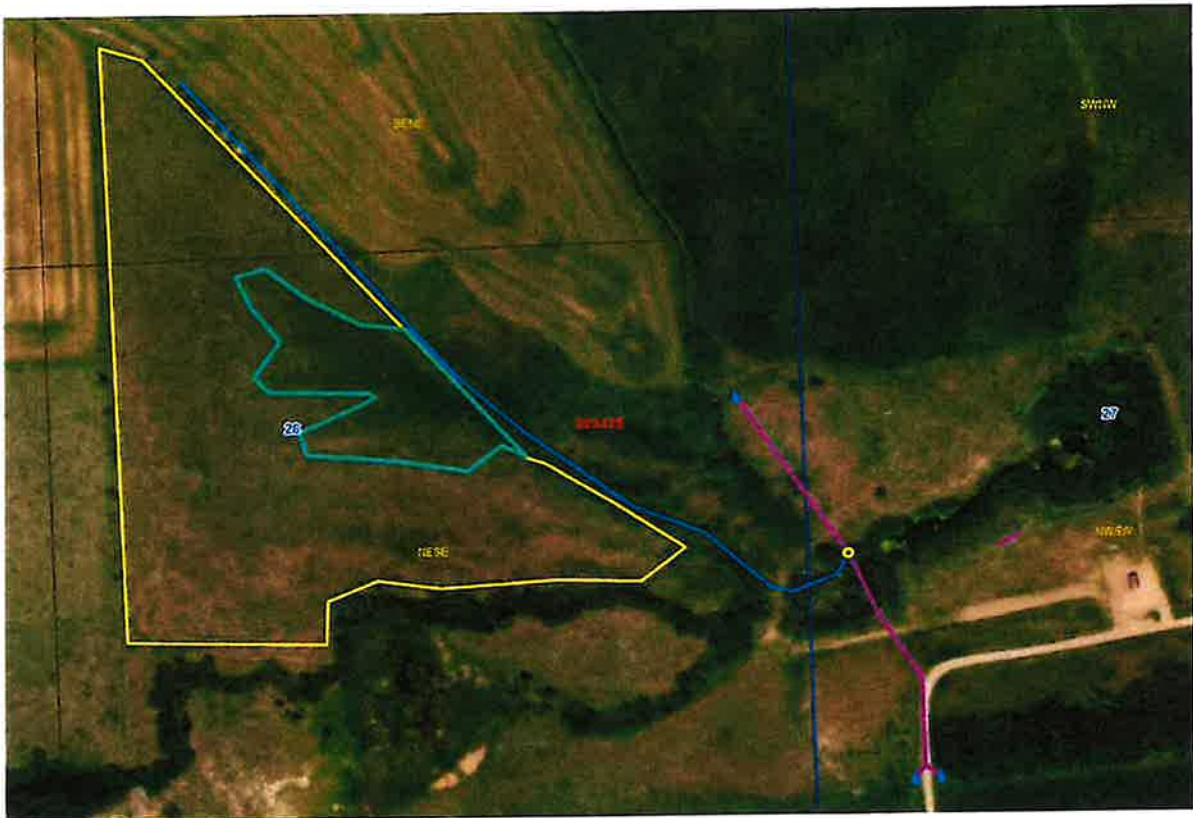
Yellow Area: entire grass pasture located downhill of the ditch

Blue Area: irrigated area observed during field examination

Yellow Dot: point of diversion for ditch and pump

Blue Droplets: riser locations

Blue Line: Jensen Ditch

Purple Line: buried pipeline

Short Purple line : pile of 30' pipeline
