IDAHO DEPARTMENT OF  
**WATER RESOURCES**

**BRBA FIELD EXAMINATION REPORT**

11-2079, 11-4054 and 11-4055

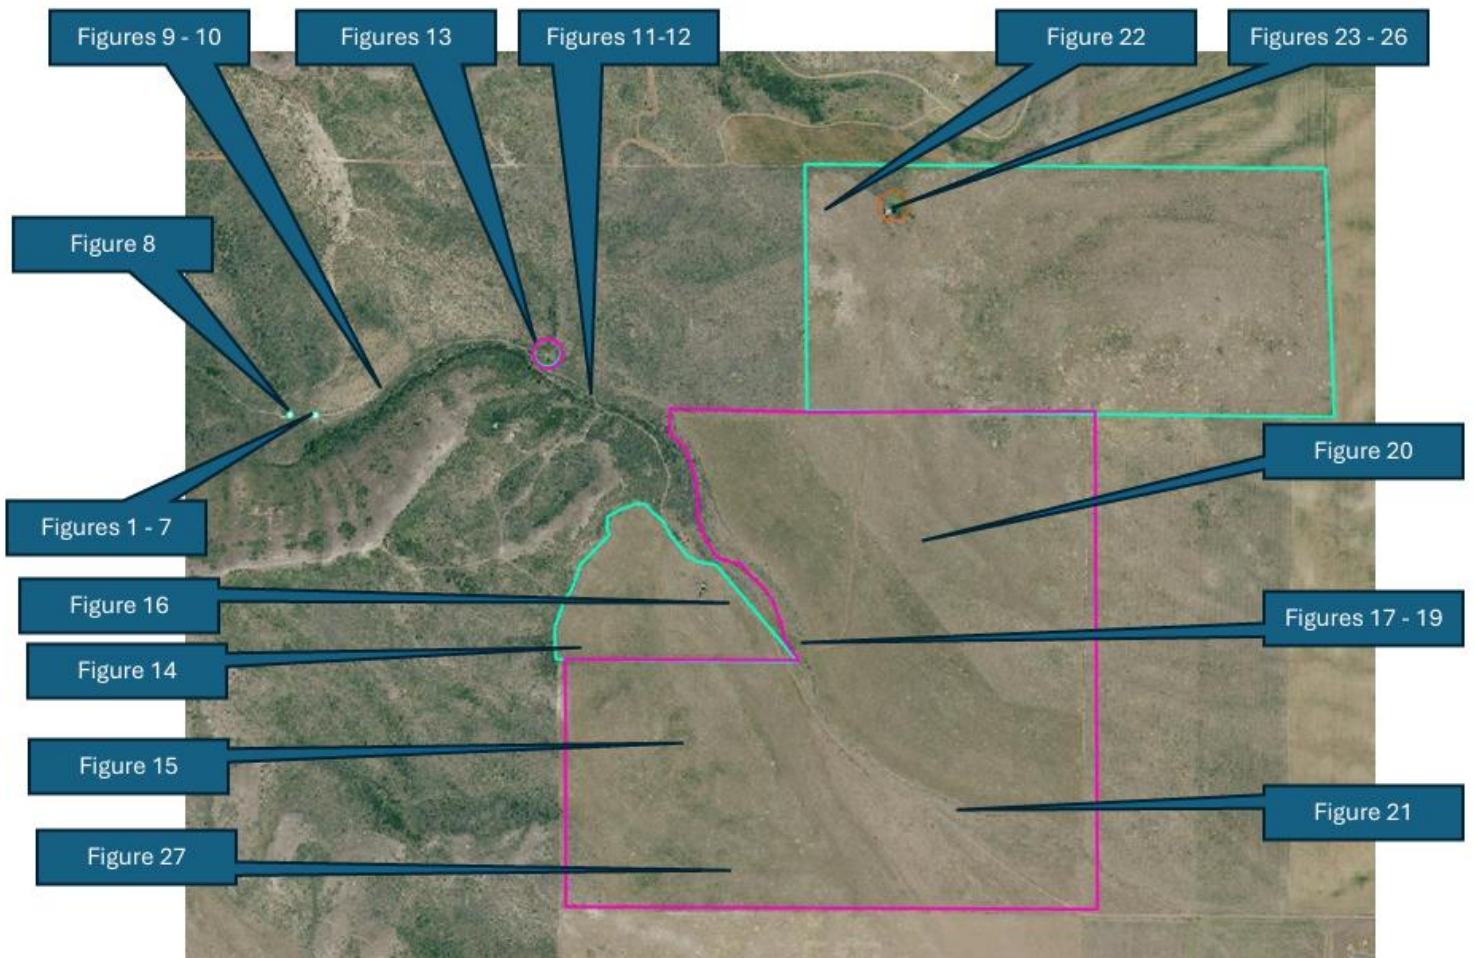
We then walked an additional 0.26 miles (measured by Esri ArcGIS Pro) to the cistern. An inlet pipe entering from the west was observed, supplying collected water to the cistern. When the rubber end was removed, water was observed trickling out of the pipe. Adjacent stock troughs were present, and Rigby confirmed stock use at these locations. A hose connected to the base of the cistern appeared to be used for filling the troughs. To the east, a rock-lined spillway was visible, directing overflow back to the creek channel below. GPS coordinates were collected for the cistern.

*Figure 1: Cistern located up about ½ mile into Red Pine Hollow.*
