IDAHO DEPARTMENT OF  
**WATER RESOURCES**

**BRBA FIELD EXAMINATION REPORT**

**Claim Number:** 11-7583

**Exam Location:** Northern half of 12S 43E 35 NWSE.

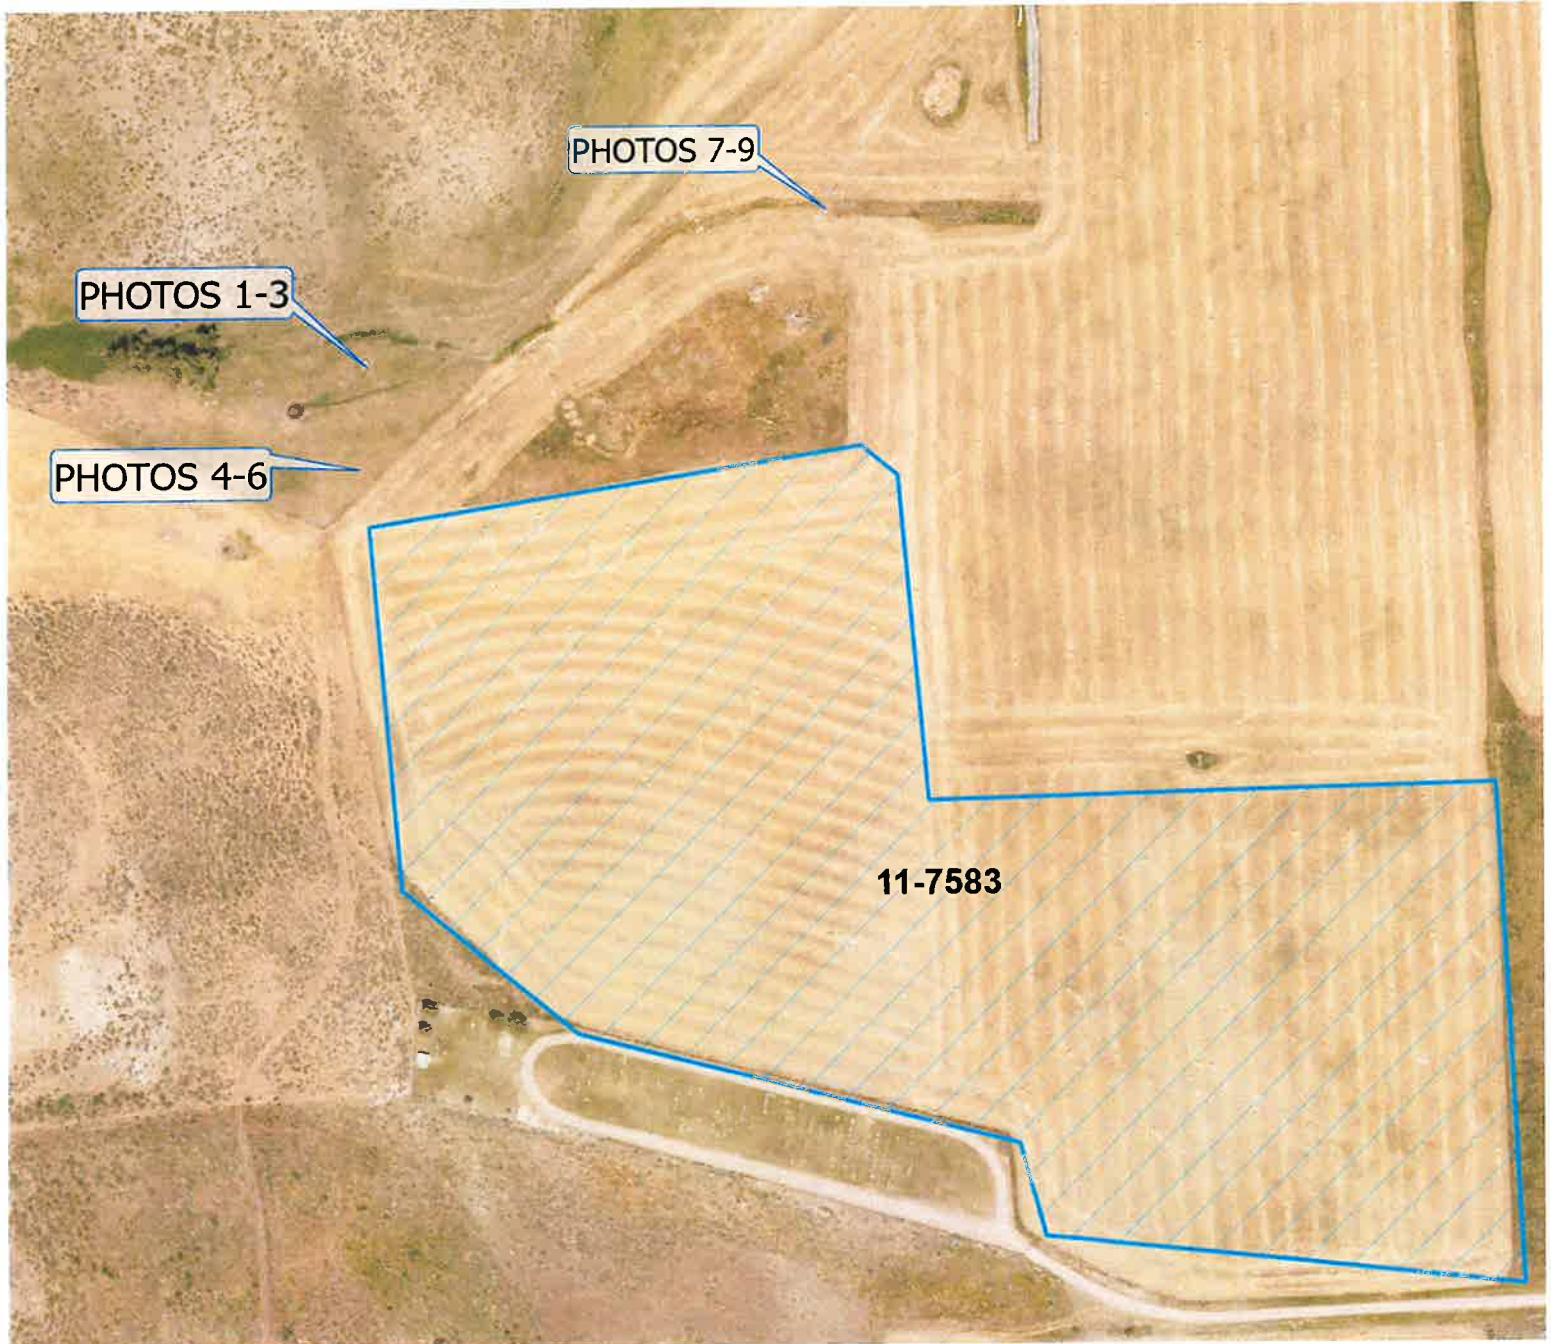
Starting at the above-ground concrete cistern (Photo 1), it was clear that the system had not been in use recently. There was no water present in the system (Photo 2), and it was unclear how water was put to use in the past. The open channel downstream of the cistern was dry (Photo 3).
