IDAHO DEPARTMENT OF  
**WATER RESOURCES**

**BRBA FIELD EXAMINATION REPORT**

**Claim Number:** 11-4110,  
11-8117

**Exam Date:** 07/29/2026

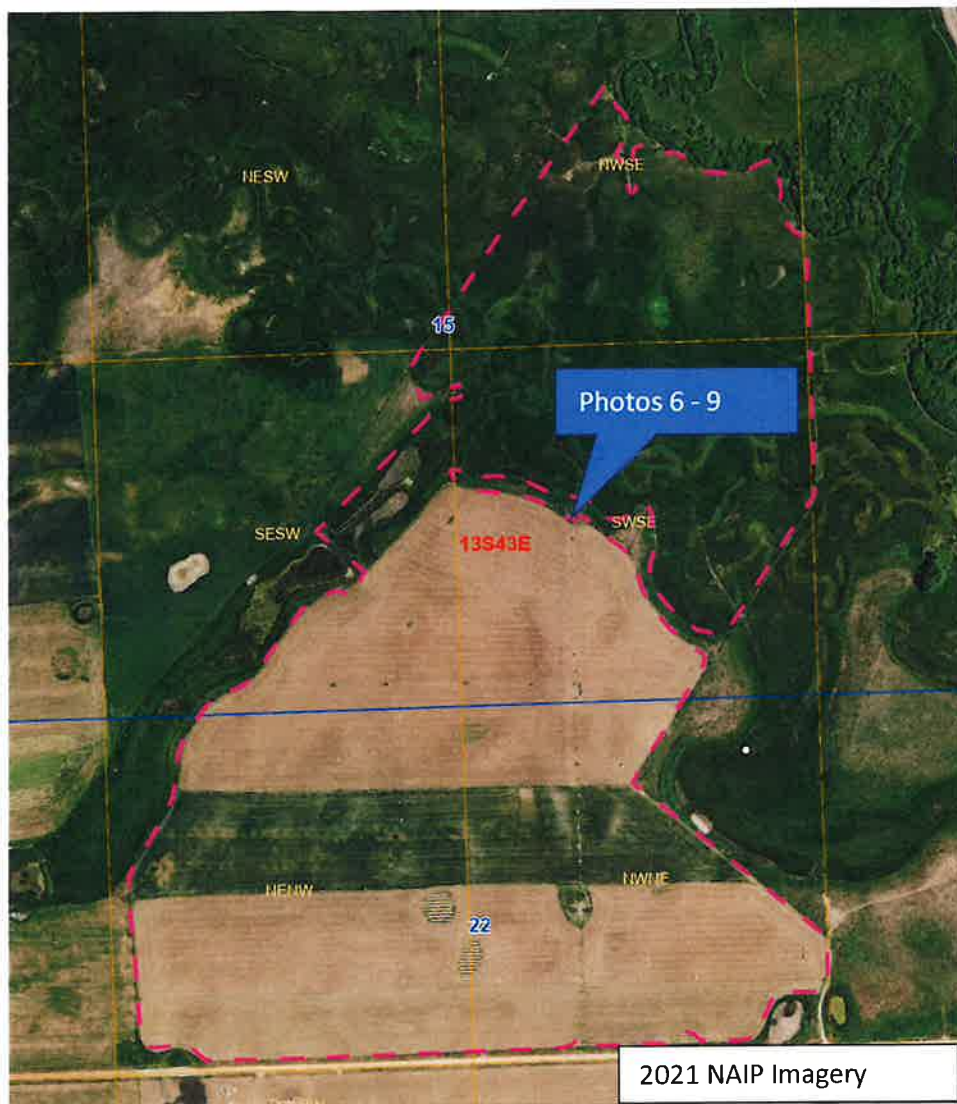
11-8117 POU

From the POD we went to see the POU for 11-8117. Dylan showed us where check dams are in place to spread the water, (Photo 5). The east fenceline is raised to act as a berm and spread the water. Then, we went to see where the pump is located for the sprinklers, (Photo 6). The pump area has been dug out and bermed-up to create a pool. The pump was replaced and a new one installed in 2017, (Photo 7). It is an 8-inch line coming from the pump and then 6-inch lines on the wheel lines. Dylan stated that share water is also used to supply the wheel lines, but they only have enough shares to run one line at a time. They have 15 shares and each share is 0.04 cfs per share. This works out to be about 270 GPM, which makes sense why they can only run one wheel line at a time with the share water.

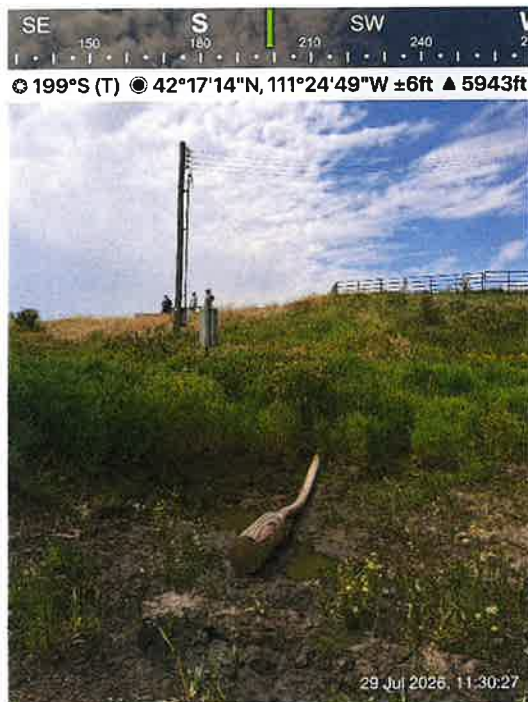
Photo 8

## Pump specifications
