IDAHO DEPARTMENT OF  
**WATER RESOURCES**

**BRBA FIELD EXAMINATION REPORT**

**Claim Number:** 11-4024B

**Exam Date:** 7/29/2026

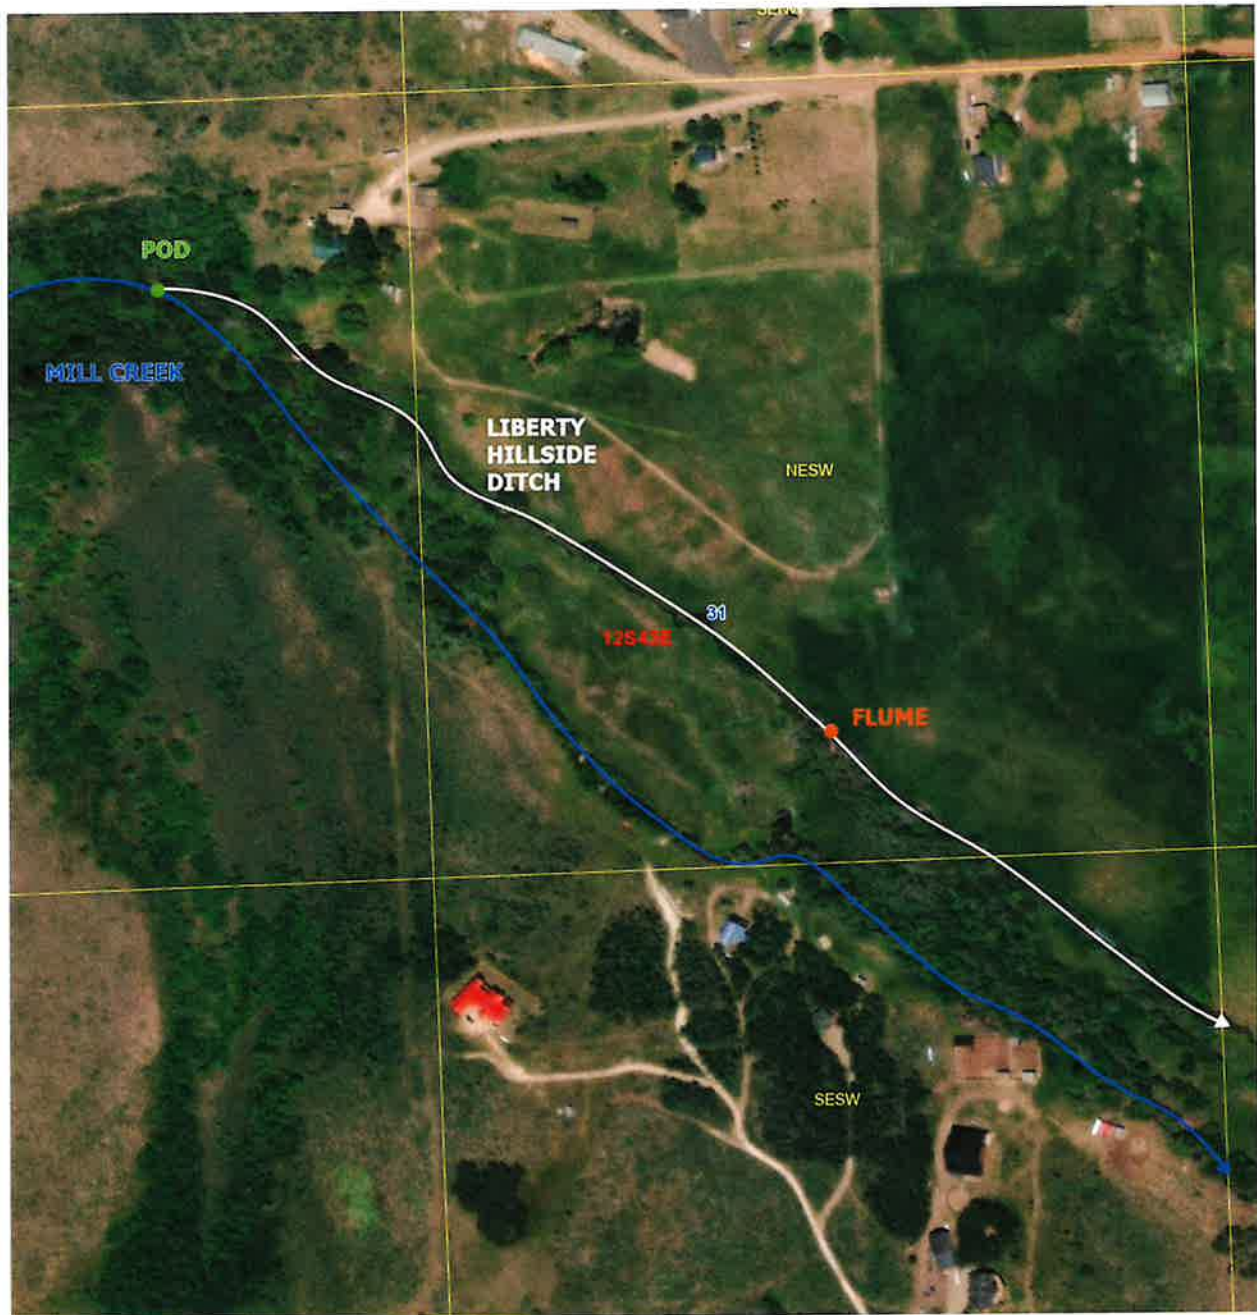
**System Map:**

We met Tyler Hymas, Dale Hymas, and Mike Derricott near 551 Old Mill Rd in Ovid. Tyler and Dale took Collin and I down to the POD on Mill Creek. We observed the rock diversion structure in Mill Creek where GPS coordinates and photos were taken.

Next, we moved to a location 0.25 miles down the ditch to where a 6 cfs cutthroat flume had recently been installed. An elevation gradient was recorded with an auto level and specifications from the flume were documented.
