RE: Delivery of Pomerelle Diversion

Memo

Subject: Field Visit to Pomerelle Ski Area diversion for 45-04114

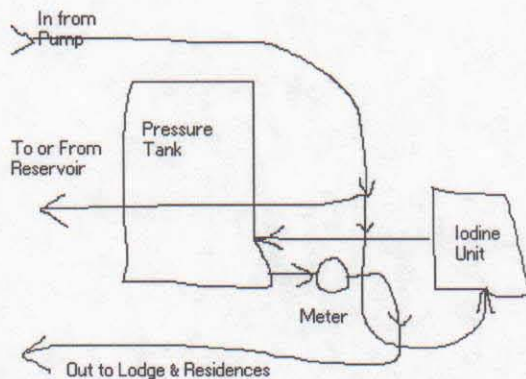
After the tee to the reservoir, water continues down the pipe and over to an iodine injection site then to a pressure tank then back out through the meter and then to the distribution line for uses at the lodge and residences. All water currently used in these facilities is metered. Mr. Anderson has provided copies of the records since 1997. The attached spreadsheet is based on his records. Note that the meter totalizes water use and reads out in hundreds of gallons. We took a reading of 08443. The previously recorded reading was 08442 on 5/5 indicating a use of 100 gallons in 11 days. During this inspection John flushed toilets and turned on water and the meter moved and appeared to be in good operating condition.
