Department of Water Resources

COMMUNICATION DOCUMENTATION

SUBJECT: 43-07322
phone call (.) walk-in (.) other (x)

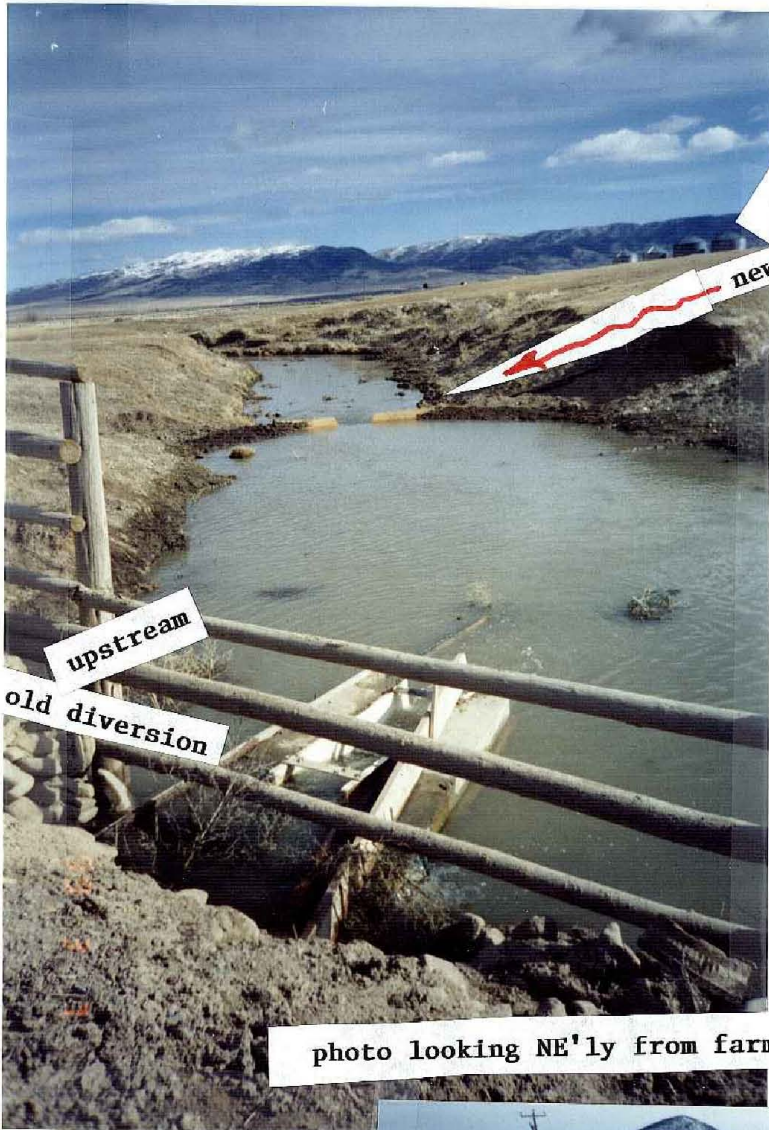
photo looking NE'ly from farm rd

I met with Dave Sundberg and Garth Steed. The new structure still isn't up to par. See photographs. The items that will be corrected:

1. The rectangular weir will have a crest length of 2.0'.
2. The fall distance seems to be acceptable, however the structure was leaning downstream and it will be necessary to plumb it up.
