DEPARTMENT OF
WATER RESOURCES

April 6, 2009

Jim Rindfleisch, Manager
Big Lost River Irrigation Dist
P. O. Box 205
Mackay, Idaho 83251

RE: Response to March 4, 2009 Letter

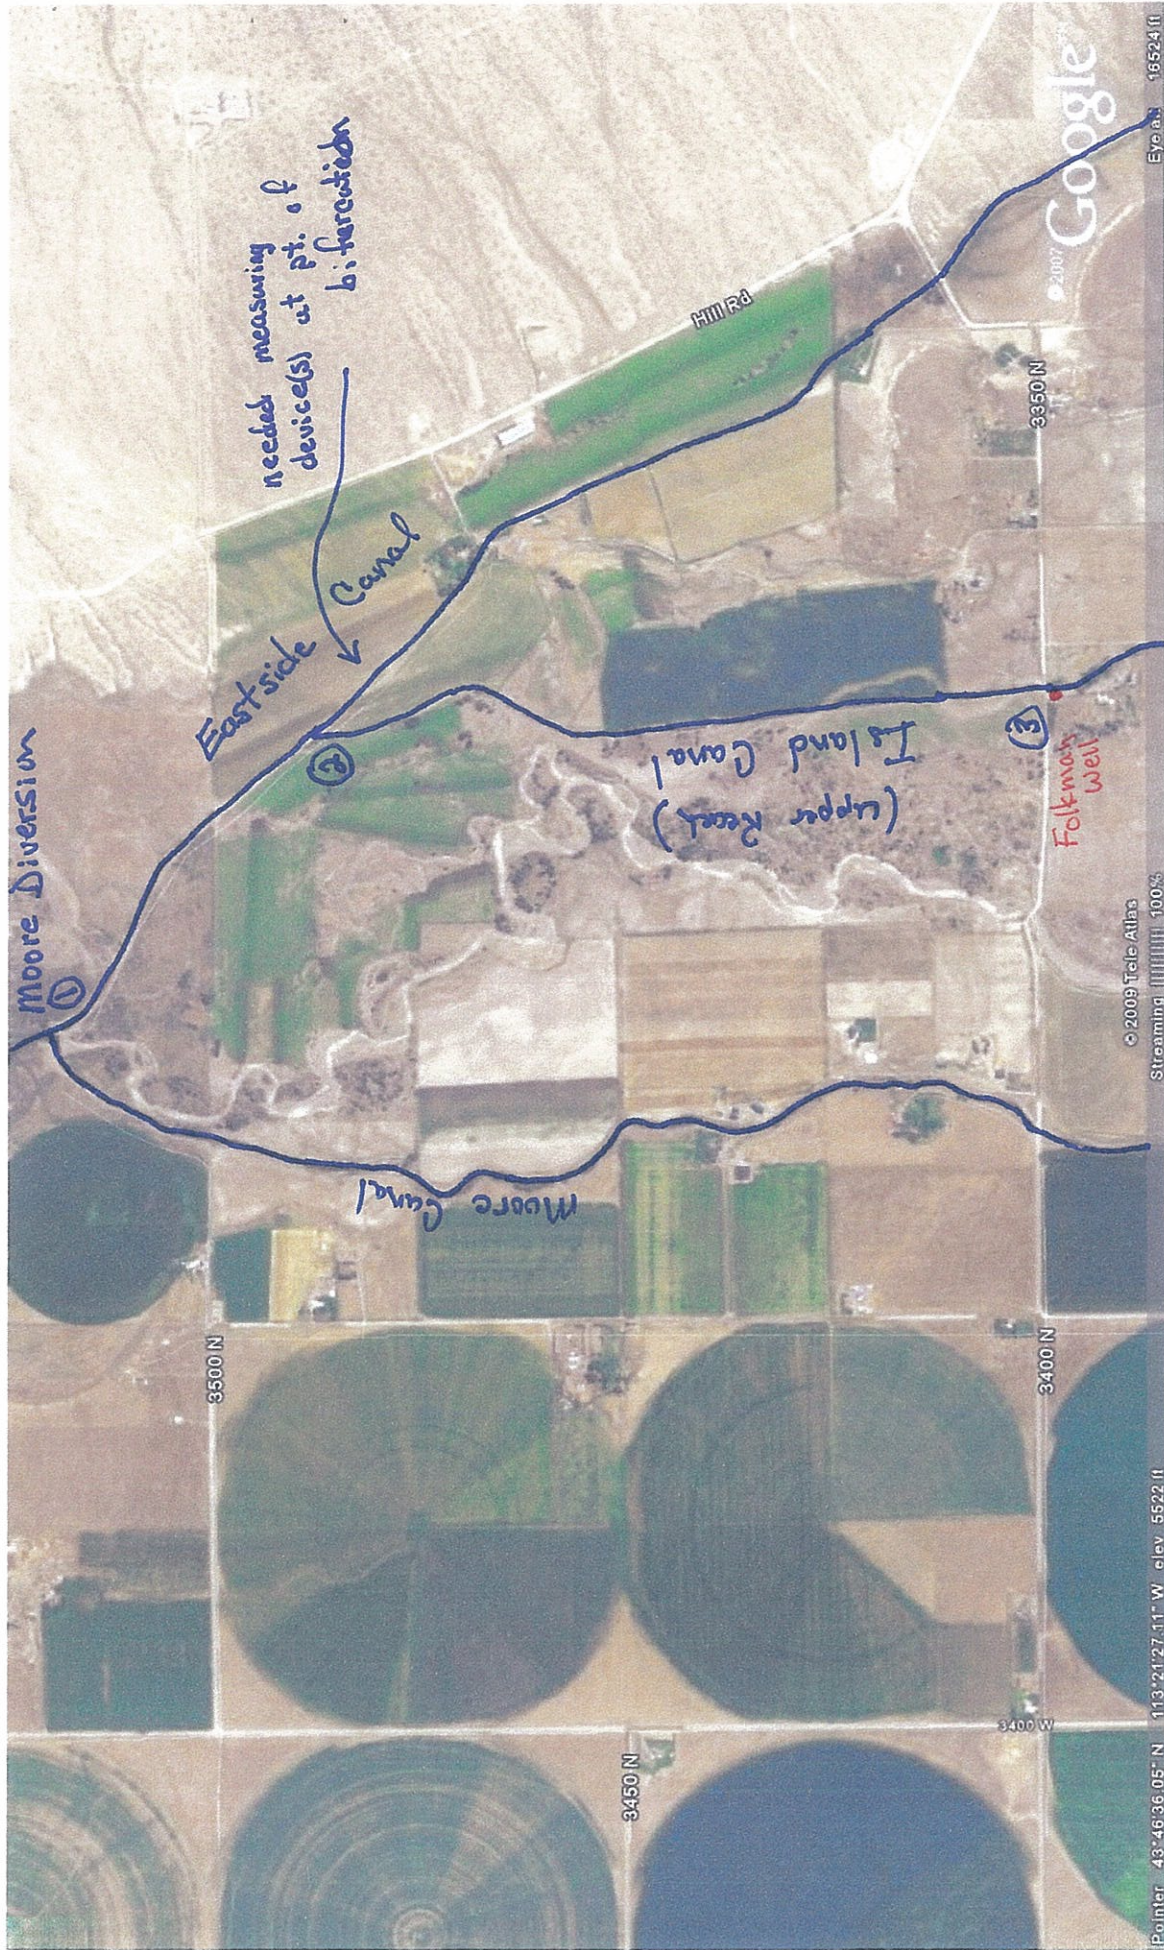
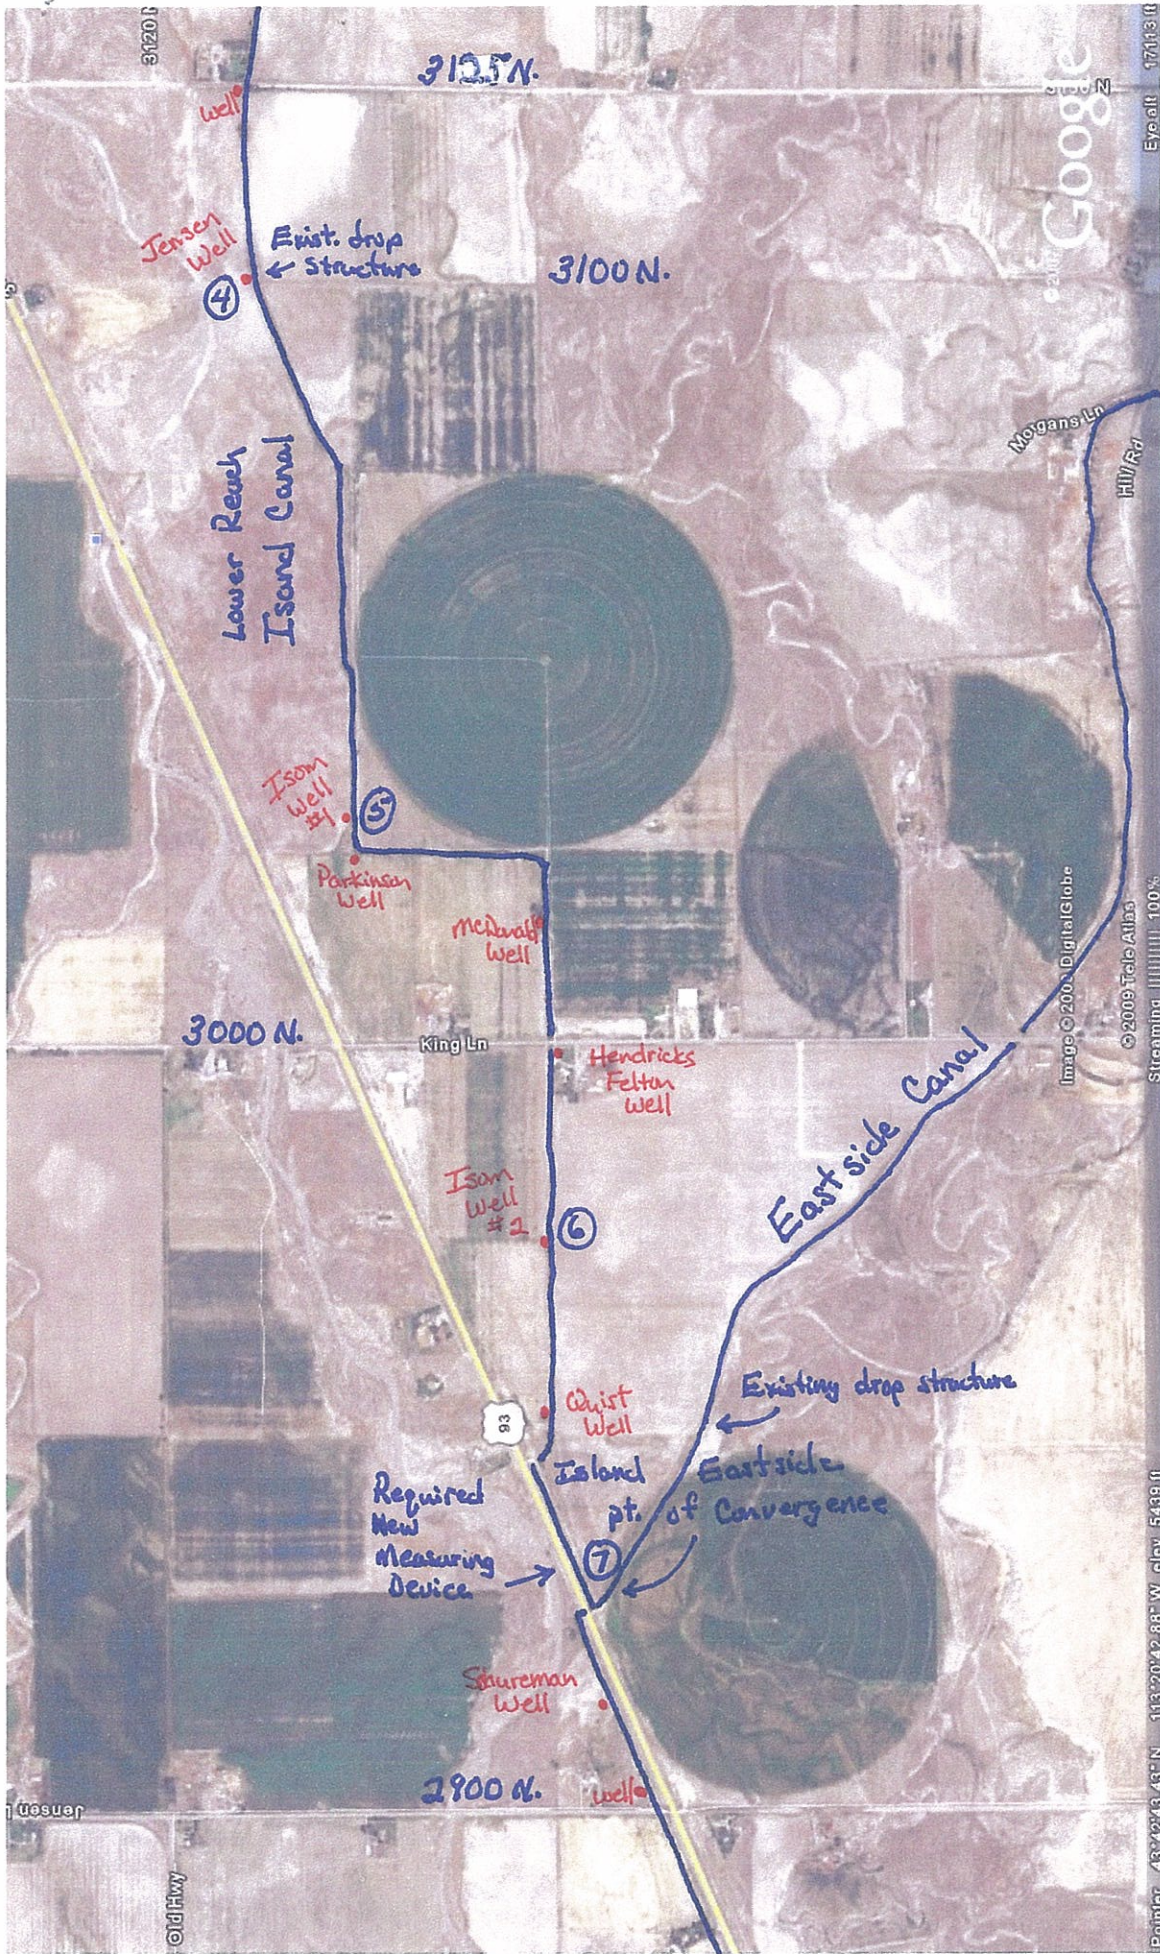
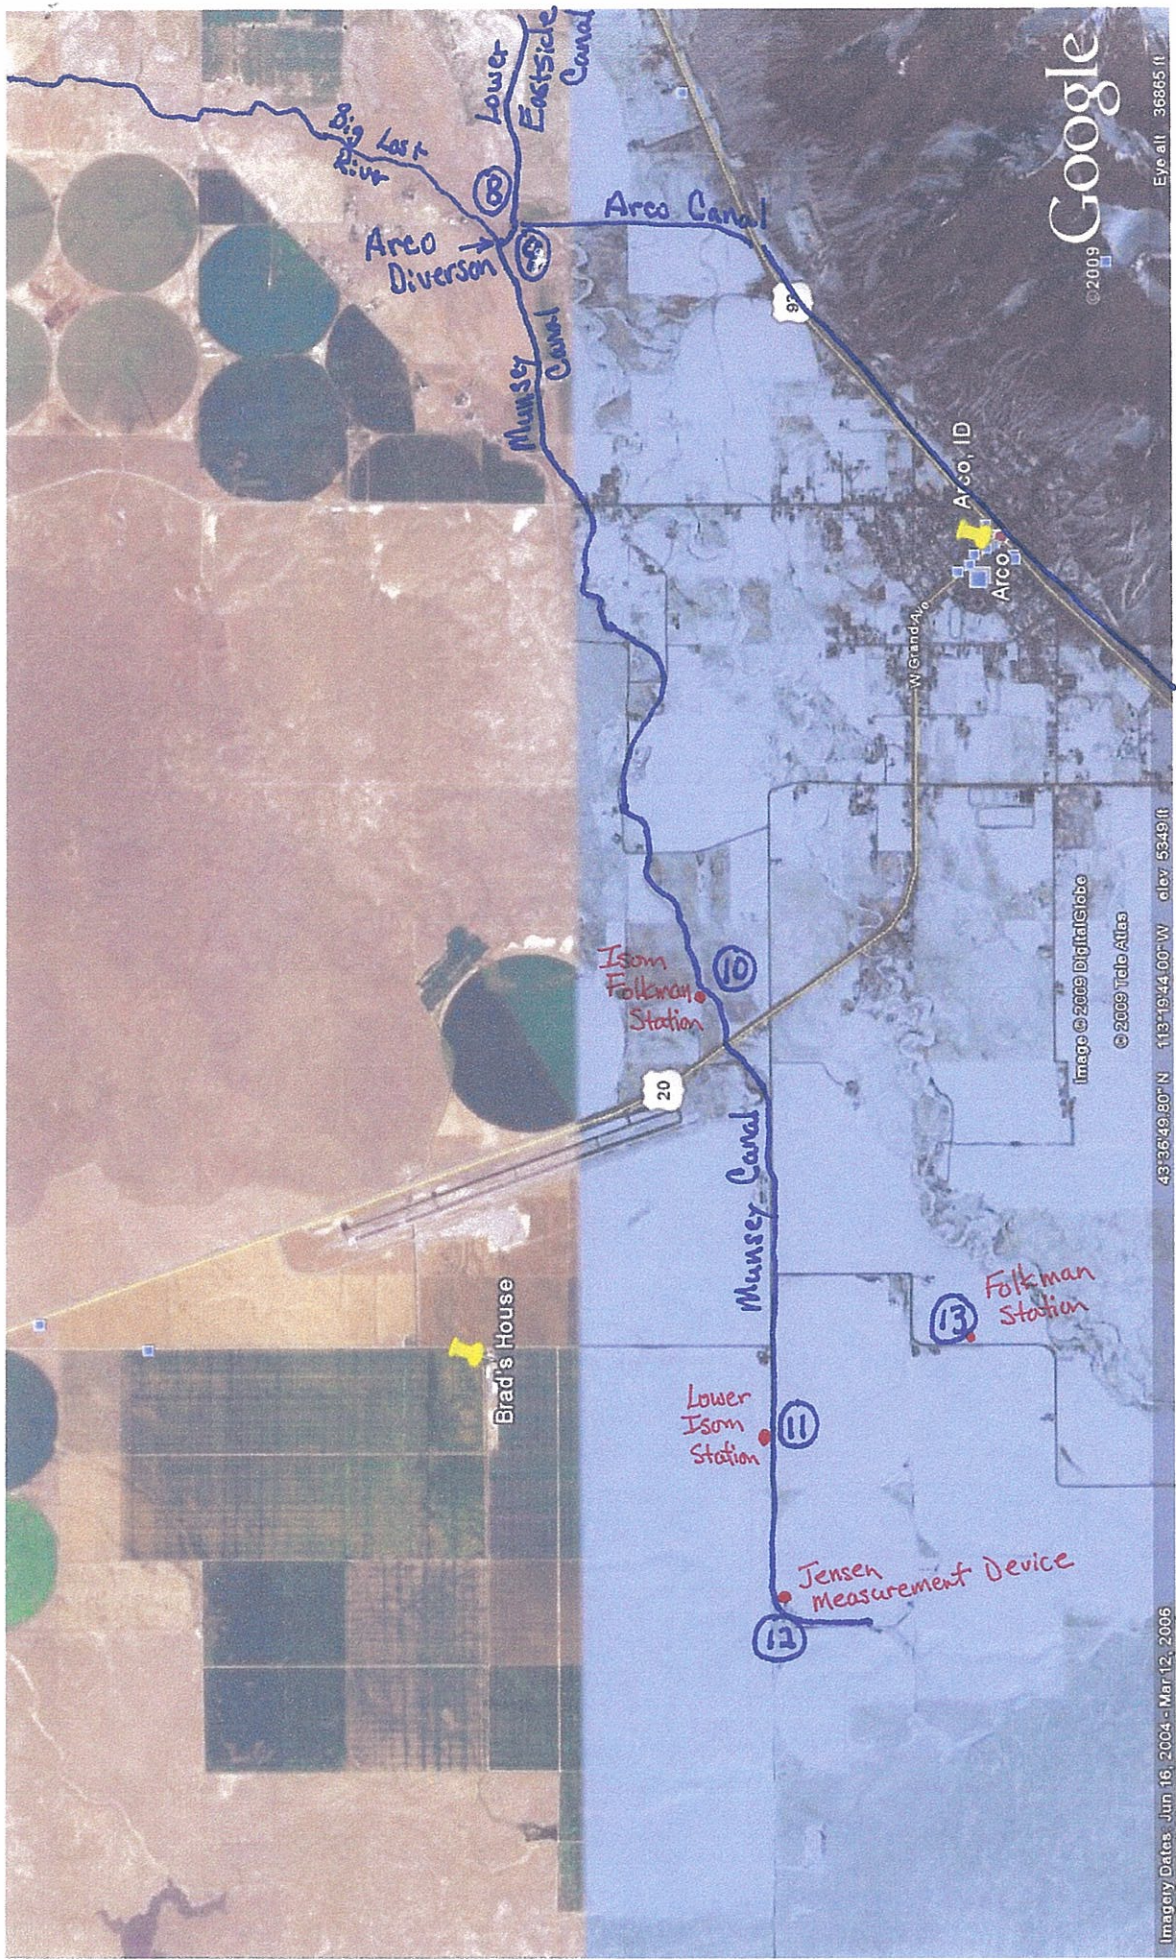
We have attached to this letter pictures taken of the Munsey Canal in August of 2008. They clearly show a substantial amount of vegetative over-growth in the canal and its laterals. A closer inspection of the canal will show that in some locations the banks have sedimentary fill extending into the main channel of the canal by as much as 5-6 feet. There is no doubt some pumping stations and fence crossings cause obstructions to water flows. But the larger cause of water flow obstruction and impediment (effecting higher

The entire 5 mile reach of the Munsey Canal is in major need of a complete reshaping of the channel and canal banks. Partial burning of vegetation, removal of debris and obstructions, and installing measuring devices is helpful, but will still fall short of what is needed to properly provide for the efficient conveyance of our valuable water resources. A substantial portion of the assessment revenue BLRID receives from Munsey Canal water users should be used for this repair and maintenance project.
