MEMORANDUM

TO: Muldoon Creek Water District (37-O) File

DATE: September 23, 2004

SUBJECT: Field Visit

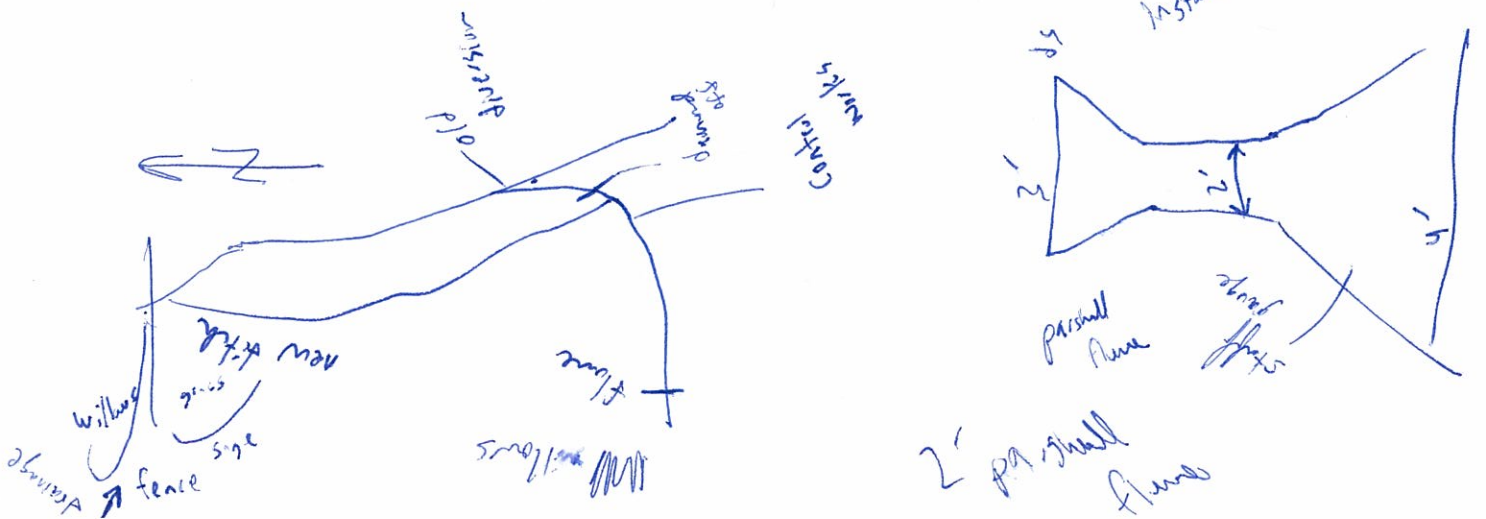
LEFT: View of Parshall flume on the Clark Lower Diversion Ditch. Note flow around the flume and overall condition, and installation of the flume. The survey revealed that the converging section slopes up, as you move downstream, and the left side is actually lower than the downstream end of the flume.
