State of Idaho DEPARTMENT OF WATER RESOURCES

Re: Your Correspondence Dated February 23, 2009 Concerning Water Right 37-7822, South Gimlet Water Users

4/1/2009 Memo to Tim Luke – South Gimlet Water User's aesthetic diversion Page 4 of 11

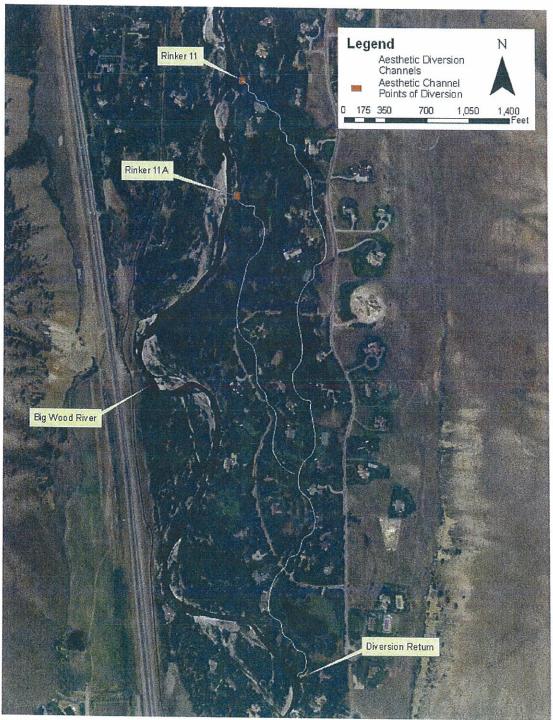
Figure 2. Approximate locations of aesthetic-diversion features in reference to the Big Wood River. Adapted from Brockway Engineering Memo dated February 23, 2009.

Flow measurements were first taken on the two authorized points of diversion (Rinker 11 and Rinker 11A) and on the diversion return point in June of 1988 by C.E. Brockway as

part of the water right field examination (Figure 2). These measurements indicated that the channels were gaining flow from ground water discharge.

If the ground water flow in the vicinity of the site does conform to this pattern, it is reasonable to expect that some ground water would discharge to the Big Wood River near the diversion's return location. Discharge at this location is inferred based on the west-to-east river meander which is perpendicular to the ground water flow path. The impermeable eastern aquifer boundary and water level elevations in the East Fork Wood River alluvial aquifer also suggest that some seepage water will discharge to the Big Wood River because water cannot flow to the east (Figures 2 and 3).
