Claim Number 63-21536

# Idaho Department of Water Resources

SRBA Claim  
63-21536  
(DOMESTIC)

**63-21536 field exam (was Bible Missionary Church Northwest Dist)**

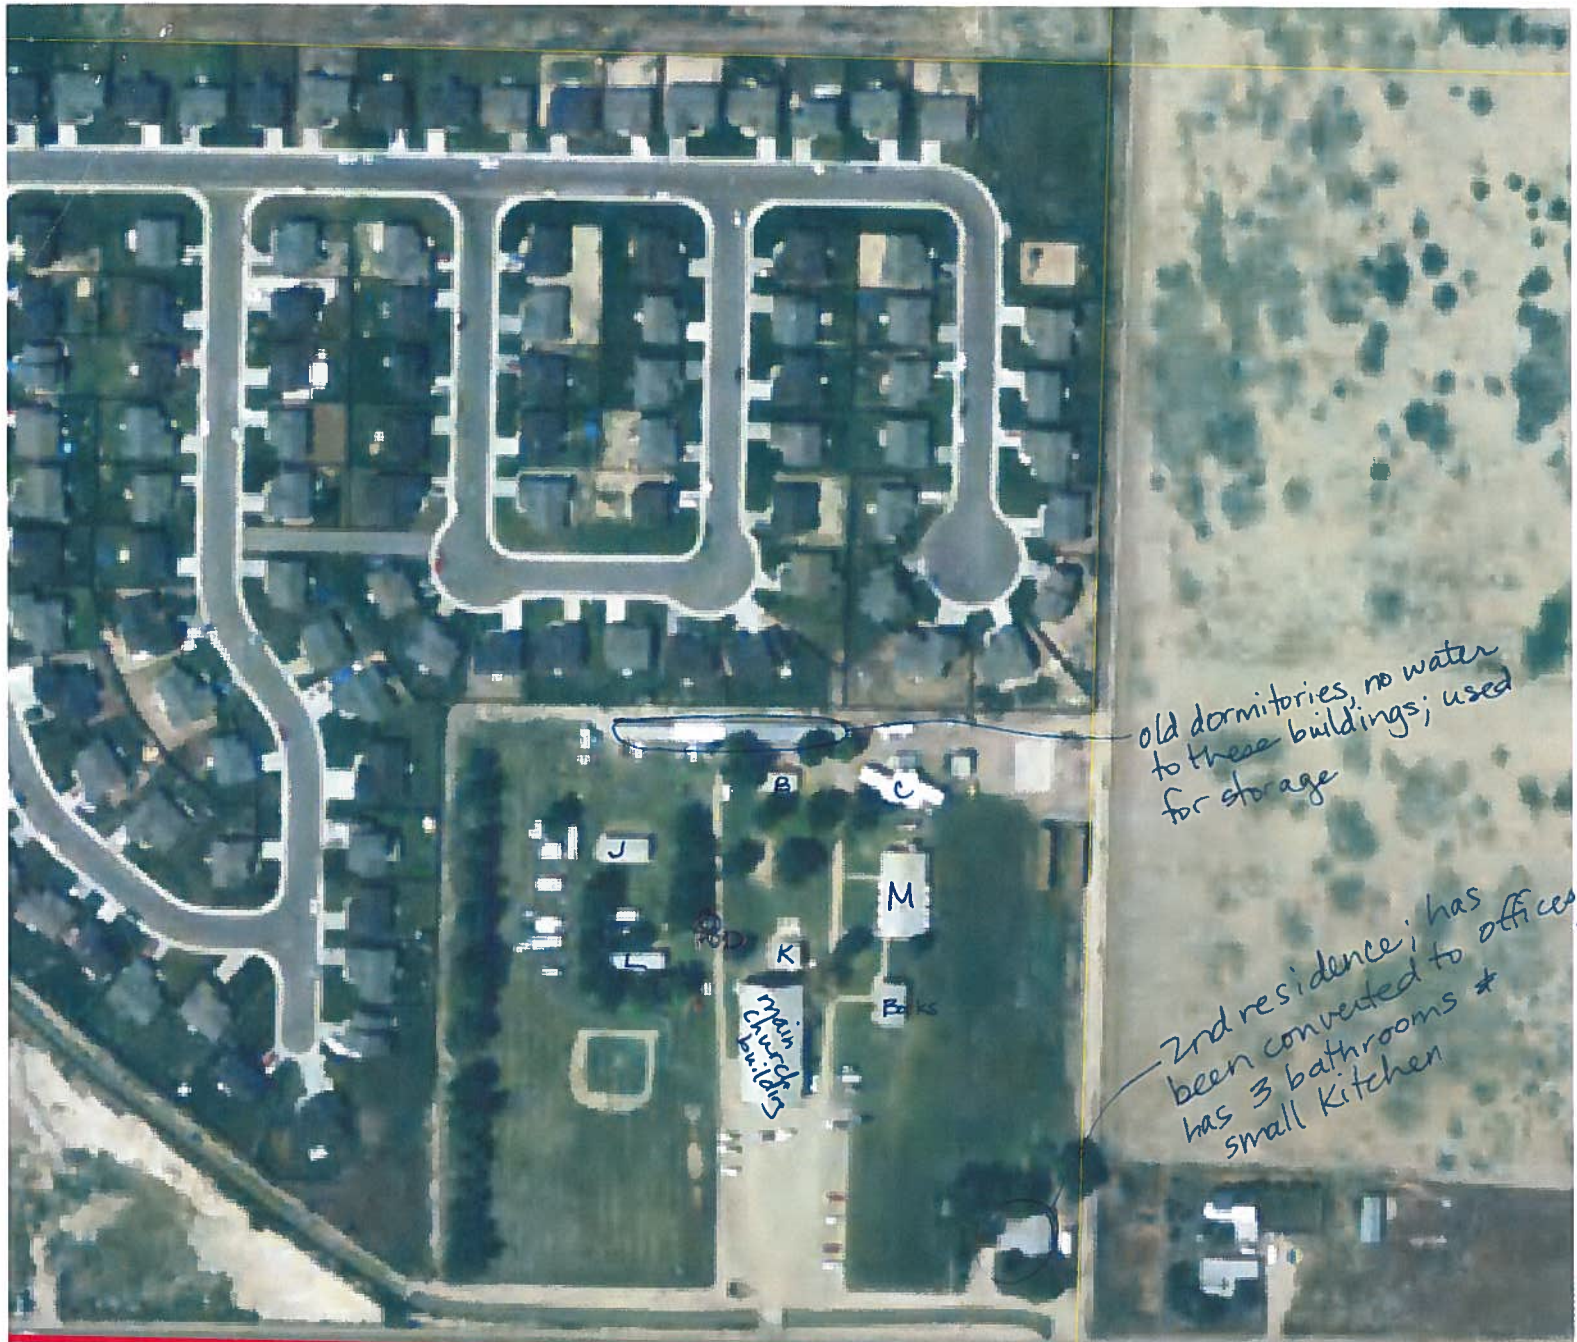
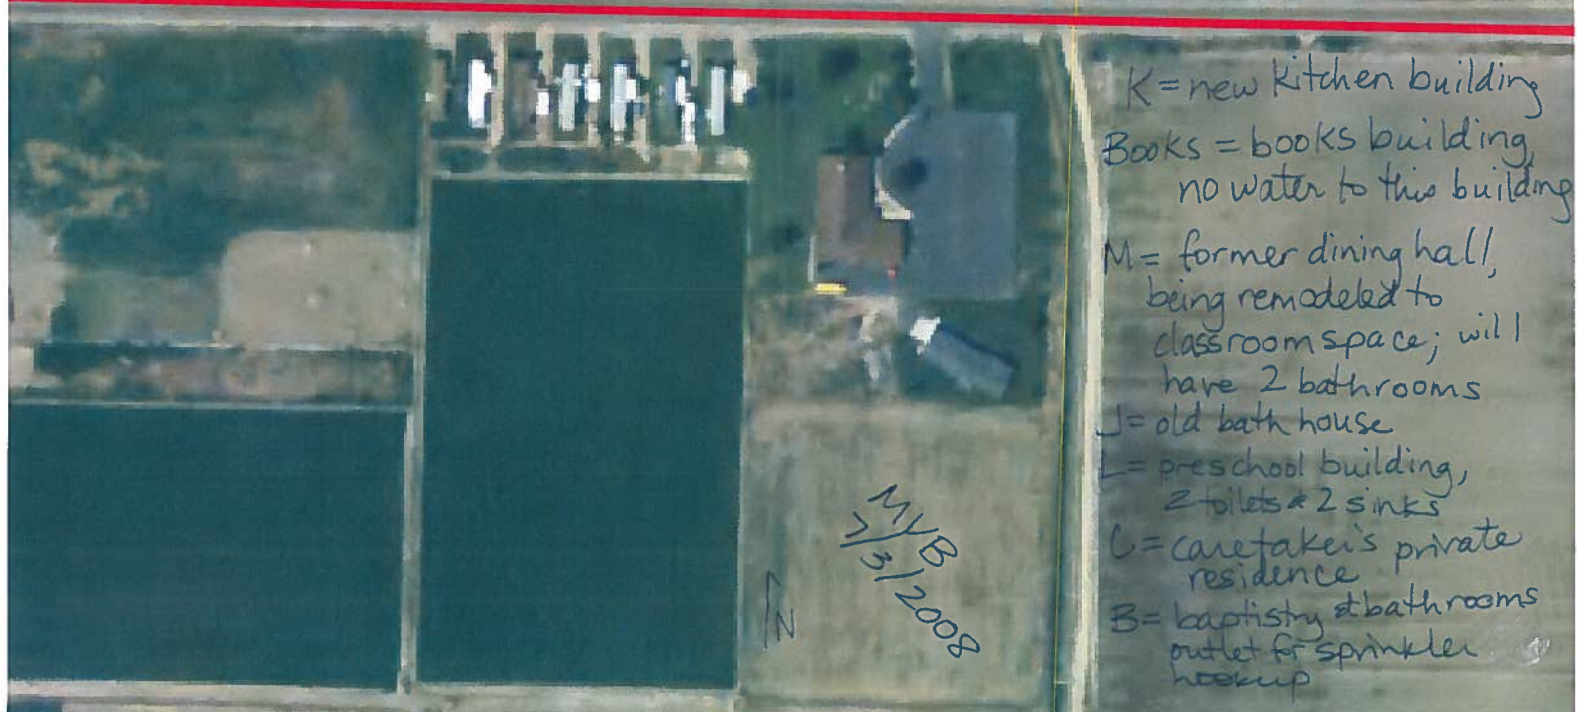
*this building is a missionary church but is not affiliated with the campground*

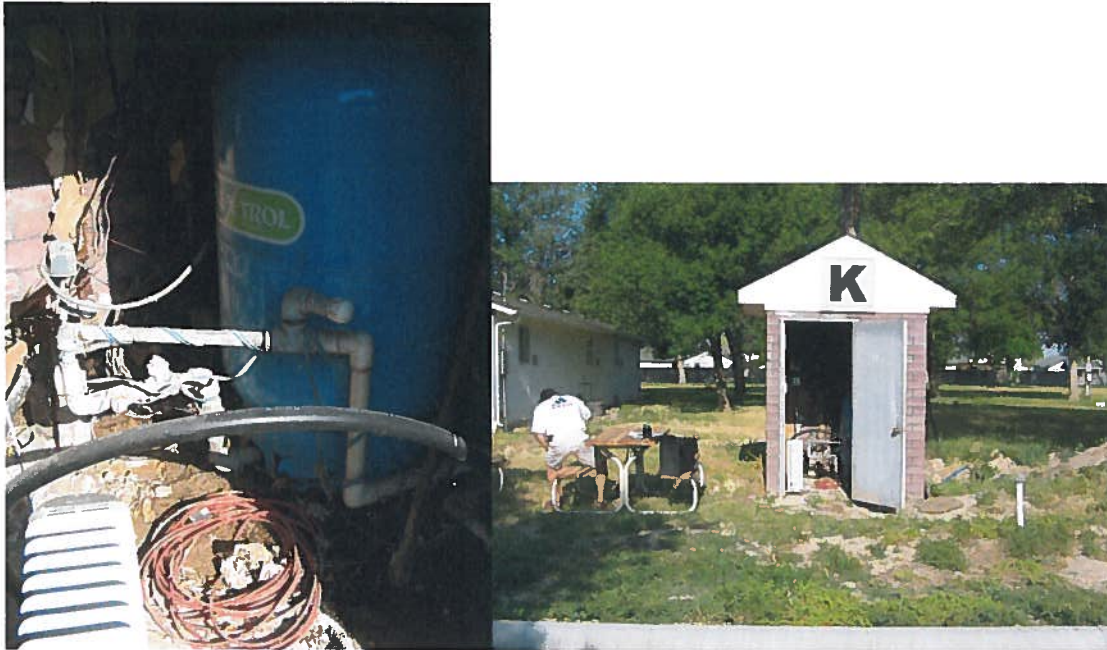
Pump is submersible. Claimant is checking on horsepower and lift, but general consensus is the well produces 25-30 gallons per minute. Claim also includes 35 RV hook-ups, but the facility has a conditional use permit with the county that only provides for 5 RV hook-ups at any given time.

The main church building, not pictured, is on the south side of the property approximately 35 yards southeast of the pump house and has 5 toilets, 1 urinal and 3 sinks spread among three bathroom facilities in the building.

well carries 40 psi regularly - pressure  
tank won't let it go higher  
submersible pump - claimants will research  
hp & lift  
claimant says system runs 25-30 gallons/min.  
facility has conditional use permit which limits  
RVs on hook-ups to 5

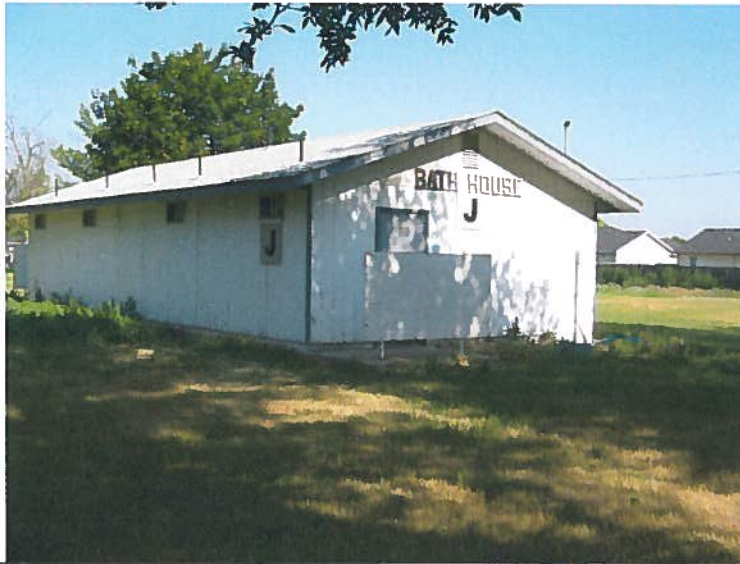
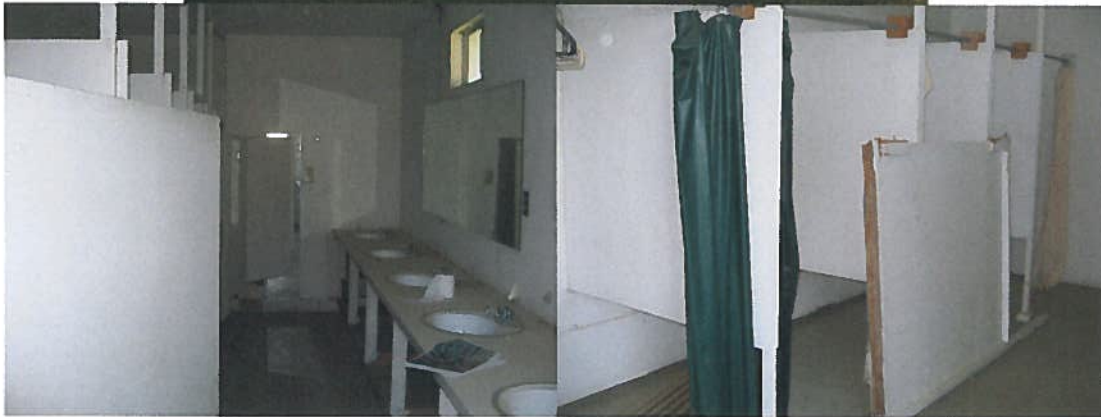
Bath house is located approximately 50 yards northwest of the pump house. Bath house has two sides, one for men and one for women. Each side contains 6 sinks, 6 toilets and 6 showers for a total of 12 sinks, 12 toilets and 12 showers for the building. The current owners state they will probably tear down the bath house because they do not wish to use the facility as a campground and do not have a use for the bath house.

Bath House 1 - 6 sinks, 6 toilets per men's & women's side - will probably be torn down  
Showers in back - 6 showers each side - Water heater on men's side

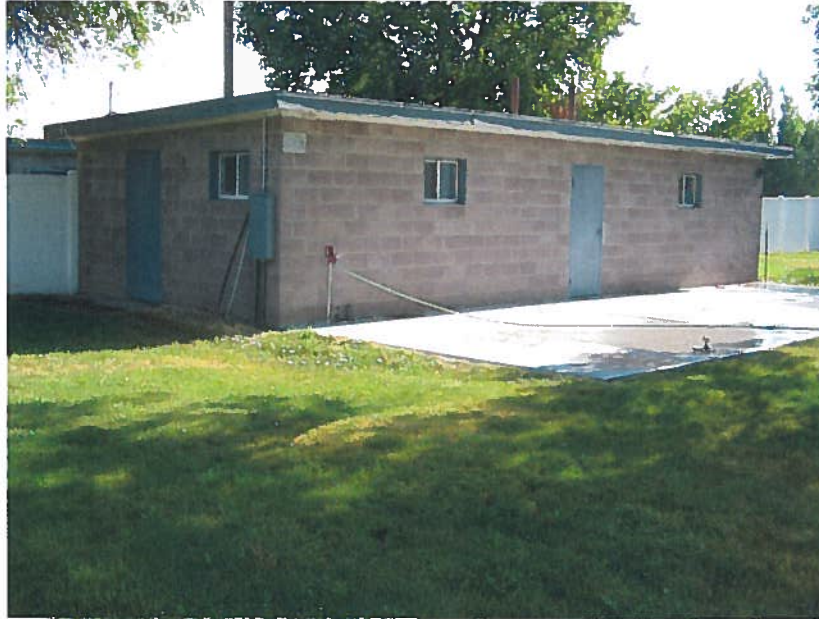
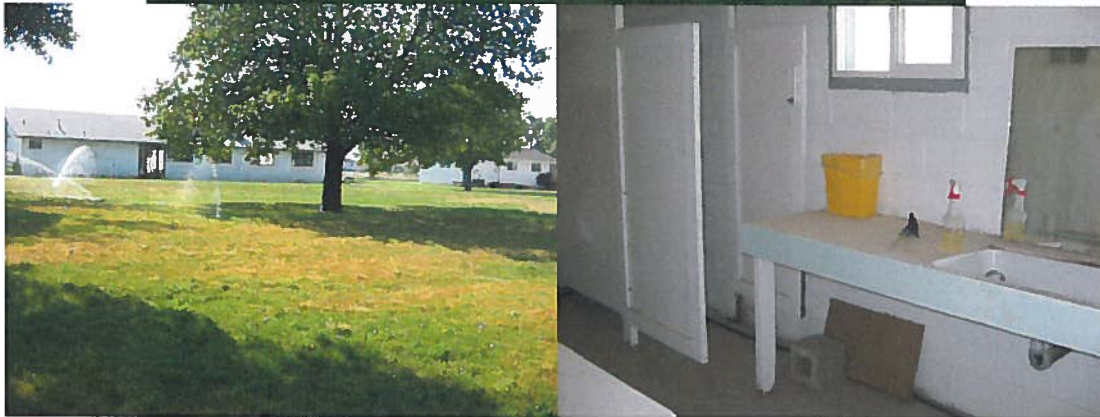
This cinder block building has several purposes and it located about 100 yards north/northeast of the pump house.. It has bathroom facilities for men and women on either side (4 toilets and 4 sinks in all; photo of women's side on lower right), an in-ground baptistery not visible in this picture, and an outlet to connect the sprinklers seen operating in the lower left picture. The outlet for the sprinklers can be seen in the left third of the top picture. The in-ground baptistery can not be seen in the picture, but it is located in the center of the cement pad, roughly 4 feet in front of the gray door in the picture. Approximate dimensions of the in-ground baptistery are 6 feet by 8 feet by 5 feet. New owners anticipate continuing to use this facility after some renovation work.

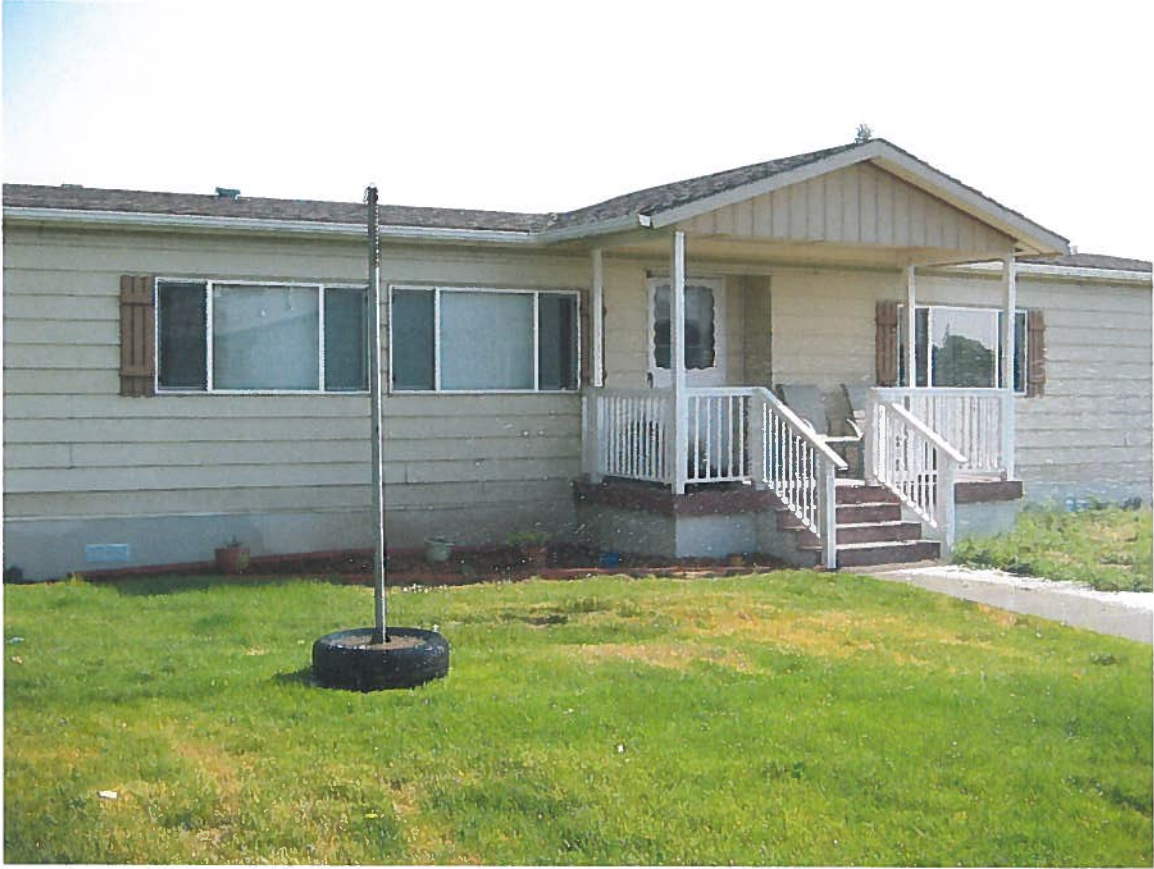
The caretaker's house is located about 125 yards northeast of the pump house. We did not enter the house during the field exam, but presumably the home has 2 bathrooms and a kitchen facility.

Caretaker's house - still a residence

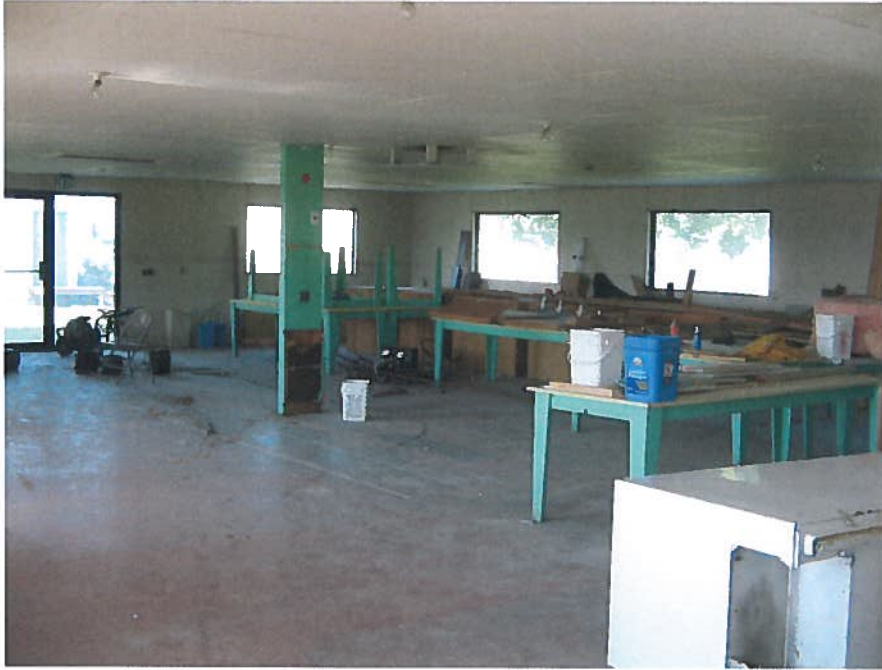
The old dining facility is located approximately 100 yards east of the pump house. It has been mostly gutted since the new owners took possession and will no longer be used as a dining facility as it is being converted to classroom space. The old building had a commercial kitchen with at least three large sinks and a bathroom facility each for men and women. The new building will retain the bathroom facilities – 3 sinks and 2 toilets.

Old dining hall - ripped out kitchen - has bathroom facility - is being remodeled to classroom space

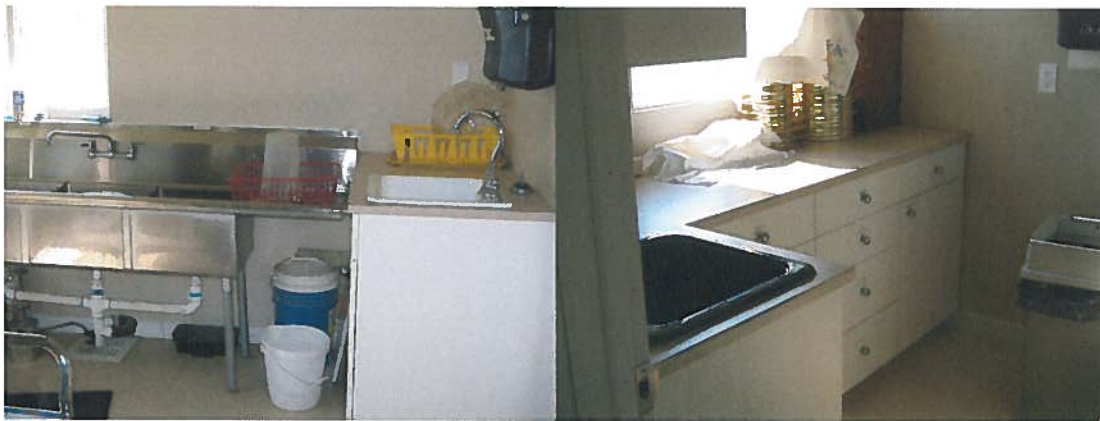
New kitchen facility, located in the building directly behind the main church building, approximately 30 yards east of the pump house. The new kitchen building has three sinks, but had no facilities before.

new kitchen bldg is immed. behind church - 3 sinks

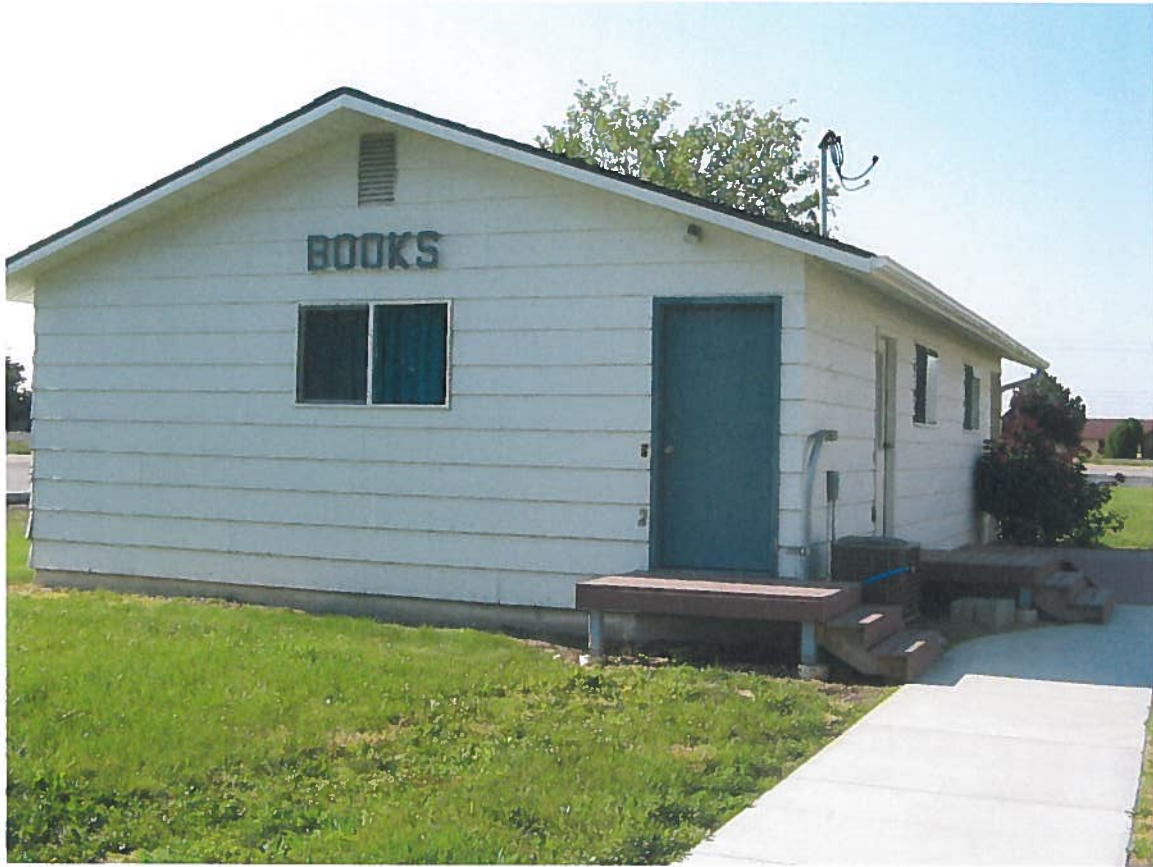
This is the old library building, which has been converted into a youth building. It is located approximately 100 yards east of the pump house. It has never had a water hook-up.

Books building is youth bldg - no outlets / no water

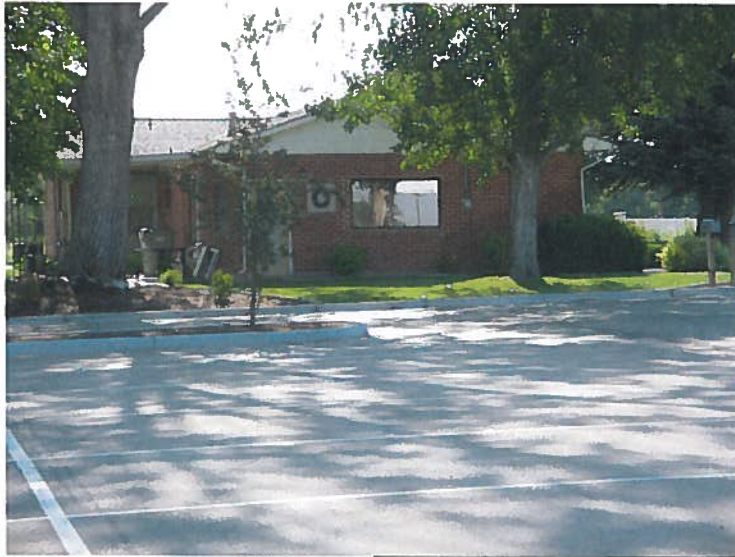
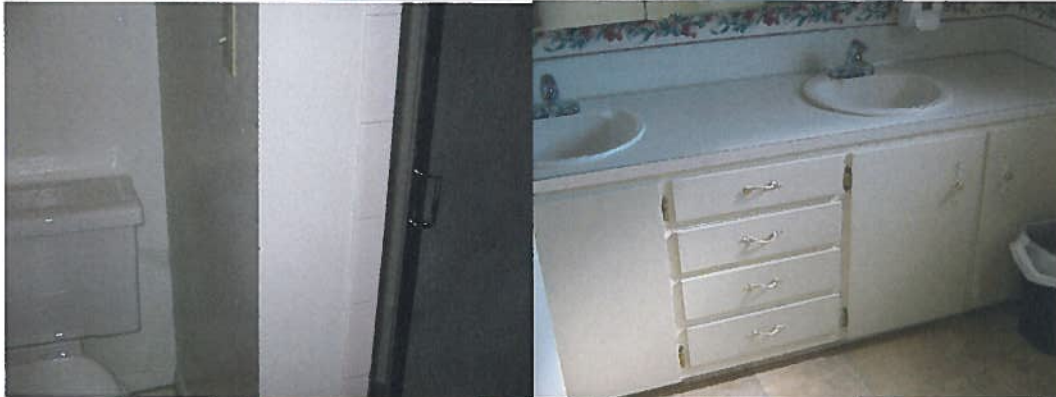
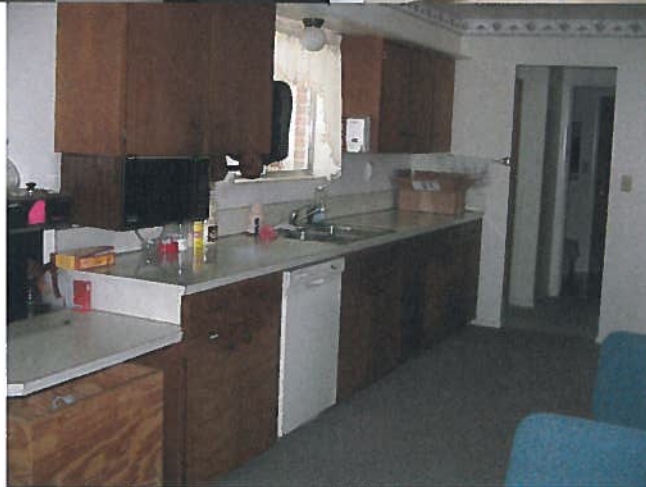
The above 4 pictures show the second residence on the property, which has now been converted to office space. The second residence is located at the southeast corner of the property, approximately 300 yards southeast of the pump house. This facility retains three bathrooms and one kitchen in all, for a total of 5 sinks, 3 toilets and 2 showers.

2nd residence is now office, but does have kitchen (1 sink, 1 dishwasher)  
3 bathrooms (5 sinks, 3 toilets, 2 showers)
