KEVIN TONER AND YODON THONDEN

JOEL PORTER

24-10750 & 24-10751

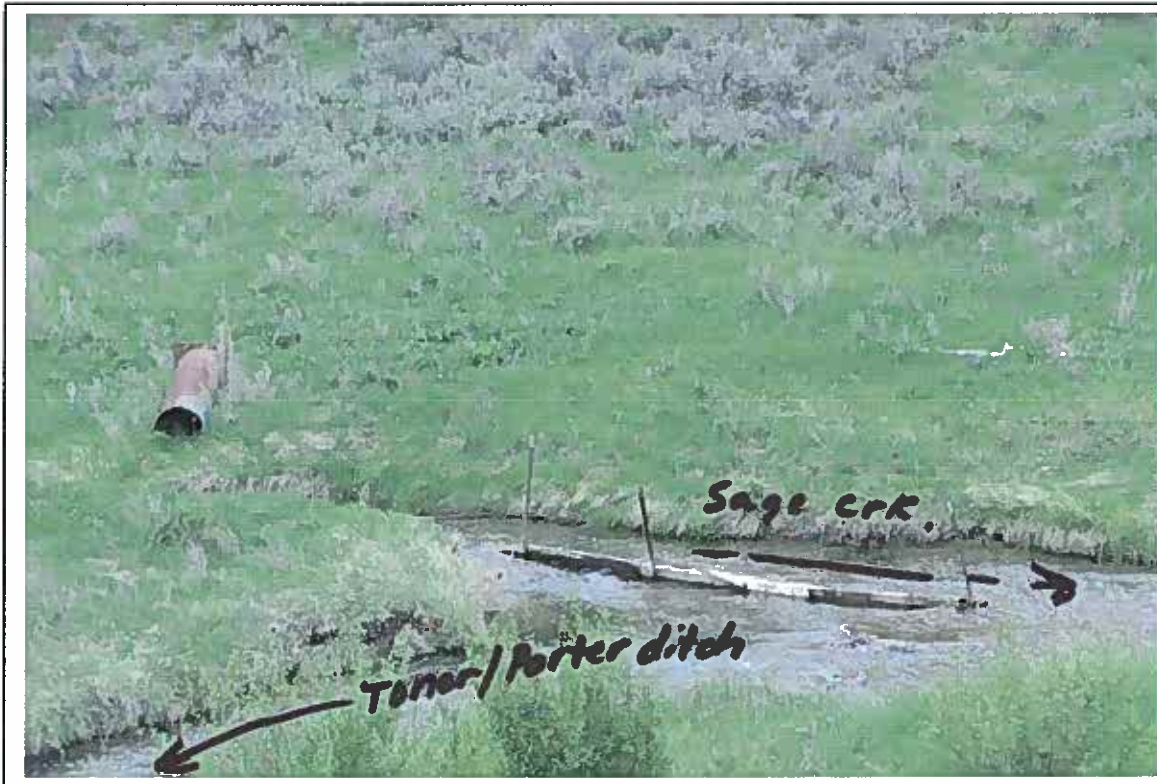
IMG 1576

Accompanied by Monte Clemo; Ranch Manager for the Toner/Porter property. Looking at the diversion from Sage Creek. Water flows into the ditch south of Sage Creek. GPS point taken on the north side of Sage Creek. South side of Sage Creek is the Toner/Porter land. GPS Filename: "SSGCRK" N42° 37.243' W111° 06.297' Sage Creek flows on the north side of the road for a while before going through the culvert on the Joel Porters ground.

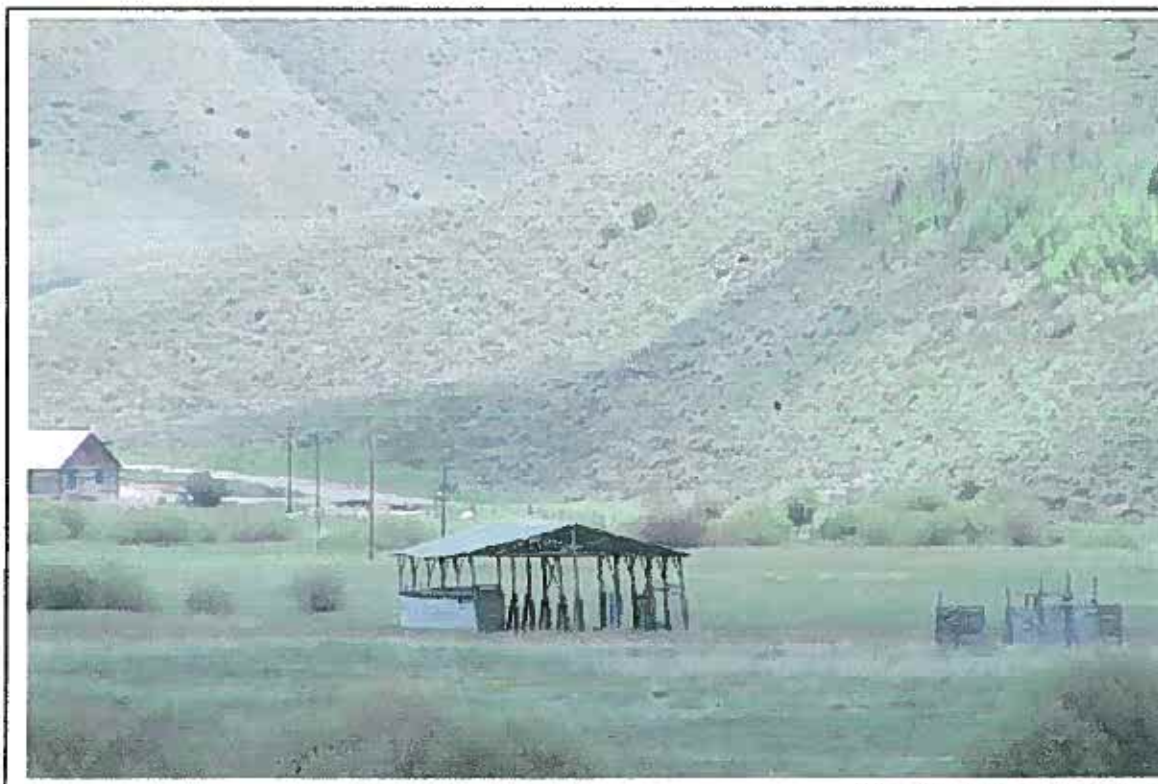
| <u>IMG 1577</u> | | <u>5/23/07</u> | <u>2:03</u> | <u>AM</u> |

Accompanied by Monte Clemo; Ranch Manager for the Toner/Porter property. Looking  
easterly at the place of use from Sage Creek.

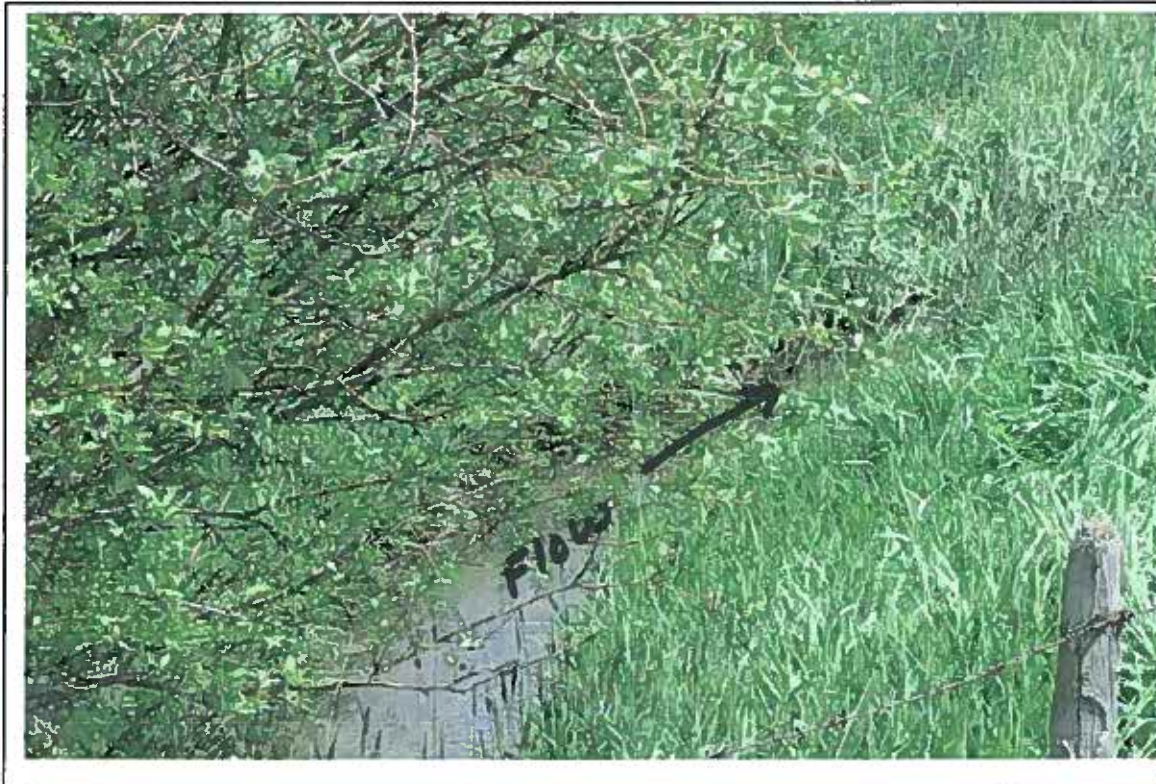
IMG\_1578

Accompanied by Monte Clemo; Ranch Manager for the Toner/Porter property. Looking east at the Sage Creek water just after it comes under the road and enters Joel Porters property. Velocity was measured in the ditch to determine the Q. Velocity was 10ft/12 seconds=0.83 ft/sec. Ditch dimensions 32 inches wide and 11 3/4 inches deep. A=1.3 ft<sup>2</sup>; therefore Q=VA=1.1 cfs. Monte Clemo has worked for Kevin Toner and Joel Porter approximately 2 years.

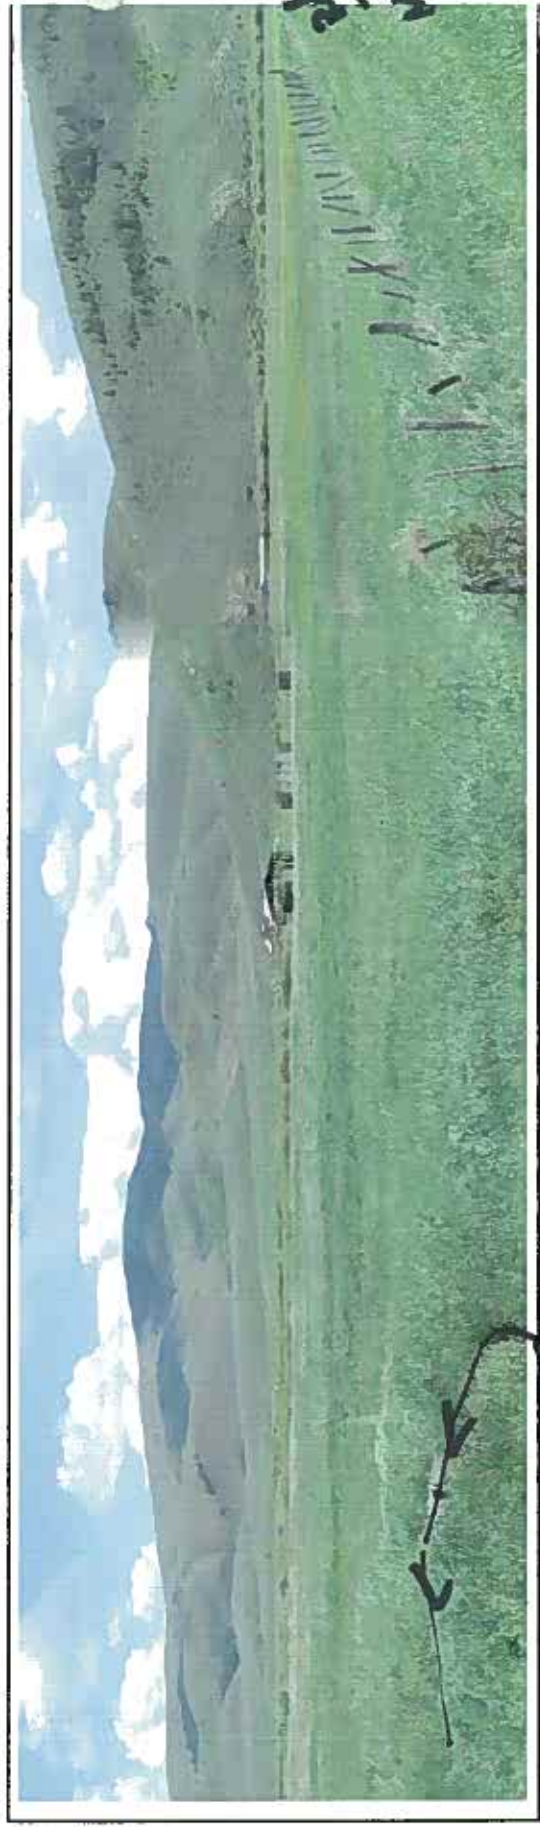
IMG\_1579-1581 Merge 1579-1581 sage crk 5/23/07 2:55 AM CB  
Photo number Photo Rename Date Time PM

Accompanied by Monte Clemo, Ranch Manager for the Toner/Porter property. Looking east at the Sage Creek water just after it comes under the road and enters Joel Porters property..
