IDAHO DEPARTMENT OF WATER RESOURCES  
RECOMMENDATION OF WATER RIGHTS ACQUIRED UNDER STATE LAW

RIGHT NUMBER: 63-9479  
NAME AND ADDRESS: STATE OF IDAHO  
DEPT OF LANDS  
300 N 6TH ST STE 103  
PO BOX 83720  
BOISE ID 83720-0050  
SOURCE: SPRING  
QUANTITY: 0.100 AFY  
TRIBUTARY: WILLOW CREEK

Review notes for recommendations of late claims filed by IDL.  
Sent as an attachment with email to IDL attorney, Tyson Nelson.  
Steve Clelland – May 1, 2013

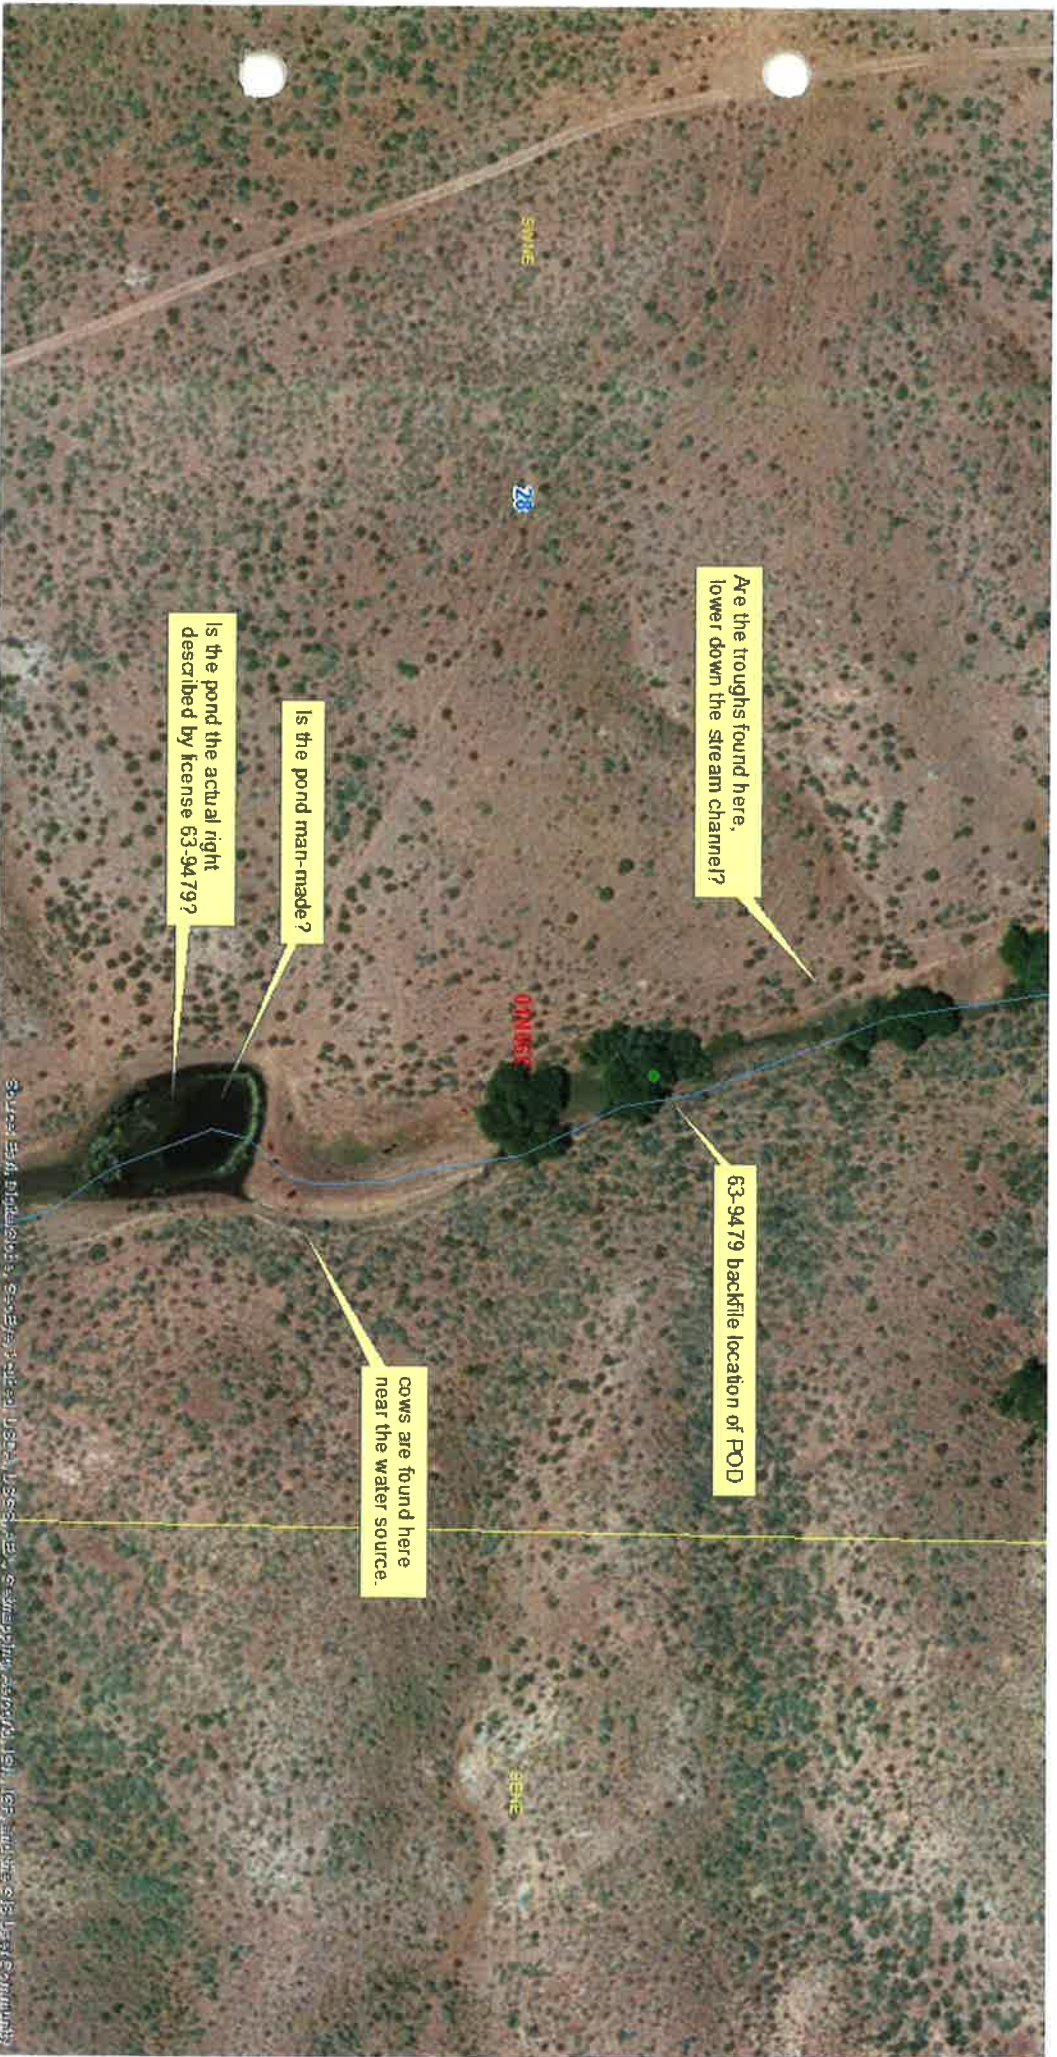
This right may not have an issue at all. License says it is a spring to a trough and I was able to approximate the POD location from the Backfile map and could easily recommend as claimed. However, there is a large pond very near the POD location and IDL has already amended a claim to correct a pond use. Is the pond a man-made diversion for this right? Is this the actual use for this source and claim? Just want to double check with IDL given what the photo shows. <See photo>

Are the troughs found here,  
lower down the stream channel?

63-9479 backfile location of POD

Is the pond man-made?

Is the pond the actual right  
described by license 63-9479?

cows are found here  
near the water source.

License indicates pipeline to trough -  
Clearly shows evidence of a pond on  
the Stream. IS it developed or Natural?

6/4/13 update from IDL - GPS point for POD  
Confirmed pond is the use of this WR.

Pond is actually = 1.6 AFA MAXIMUM  
Adjusted for slopes = 0.64 AFA

6/5/13 Spoke w/ Tyson Nelson - ponds were enlarged  
by lessee after 1971 and require permit.  
Should be allowed since this is De Minimis use.
