IDAHO DEPARTMENT OF WATER RESOURCES  
RECOMMENDATION OF WATER RIGHTS ACQUIRED UNDER STATE LAW

RIGHT NUMBER: 63-9577  
NAME AND ADDRESS: STATE OF IDAHO  
DEPT OF LANDS  
300 N 6TH ST STE 103  
PO BOX 83720  
BOISE ID 83720-0050  
SOURCE: SPRING TRIBUTARY: WILLOW CREEK  
QUANTITY: 0.100 AFY

Review notes for recommendations of late claims filed by IDL.  
Sent as an attachment with email to IDL attorney, Tyson Nelson.  
Steve Clelland – May 1, 2013

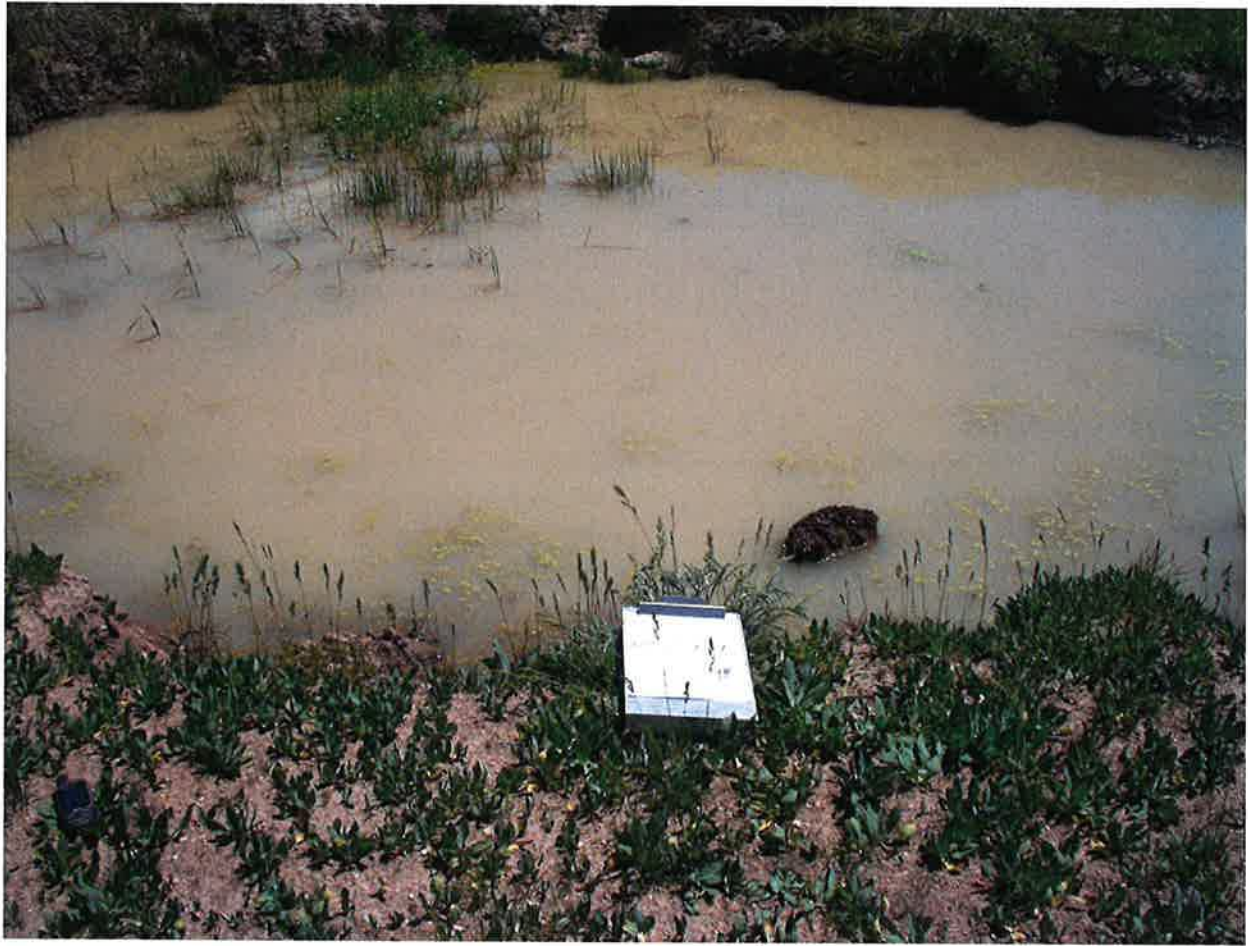
Water right 63-9577, photo showing stock pond (POD and POU at the same location)

| WR Number | Field Work Notes |
|---|---|
| 63-9577 | The lessee removed the stock tank and built a stock pond at the spring location |

The plotted POD in the Backfile map (SWSE) does not appear to be located at a source of water. It appears there may be an error and the actual location of the POD/POU for this right should be moved to the SESE tract to the east. <See photo>

6/4/13 updates from IDL w/ GPS show correct POD/POU Locations. Accomplished transfer to new location in S.23 SESE.

6/5/13 Conv. w/ Tyson Nelson - IDL Atty confirms the trough was removed and a pond constructed at the spring (POD) site. The fence around the spring area was removed. Convert to SW storage use.

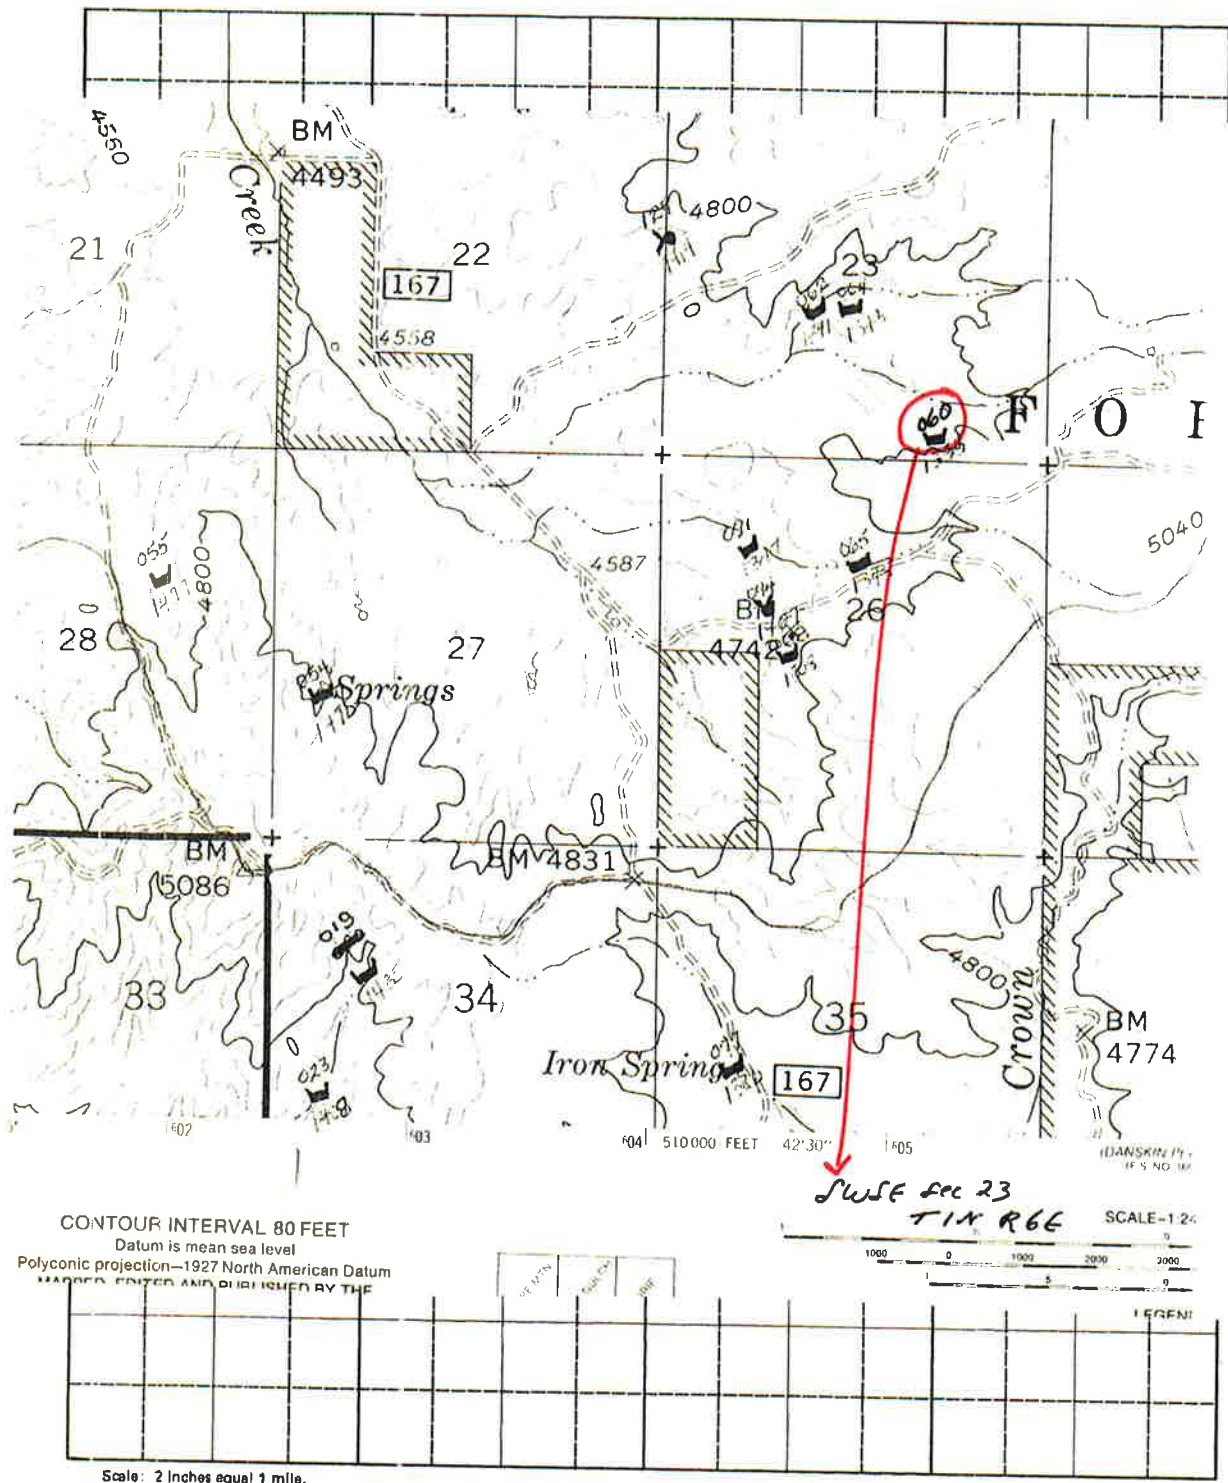
11. Map of proposed project: show clearly the proposed point of diversion, place of use, section number, township and range number.
