IDAHO DEPARTMENT OF WATER RESOURCES  
RECOMMENDATION OF WATER RIGHTS ACQUIRED UNDER STATE LAW

RIGHT NUMBER: 63-9587  
NAME AND ADDRESS: STATE OF IDAHO  
DEPT OF LANDS  
300 N 6TH ST STE 103  
PO BOX 83720  
BOISE ID 83720-0050

63-09587

### **Post-review follow up issues for IDL claims in basins 61 and 63.**

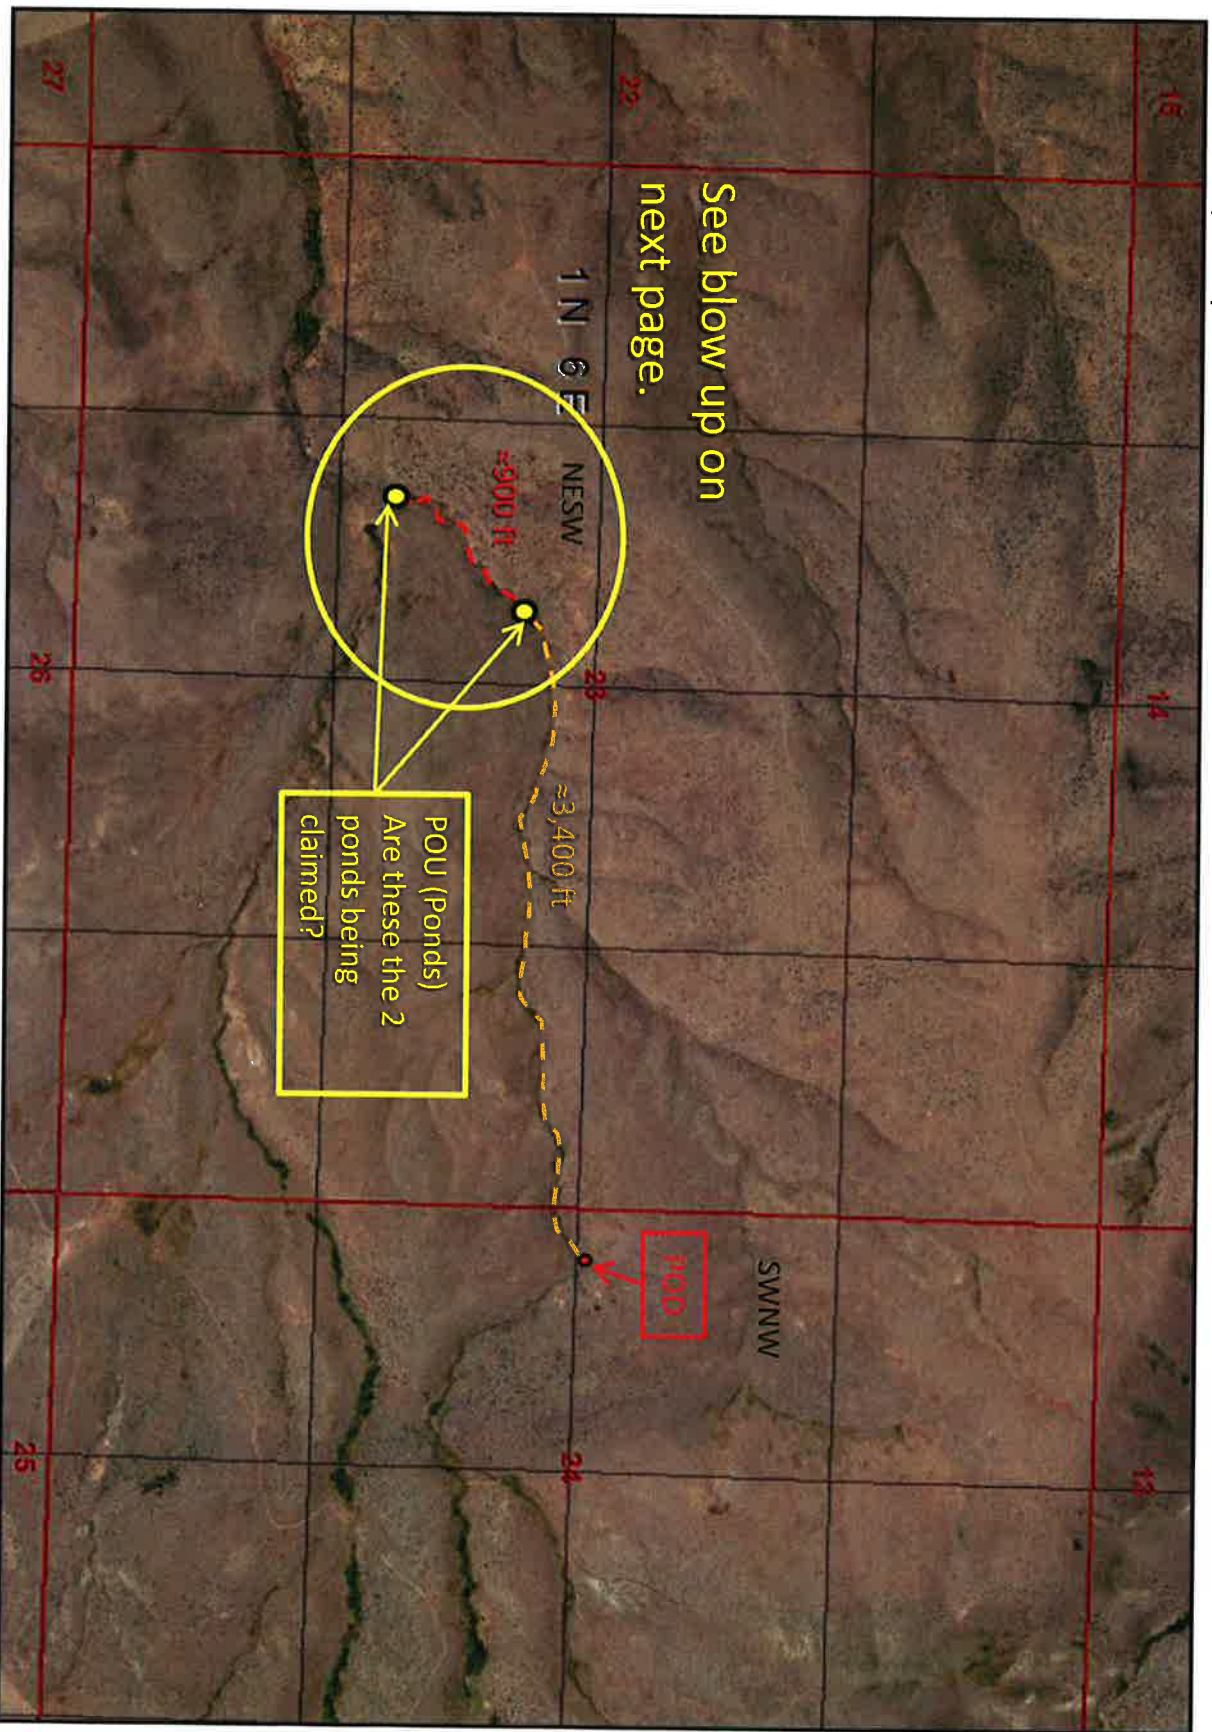
Claimed

POD: T01N, R06E, S24, SWNW  
POU: T01N, R06E, S23, NESW

Aerial photography shows 3 ponds  
in T01N, R06E, S23, NESW.

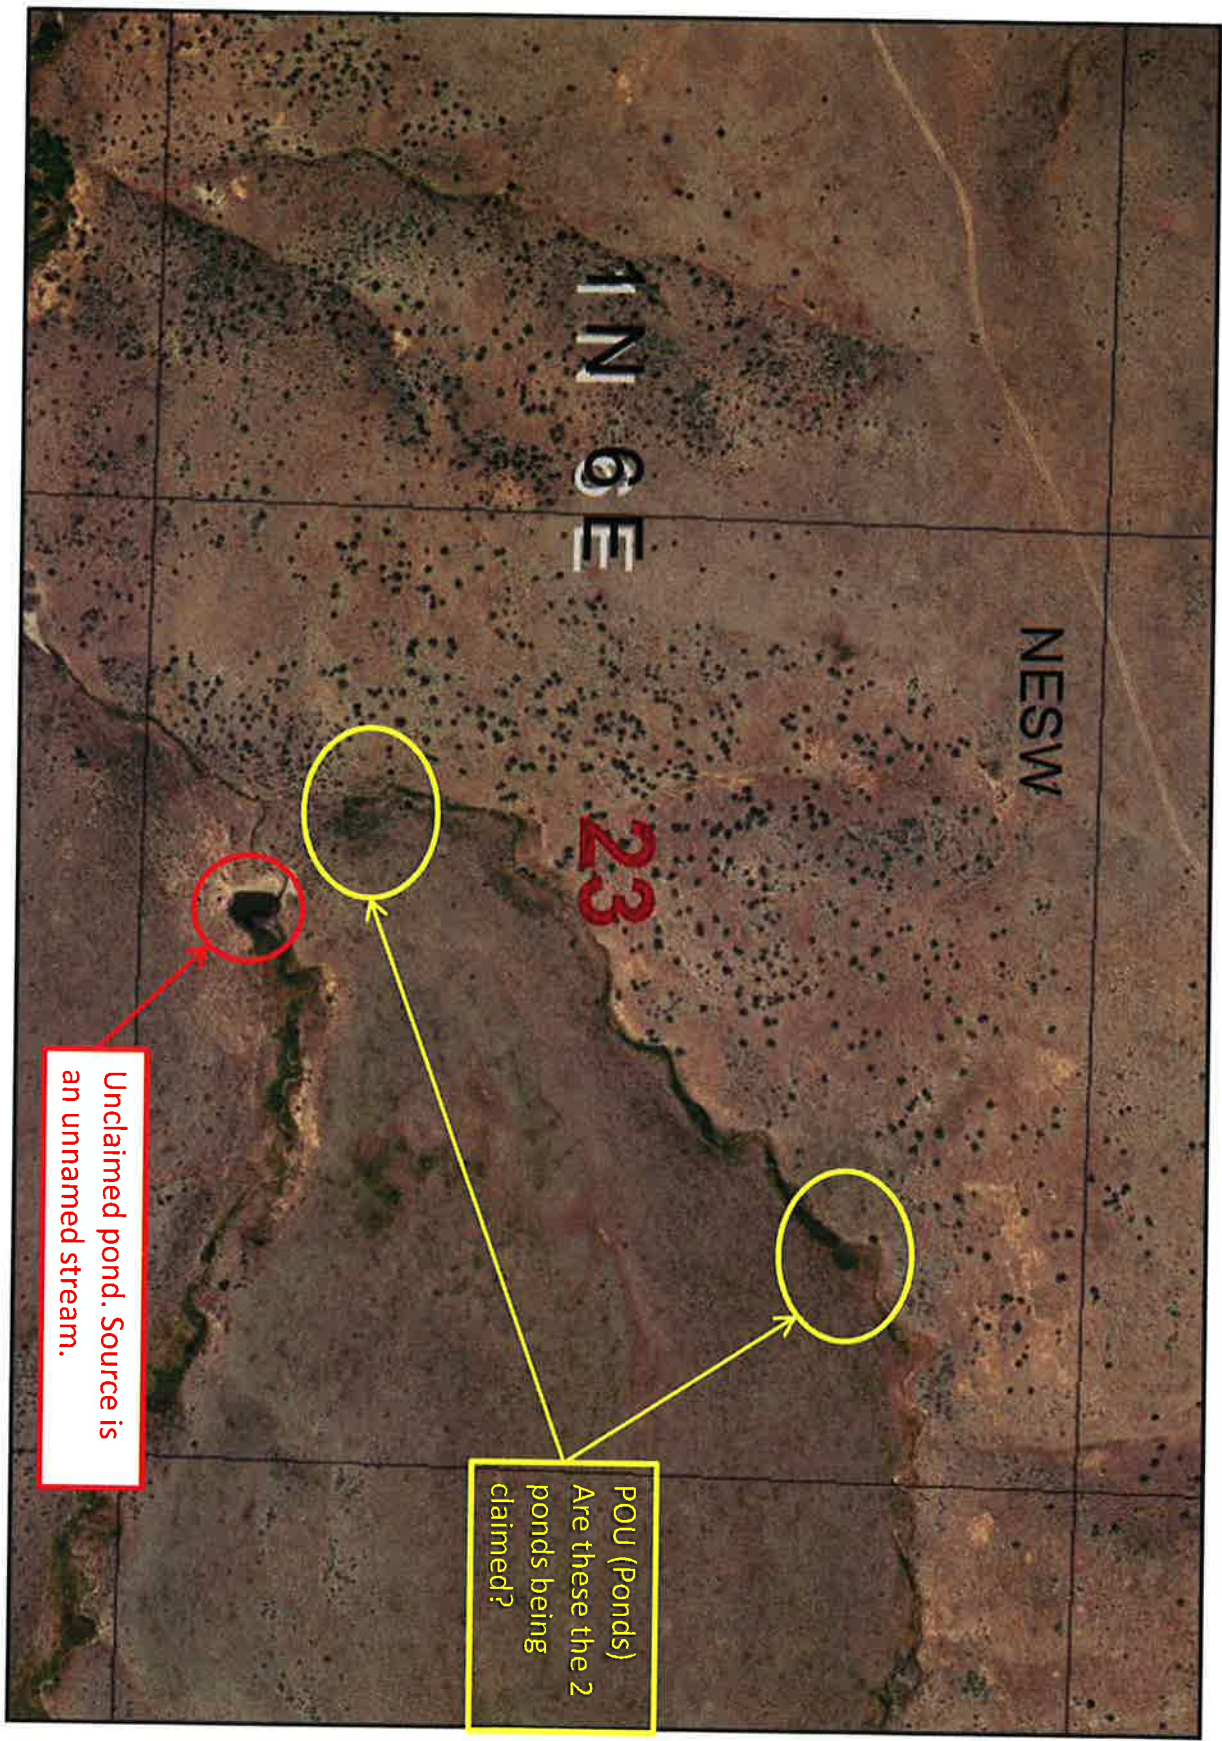
The application for permit for this right describes water being diverted from a spring in T01N, R06E, S24, SWNW and piped approximately 3,400 ft to a trough in T01N, R06E, S23, NESW, and then piped from that trough approximately 900 ft more to another trough also located within T01N, R06E, S23, NESW.

Aerial photography does not show any troughs, but does show what could be 2 ponds. This claim was licensed with 0.20 AF of storage suggesting that the troughs could actually be ponds/reservoirs. If these 2 ponds are what the claimant is claiming then there are no issues with the claim.

### 63-9587

This claim is unique as it involves the distribution through a pipeline system to two troughs from a spring over ½ mile away. The Backfile map is poor to scale for this description. Very little appears in the photo to indicate a POD spring. The same can be said for the POU troughs. I had hoped to use the pipeline length information in the Backfile to better estimate these locations. Unfortunately the pipeline numbers were of little help. The Backfile states there are 3400 feet of pipe between the spring and the first trough (IDL#064) and 900 feet of pipe to the second trough (IDL#062). I doubt the pipeline traveled in a truly straight line but it was a guide worth considering. Using GIS mapping to incorporate this info, I was unable to estimate where any of these points are located. The attached photo includes some lines to scale in the photo to help illustrate the distances mentioned. <See photo>
