IDAHO DEPARTMENT OF WATER RESOURCES  
RECOMMENDATION OF WATER RIGHTS ACQUIRED UNDER STATE LAW

RIGHT NUMBER: 63-9588

IDL 61 & 63 LATE CLAIMS update

### Post-review follow up issues for IDL claims in basins 61 and 63.

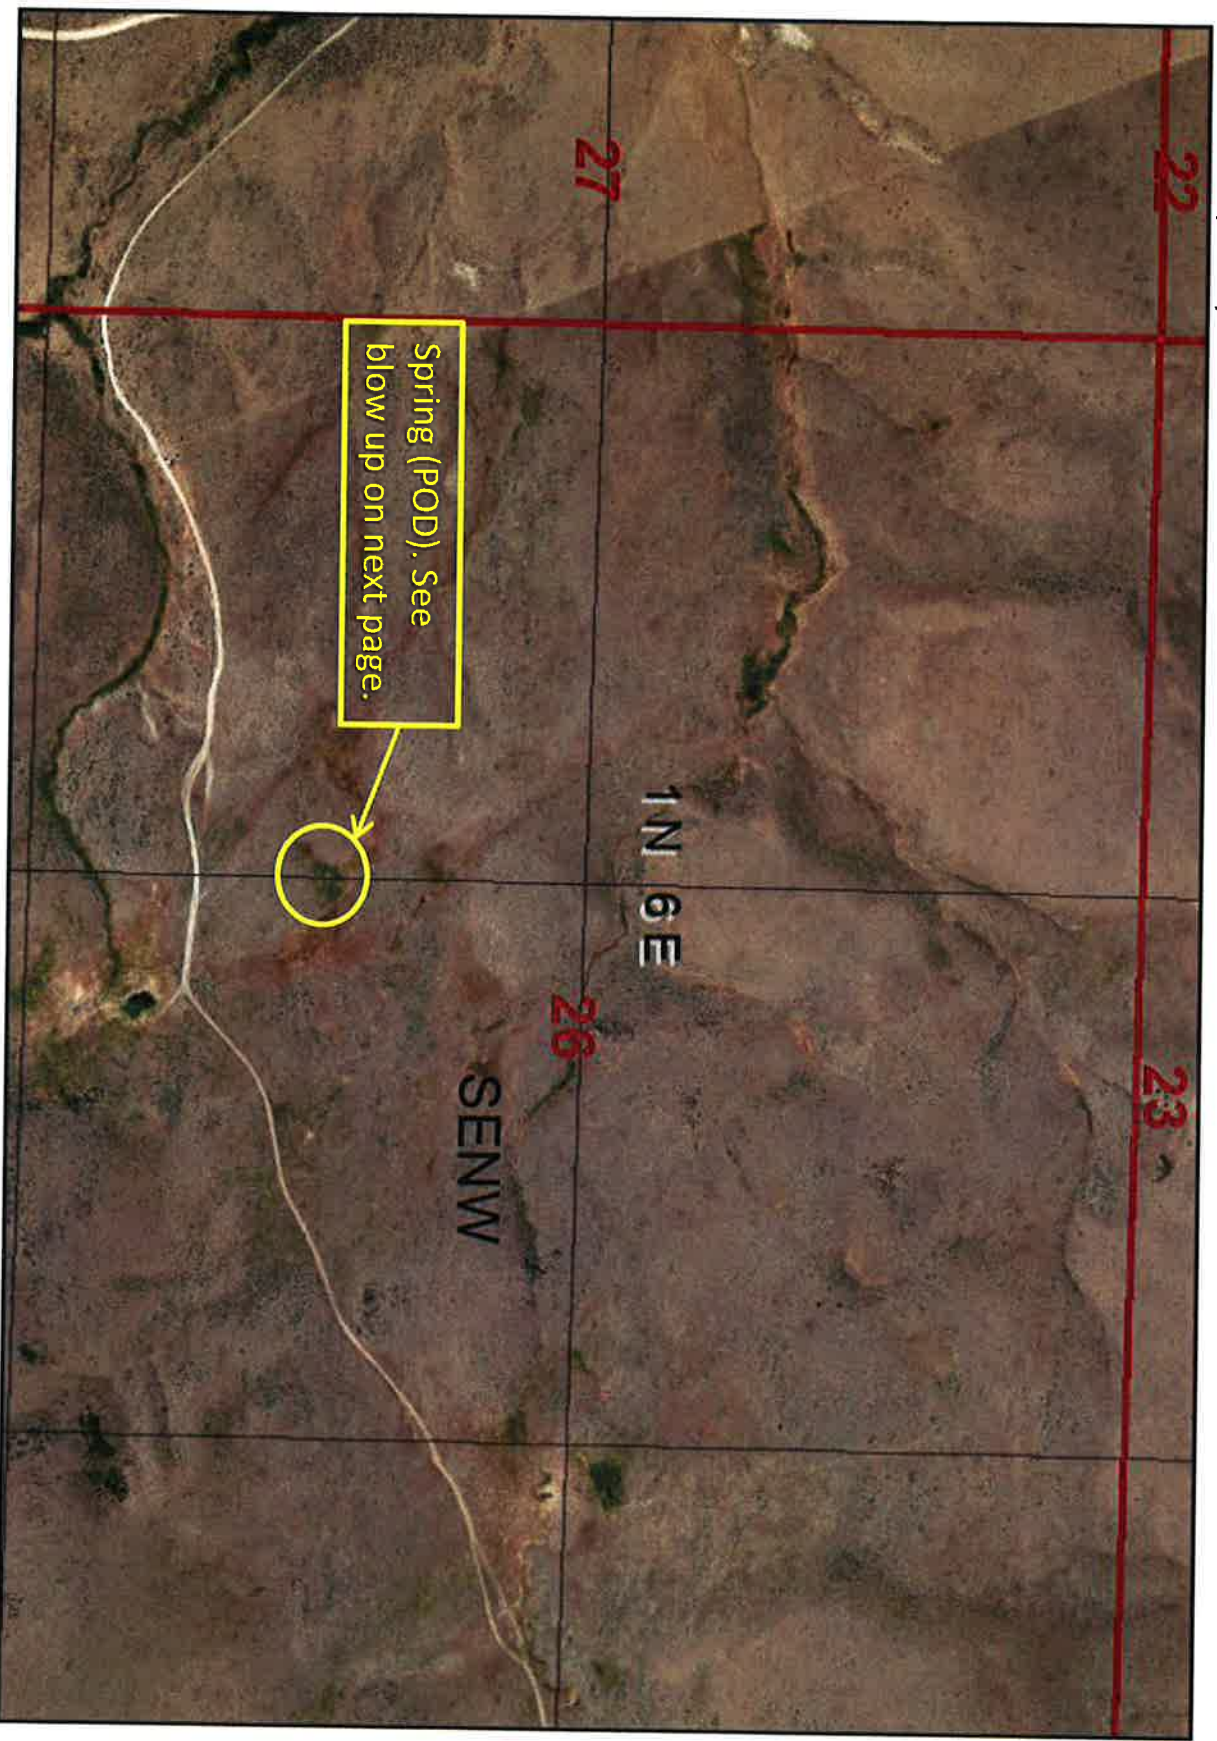
63-09588

The application for permit describes a pond developed from a spring in T01N, R06E, S26, SESW.

*Not this site - per IDL*

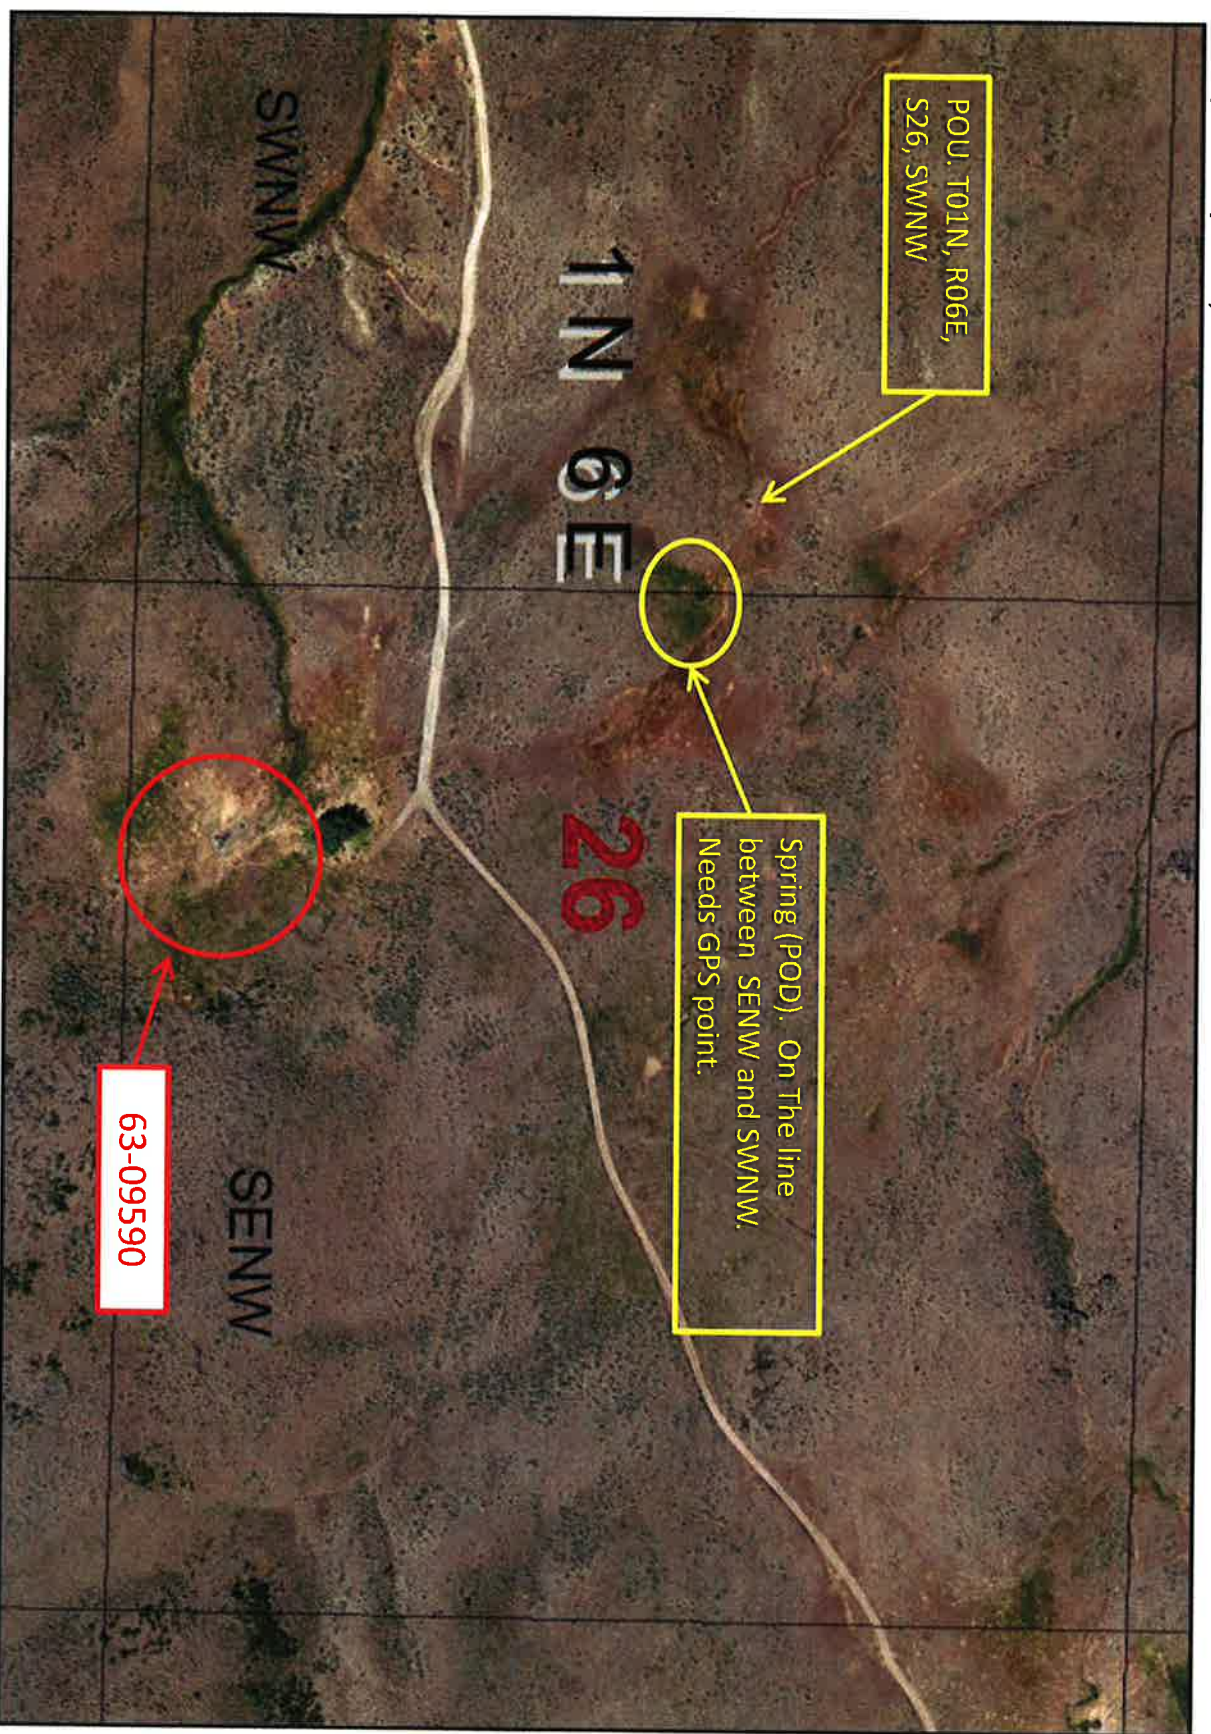
63-09588

The POD is located on the line between the SENW and SWNW quarter-quarters. A GPS reading would be needed to determine exact location of the POD. Also, aerial photography shows the POU located in T01N, R06E, S26, SWNW instead of T01N, R06E, S26, SENW.

*Not this site-per IDL*

It looked as though 63-9588 was easily located on the aerial photos as claimed. There is a clearly visible pond site in the SENW (Sec. 26) which seems to match the claim and license. In the draft recommendation I have converted the purpose of use for this right to a storage type use based on the pond development. However, when beginning the review for 63-9590 I found that both these claims appear to be located in the same area. Although 63-9590 is claimed and licensed in the NESW, there doesn't appear to be any type of water source in that tract (QQ). It looks to be incorrectly described as to its location. I will need further information from IDL to explain how these two rights relate to the water sources found on the maps of the area. The right 63-9588 is for IDL#094 and 63-9590 is for the IDL#068 as identified on the Backfile map. <See photo and rec'd for 63-9588>
