## AMERICAN FALLS FARM LLC PIVOT EXPLANATION

### I. FACTUAL BACKGROUND.

## II. MALFUNCTION INFORMATION

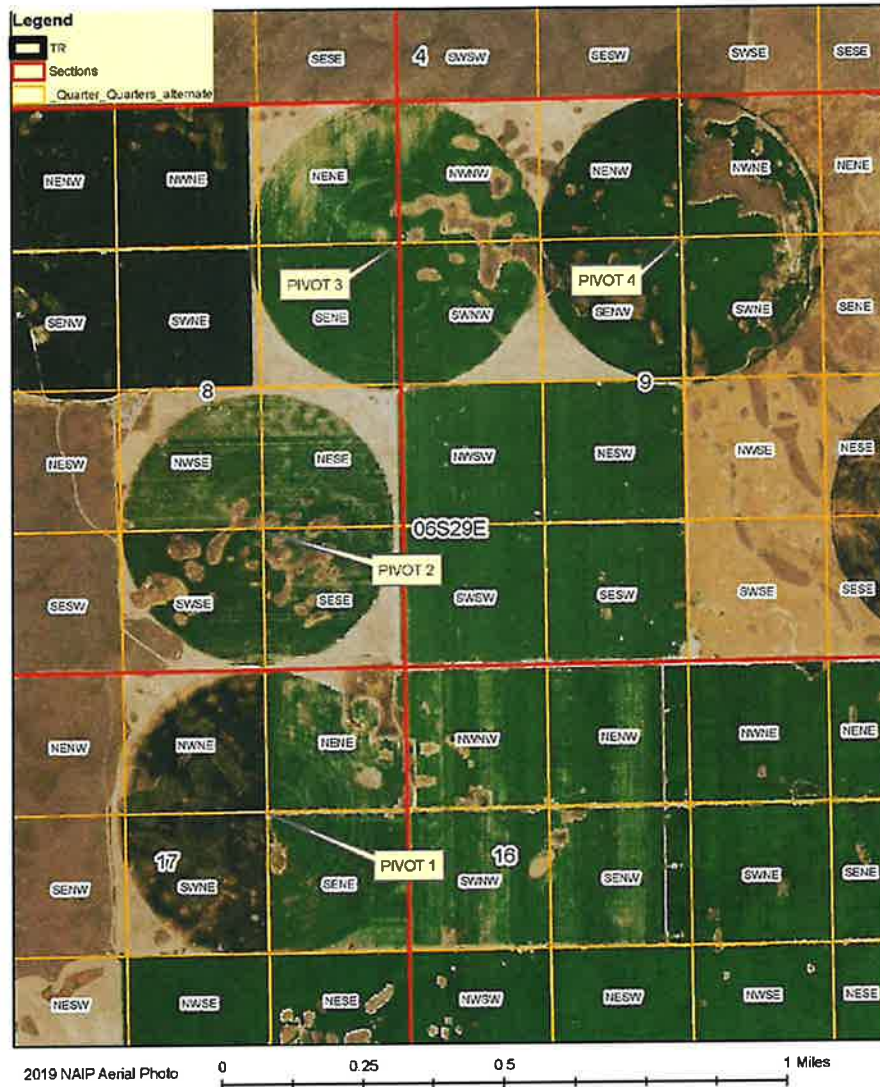
A map of the pivots with VRI systems is set forth below—the only pivot that experienced the malfunction is the pivot labeled as Pivot 1 below (it is referred to internally as Pivot #206 by the tenant, Lance Funk Farms):

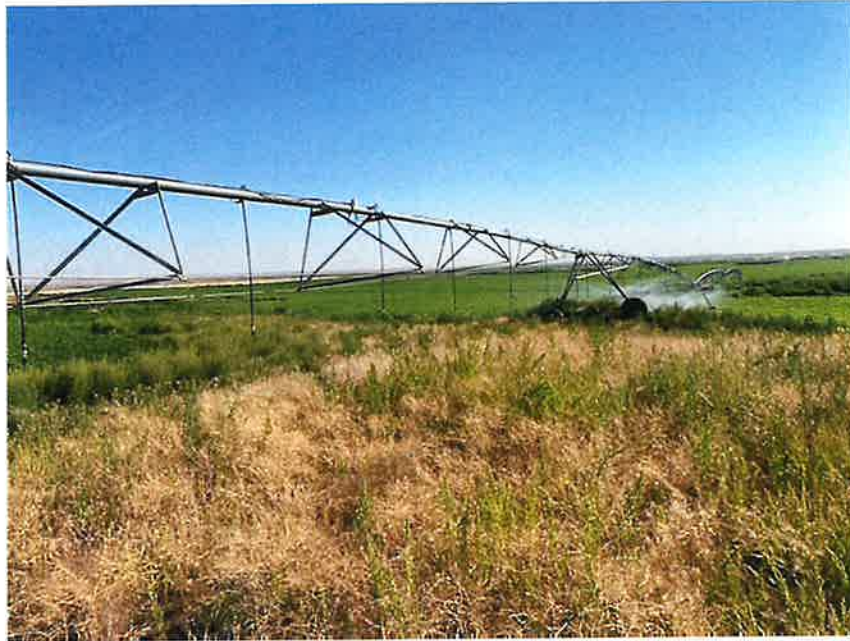
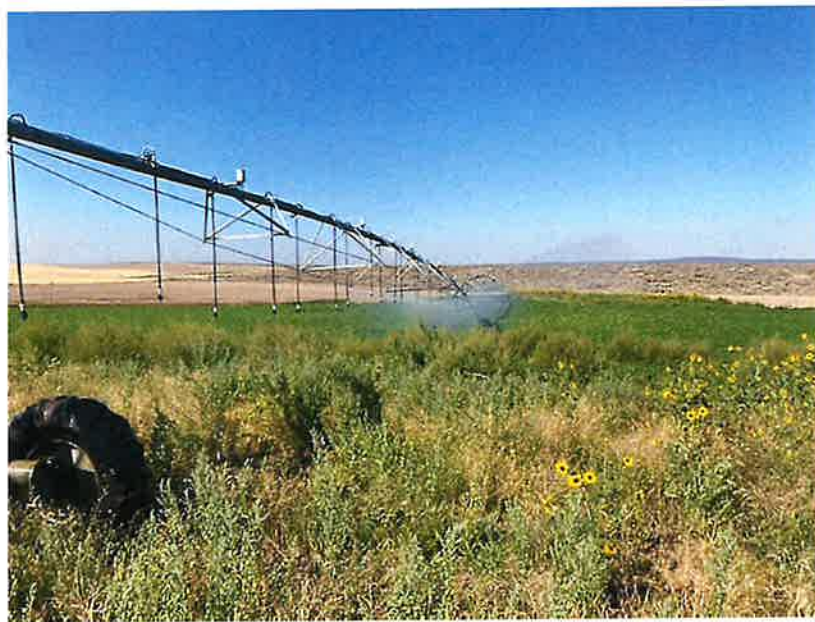
In June, Darren Watt reported that there was too much pressure at the pivot, and the result was that the individual valves were blowing out. Double M ordered the replacement valves, but because they were not immediately available, Watt attached the individual risers to the pivot until the replacement valves were available to install—otherwise, the pivot would not be function and the crops would be damaged. The valves were eventually replaced after IDWR’s site visit, and Pivot 1 is currently functioning properly as evidenced by these photos:

Additionally, Double M looked at computer program inputs and adjusted them to fine tune the mapped rock patch areas.

Double M initially thought the issue was with the Zimmatic pivot. However, Double M has ultimately concluded that the most likely cause of the malfunction was the VFD, which

apparently was not adjusting to pressure changes like it should have to prevent blowing out the valves. There is a VFD transducer which receives a radio signal from the pivot to increase or decrease water output from the VFD to increase or decrease pressure. The VFD is now functioning properly. However, Double M intends to test and fine tune the VFD next spring to minimize the potential for any problems in the future. This conclusion that the main issue was likely the VFD is supported by the fact that the VRI systems installed on Pivots 2-4 did not malfunction as evidenced by the photos in the *Petition for Reconsideration*.
