STATE OF IDAHO  
DEPARTMENT OF WATER RESOURCES  
IN-OFFICE REVIEW/BENEFICIAL USE FIELD REPORT

**A. GENERAL INFORMATION**Permit No: 63-34066Exam Date: 2/19/2019

Permit 63-34066 – Field Exam Maps.

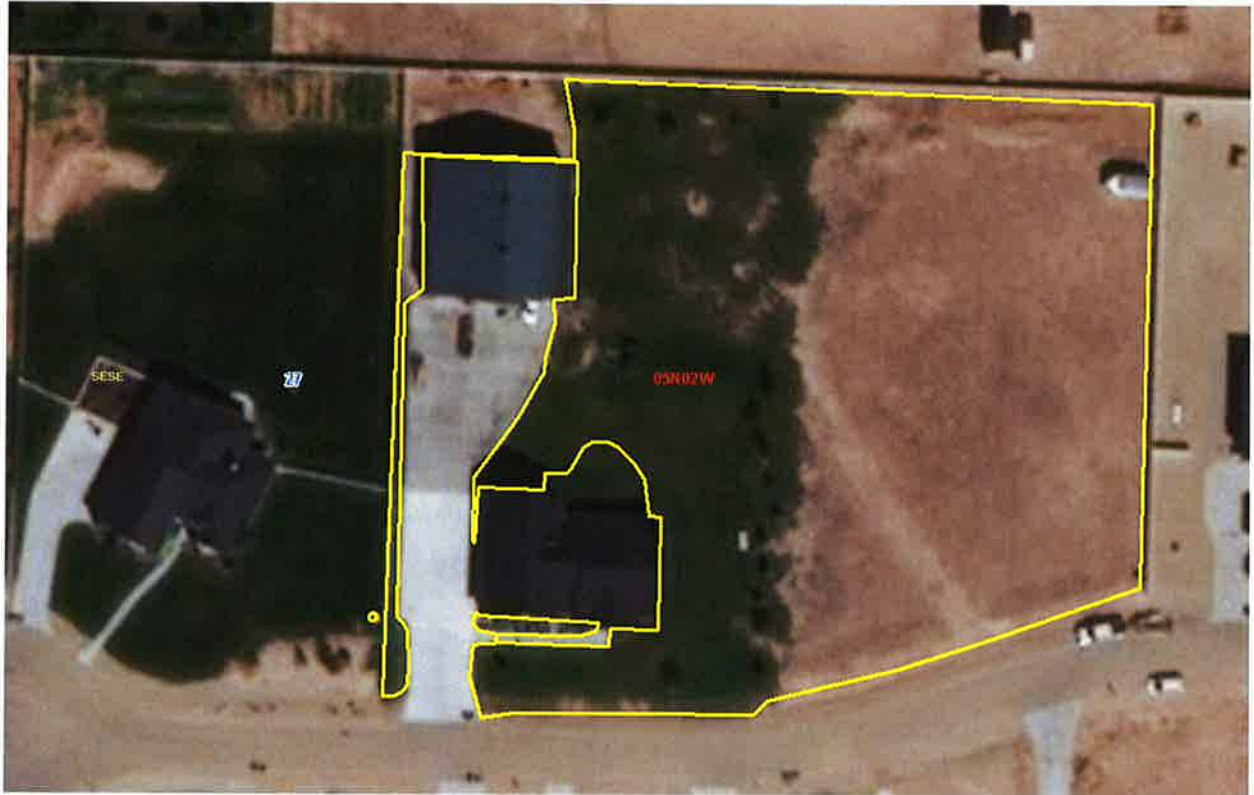
The photo below shows the point of diversion (yellow dot) and the place of use (yellow border). This property is comprised of 2 tax parcels. Parcel with the home is Lot 16 and parcel east of the home is Lot 15. The parcel line goes along the trees just east of the home.

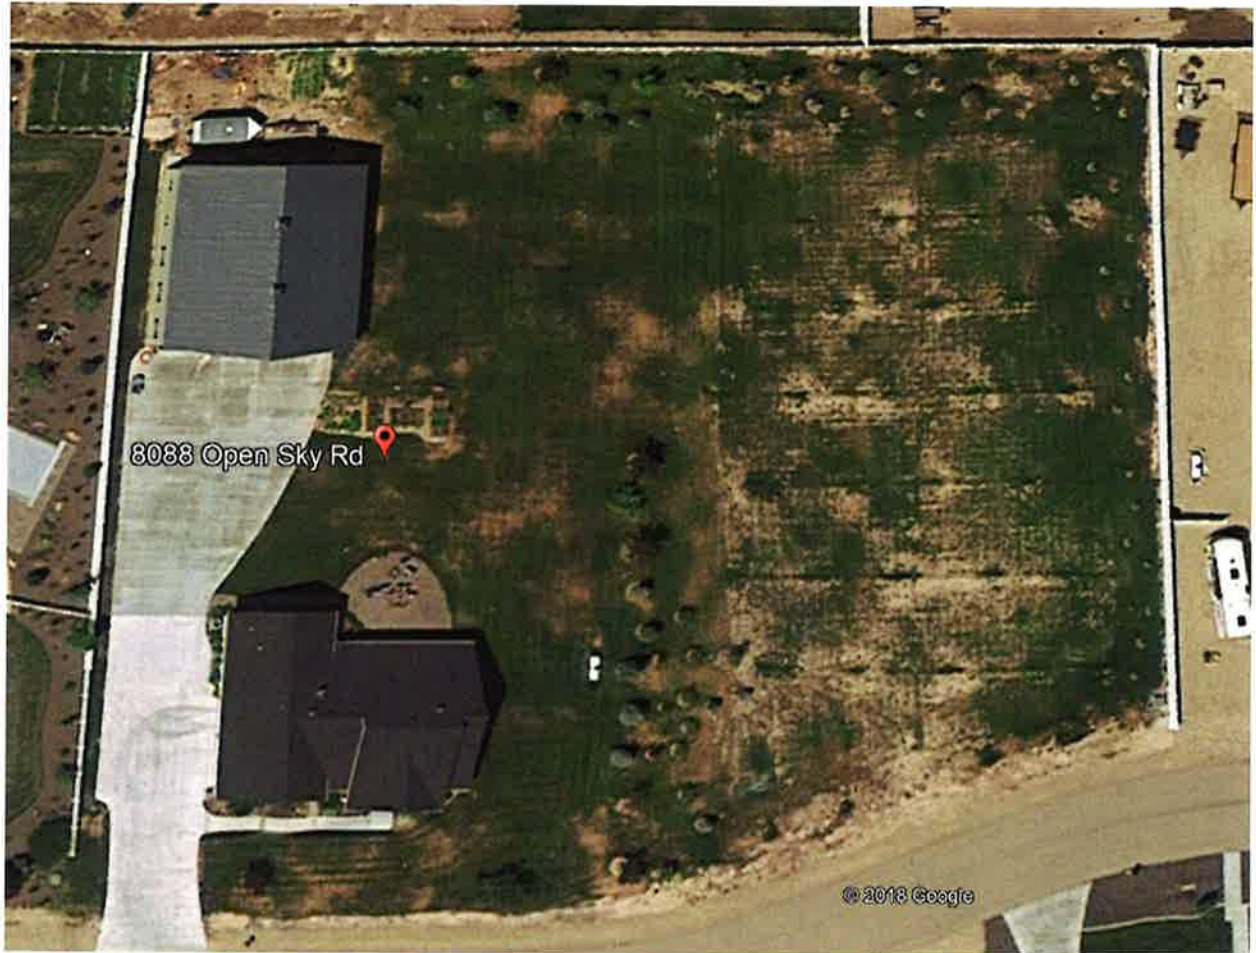
Permit 63-34066 -- Field exam Maps

The following is a 2018 Google Earth aerial image of the property that shows the entire property being irrigated.
