**Date:** December 1, 2017  
**To:** Water Right 37-4061 File  
**From:** William Mills  
**Re:** POD Site Visit Re: Possible WSB Lease

On 11/28/2017 I met with Rusty Kramer, Watermaster for Water District 37B, Walt Poole and Terry Gregory of Idaho Fish and Game (IDFG) to look at the main point of diversion for Camas Creek water right 37-4061(17.34 cfs) and discuss how to manage the water right in a way that would allow IDFG to lease the water right to the water supply bank without actually installing controlling works and measuring devices at the points of diversion (PODs).

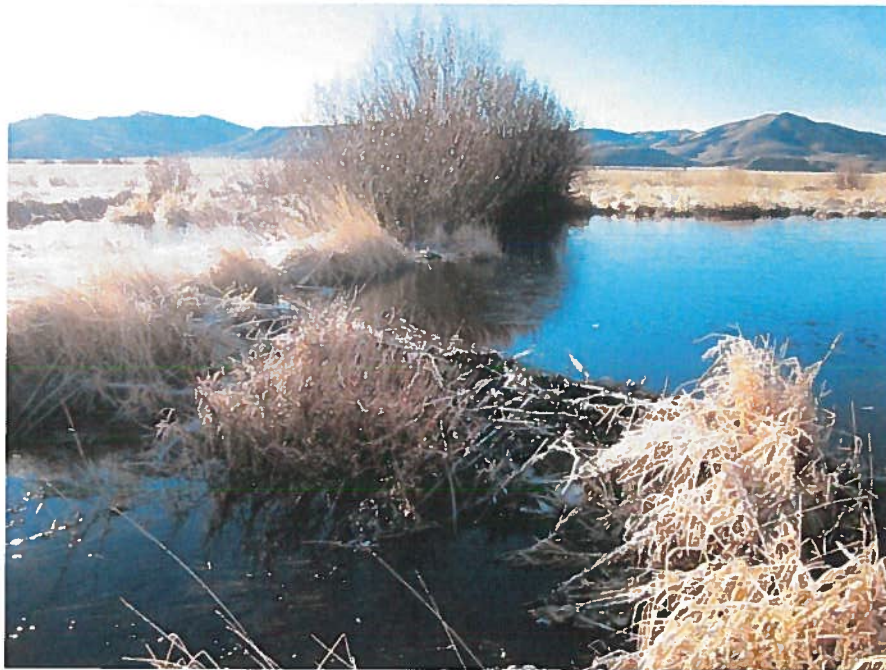
Figure 1: Beaver Dam at Head of Ditch

Besides the small beaver dam at the head of the ditch (Figure 1) there currently are no controlling works present to prevent water from flowing down the ditch. Mr. Gregory and Mr. Poole suggested bringing in a load of rock and dirt to block the head of the ditch to completely obstruct water from flowing into the ditch from Camas Creek. For purposes of leasing this right to the water supply bank, that would prevent the diversion of water from Camas Creek and therefore would likely be sufficient. When the South POD located in the NWSESE of Sec 1, Twp 02S, Rge 11E was brought up, the gentlemen from IDFG indicated that they had no previous knowledge of the second diversion. They also indicated that it would be next summer (2018) before they could actually get out to the site and inspect it due to high water in the marsh from recent rains. I showed them an aerial photography close-up of the South POD site where there appears to be a dry channel that may be a ditch just south of the recorded POD, but it may also be part of the braided stream channel. We discussed the possibility of relinquishing the South POD if it was determined to be a stream channel without any controlling works. However if upon inspection, it was determined to be a ditch with no controlling works, they could obstruct the head of the ditch in the same manner as discussed for the North POD. Mr. Gregory indicated he would need to visit the South POD prior to making a determination as to how to proceed at that location. We also discussed the possibility that a stream alteration permit might be required to work on the South POD.

In conclusion, at this time IDFG has no intention of diverting the water for irrigation, however there currently are no controlling works at the head of the ditch on the North POD to prevent the creek from flowing into the ditch. IDFG intends to fill in the head of the ditch at the North POD to prevent any creek water from entering the ditch. As for the South POD, how to proceed, or if water could actually be diverted there still needs to be determined.

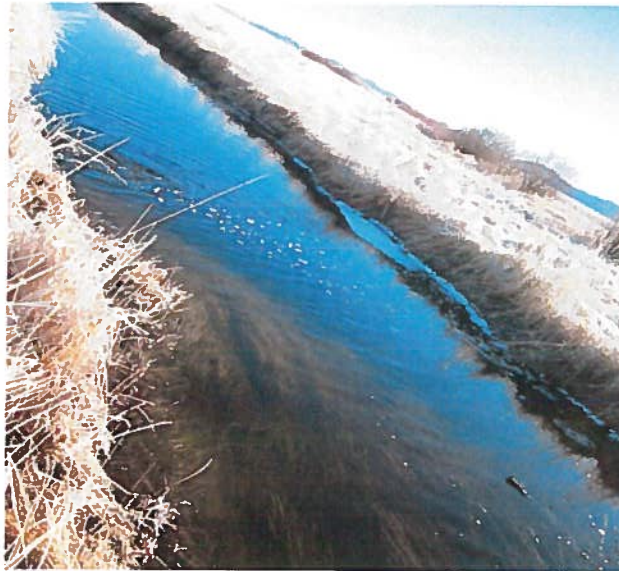
Figure 2: Flow in Ditch Just Below Beaver Dam  
(Flowing NW, which is towards top left of photo)

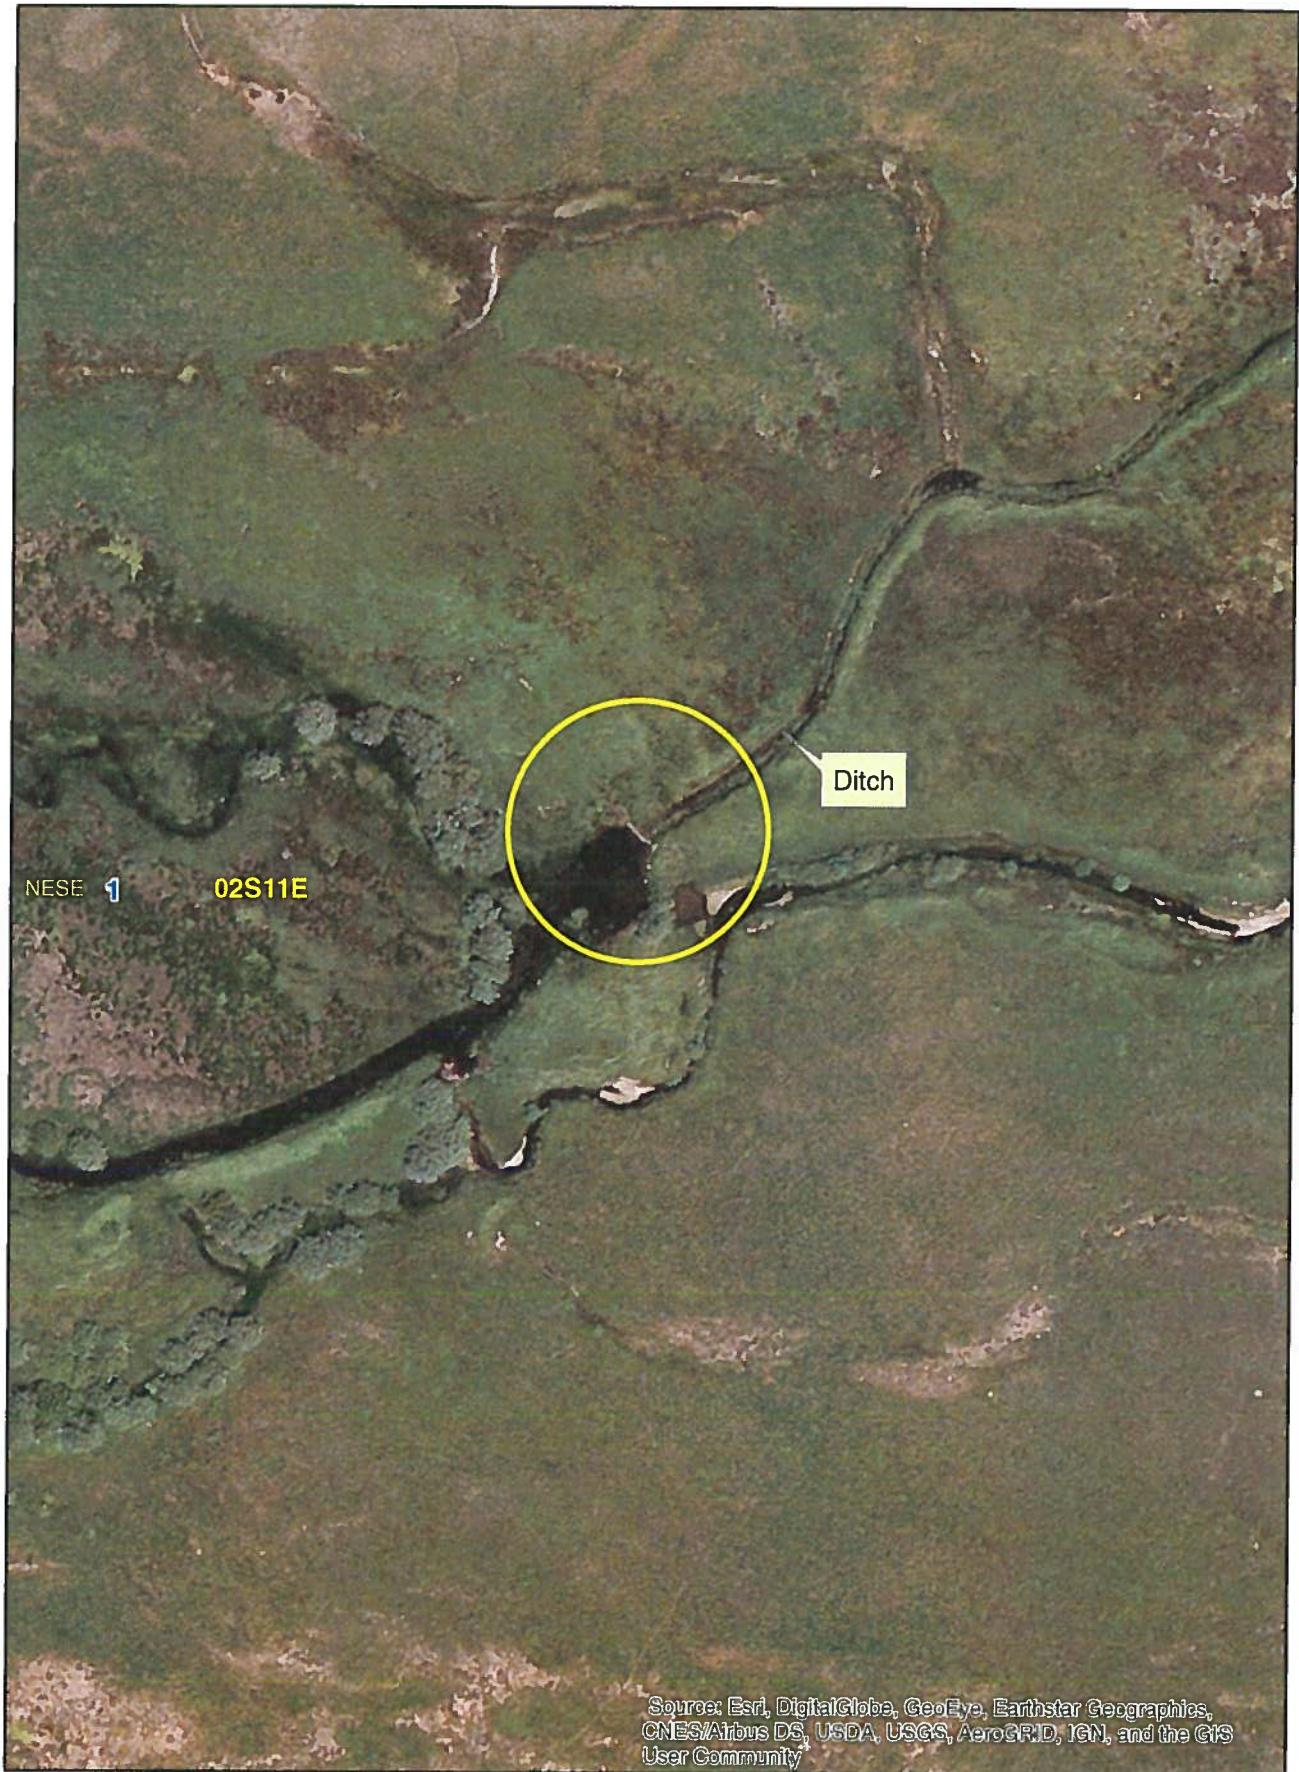
# Northern Diversion

The four of us walked out through the marsh to the location where a ditch diverts water from Camas Creek to the upper portion of the place of use (POU). This North POD is located in the NENESE of Sec 1, Twp 02S, Rge 11E:
