STATE OF IDAHO  
DEPARTMENT OF WATER RESOURCES  
BENEFICIAL USE FIELD REPORT

Permit No: 37-22544

Exam Date: 10/30/2015

# Wildlife Storage 37-22544

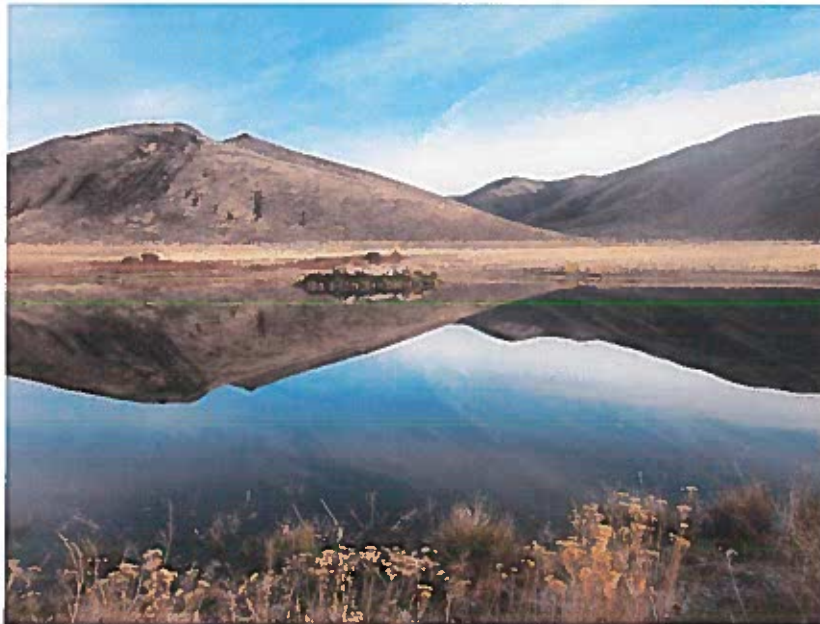
Figure 1: Looking northeast across the pond

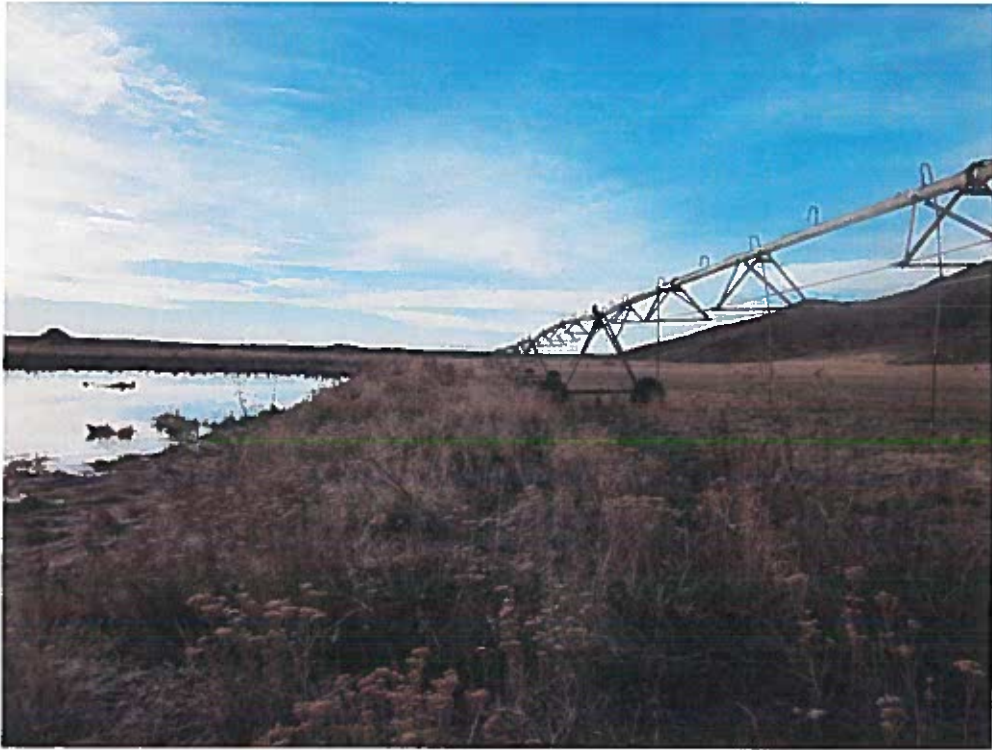
There is an embankment that runs from the northwest end of the pond approximately 400' to the south and then runs east another 260' to the east end of the pond. The embankment extends approximately 160' north of the pond and the entire 400' north-south portion of the structure act as a pivot stop on the west side. The embankment reaches a peak height of 8' where it crosses the stream channel. At the outlet where the embankment crosses the stream channel, there is an inline water level control structure (see figures #3 and #4). I could not hear or see water flowing through the structure and as stated before, the stream channel below the embankment was dry. Since there was a small amount of water flowing into the pond and the level of the pond was just slightly below the level of the spillway, there was likely seepage loss back into the marsh and/or evaporation keeping water from spilling out through the level control structure. The pond is designed to maintain the water level at the 6' depth and the permitted capacity on a year round basis. As was noted on the other pond as well, ducks and geese were on the pond when I arrived but abruptly flew away upon my arrival.

Figure 2: Looking south down embankment on west side

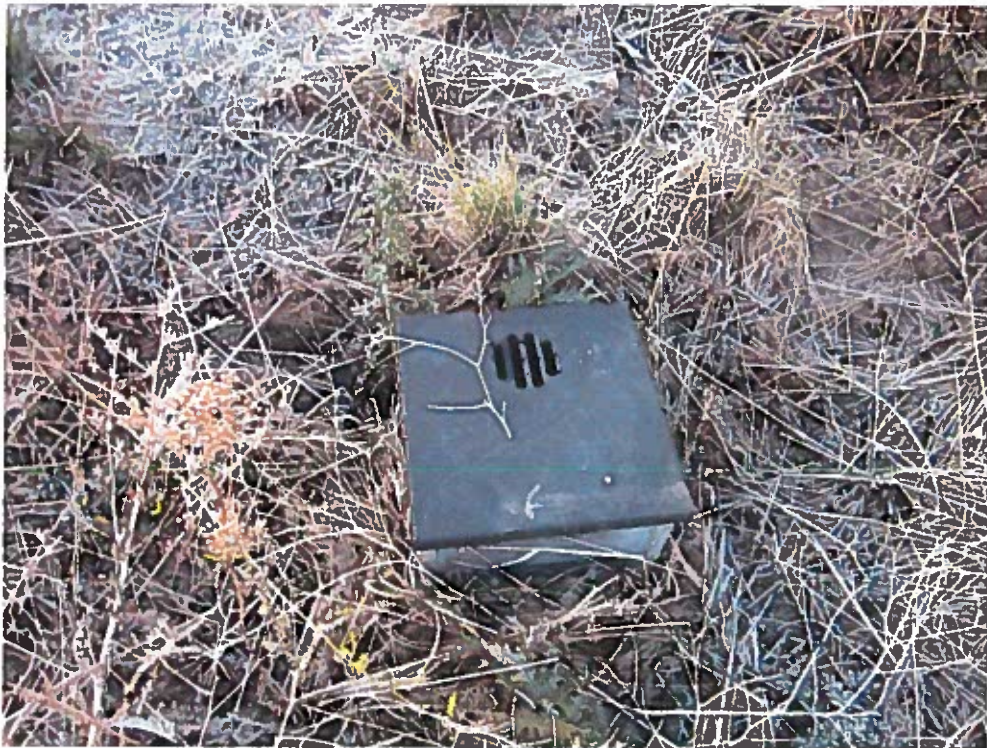
*\*attached printout*  
*Dikes - both spillway and adjustable level control are present*

Figure 3: Water level control structure above outlet

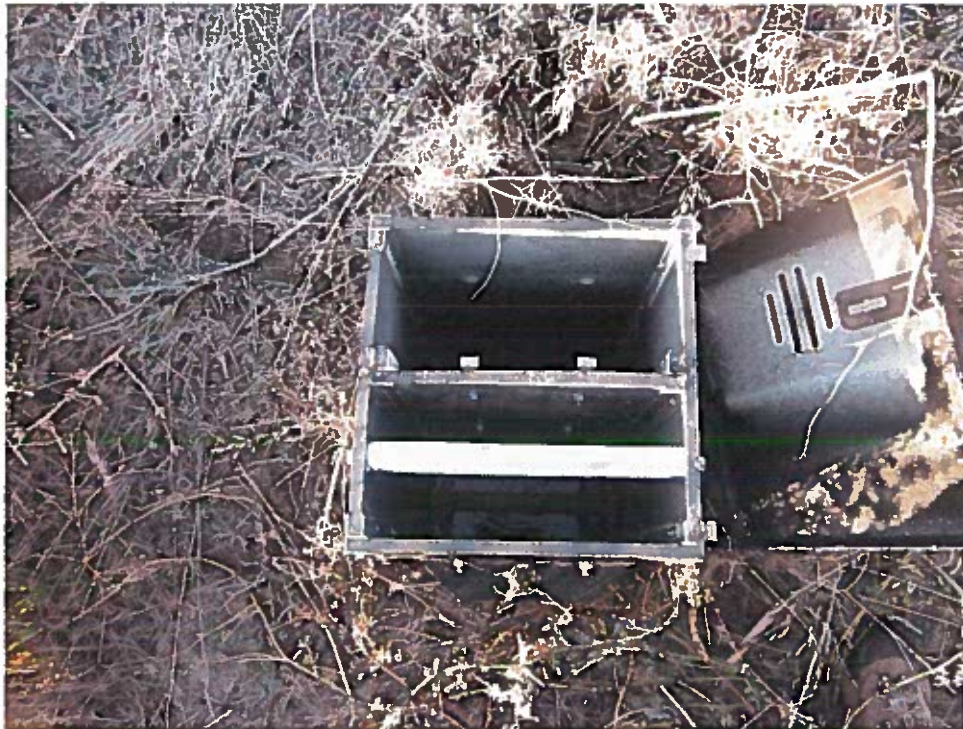
Figure 4: View inside level control apparatus-water rises up to orifice at preset height, excess flows through, cascades into outlet pipe and out to stream channel

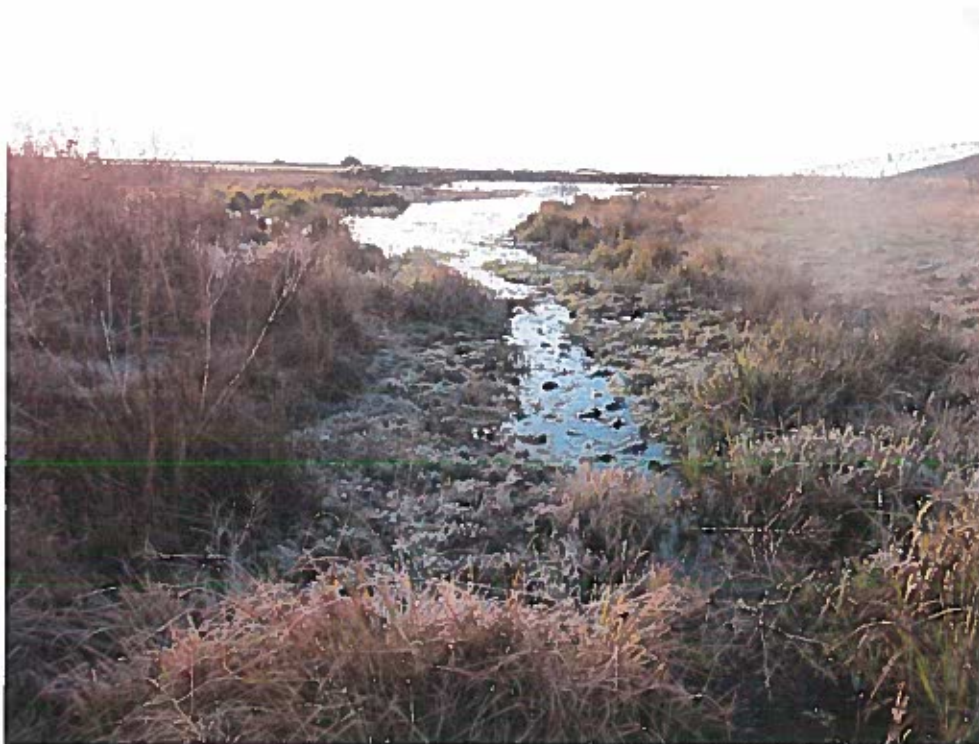
Figure 5: Water flowing in unnamed stream channel towards the pond

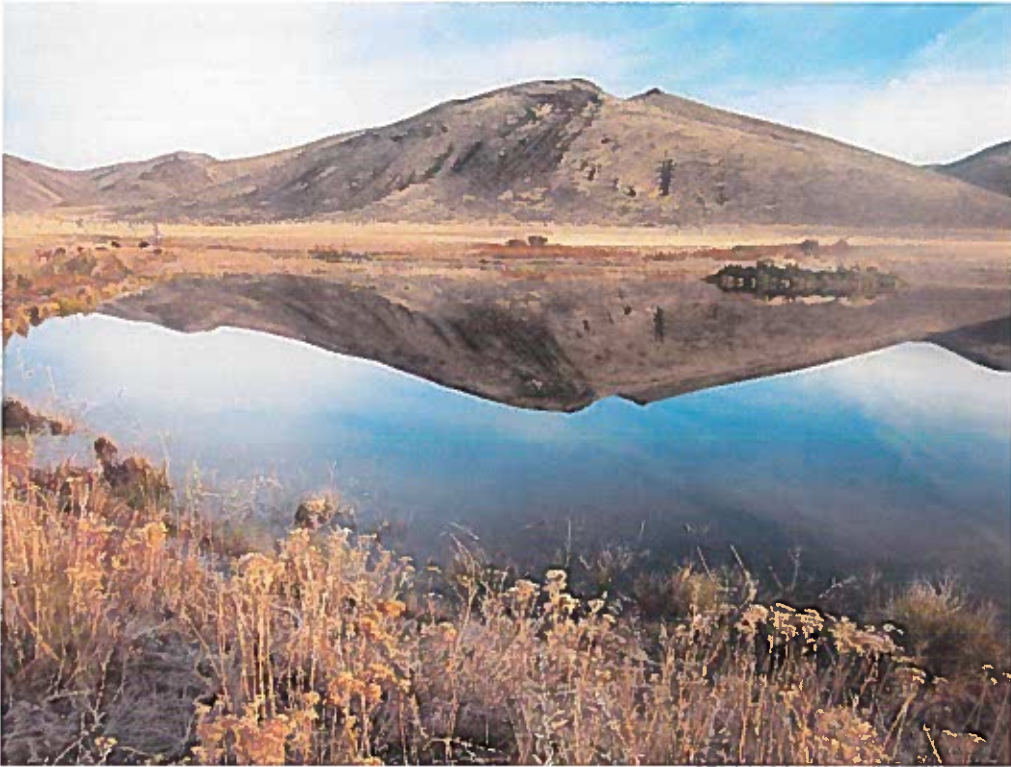
Figure 6: Looking north along west edge of pond

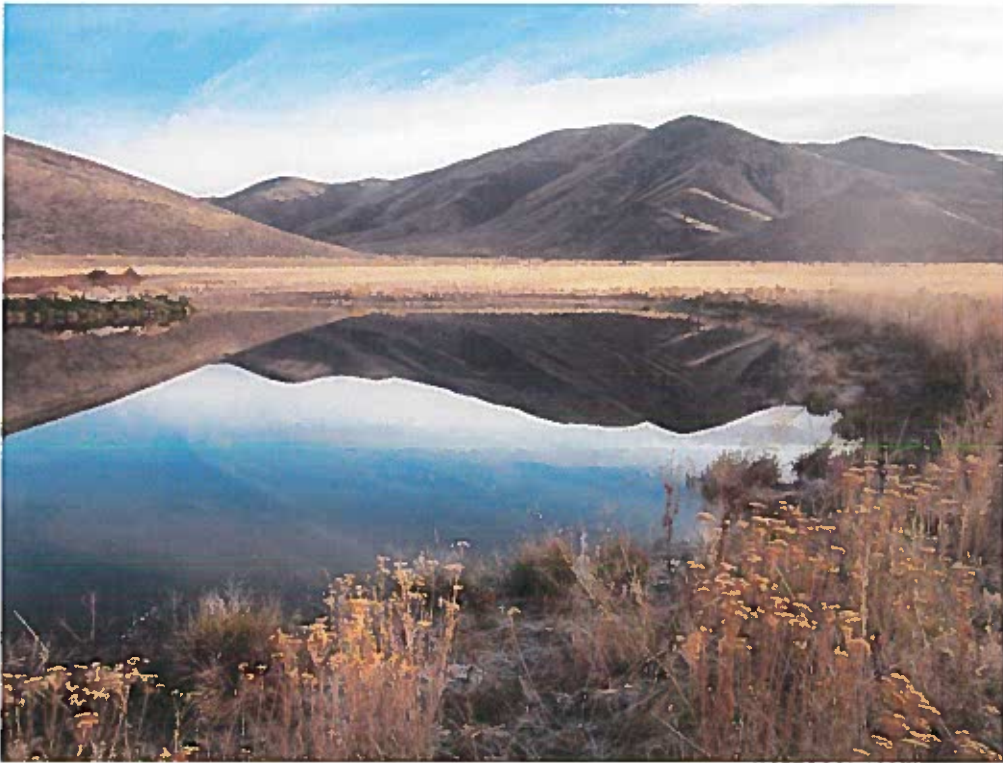
Figure 7: Looking east along south end of pond

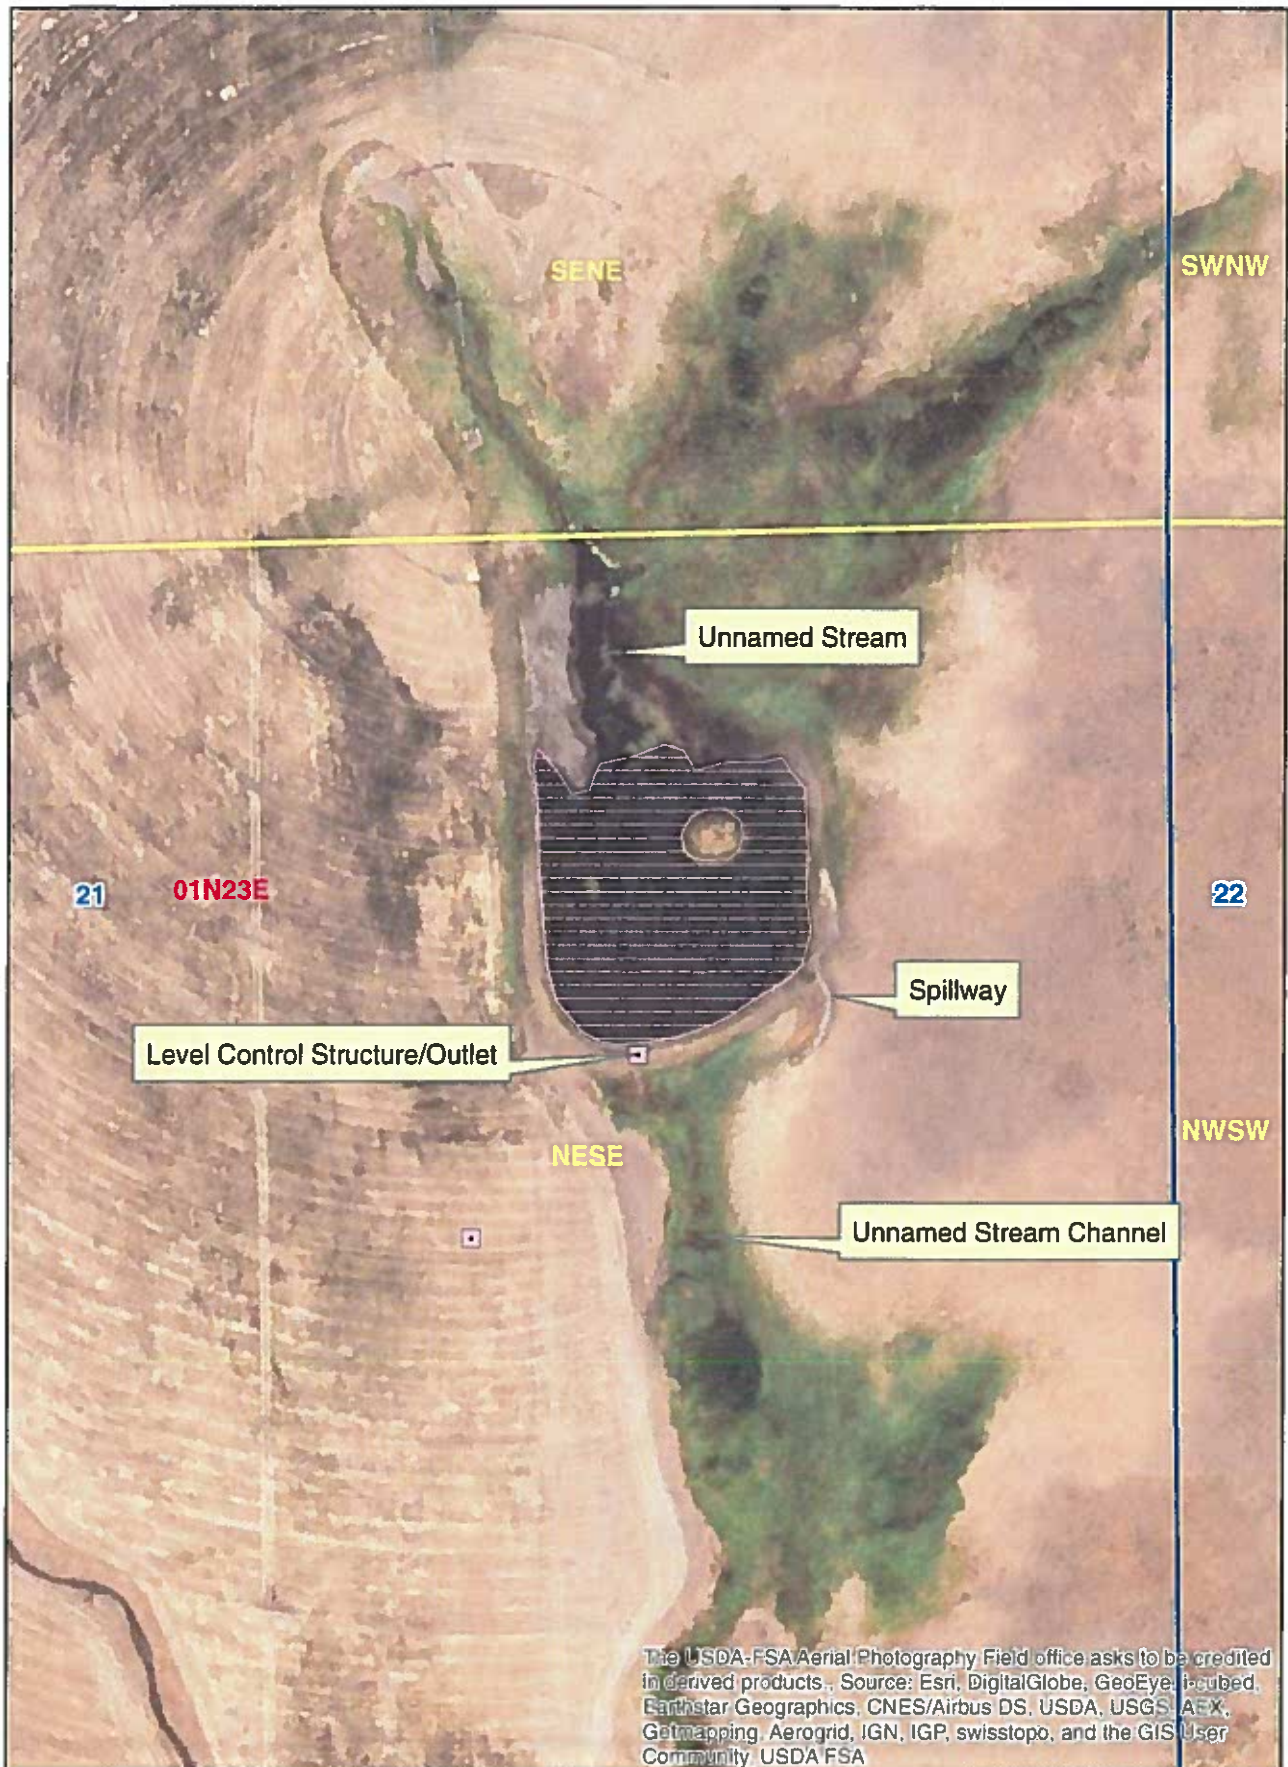
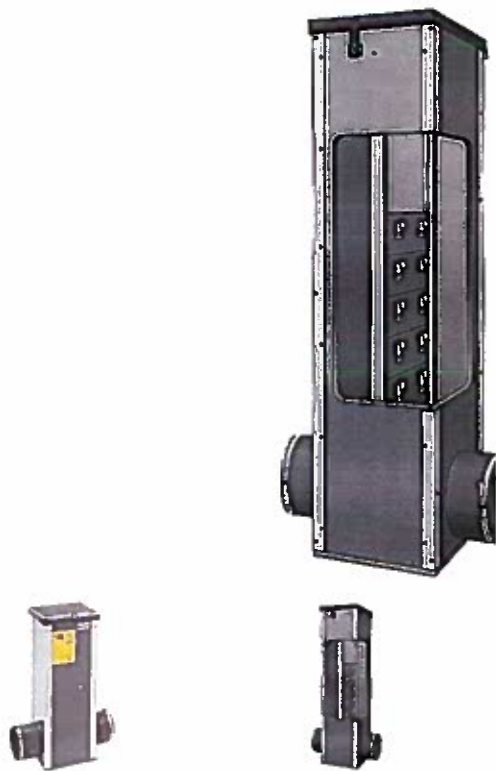
## Inline Water Level Control Structures™

- Available in Manual or Automatic. (Call for details on Automatic.)
- Structures are not pressure rated.
- Structures are intended for gravity flow. Low pressure and some seepage may occur.

- Constructed of rugged 1/2" PVC with lockable plastic lid.
- Stainless steel screws and custom anodized aluminum corner extrusions used for strength and durability.

- Flexible couplers allows PVC, plastic pipe, or other materials to be easily attached. (Please specify type of pipe when ordering.)
- Stoplogs made of PVC in 5" and 7" heights for adjustability. (Maintenance of stoplogs is recommended: Remove stoplogs and grease the o-ring on each board with Lubriplate Grease.\* Ensure that there is no debris in the tracks or along the bottom of the structure. Replace stoplogs after greasing.)
