## IN-OFFICE BENEFICIAL USE EXAM REPORT

Permit No. 65-23477

## MEMORANDUM

**TO:** LICENSING FILE 65-23377  
**FROM:** VICKY MUSIC  
**SUBJECT:** FIELD EXAM AND LICENSING RECOMMENDATIONS  
**DATE:** 8/19/2014

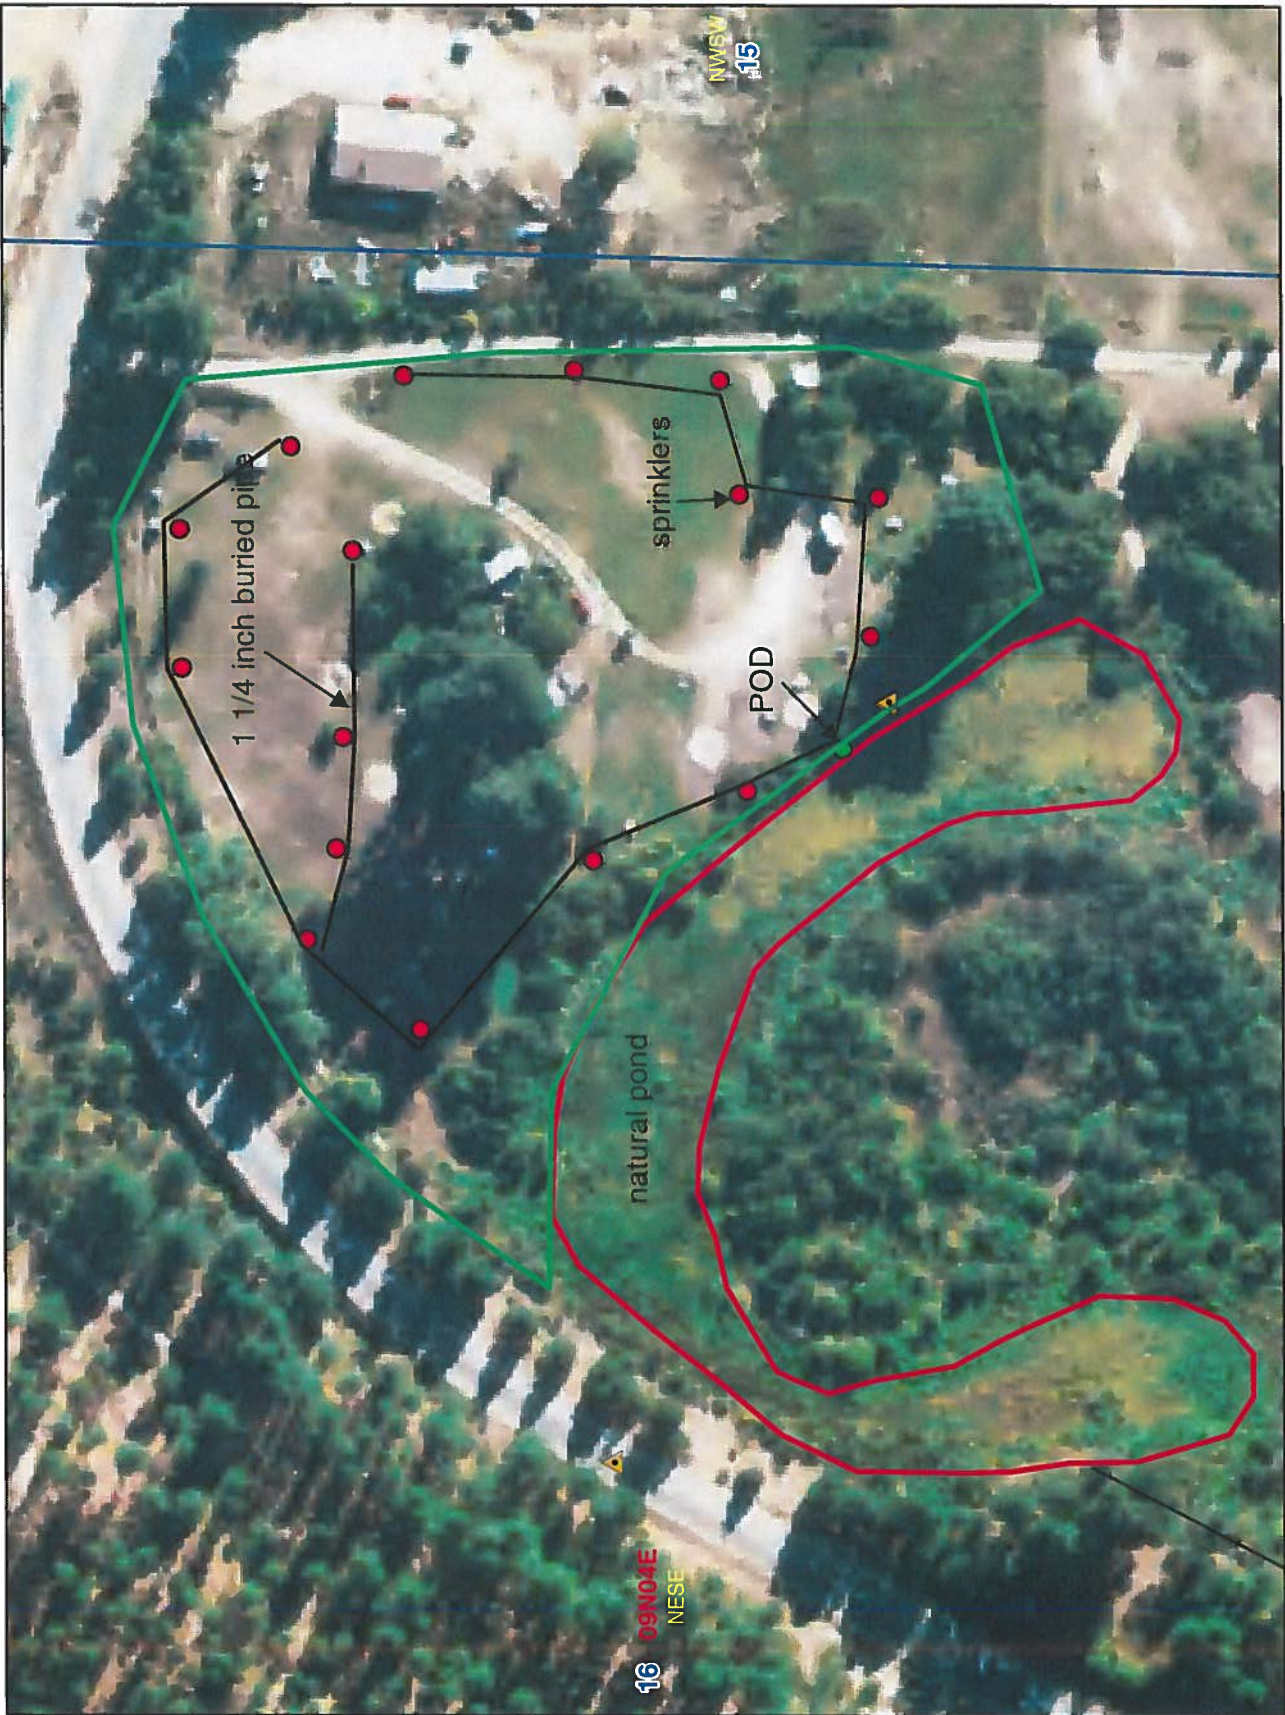
65-23477 -- 2013 NAIP -- POD and delivery system labeled. POU is outlined in blue.

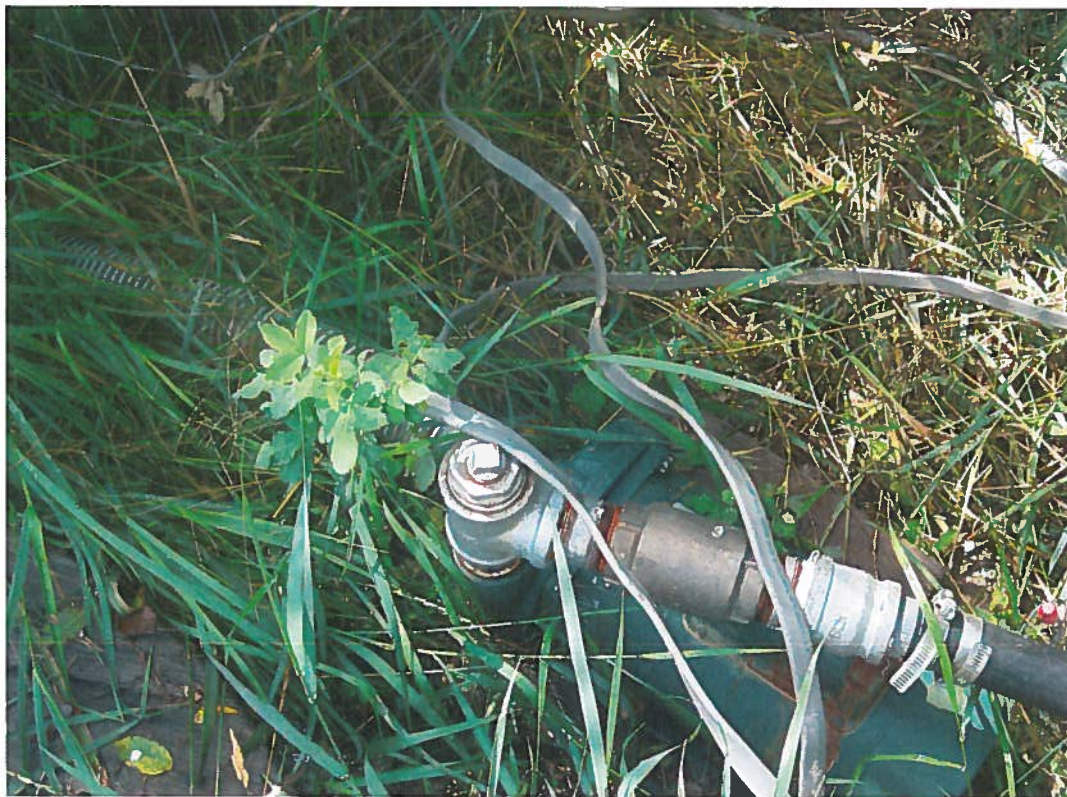
The electric pump is a 3 hp McDonald centrifugal, mode # 92300, and the motor is an Everson [? – rusted]. The faceplate on the motor was rusted, so the specs were illegible. Water is pumped from the cistern through a 2-inch diameter rubber hose to 1 ¼ -inch buried pipe to the sprinklers. The piping reduces in size to ¾- or 1-inch diameter to the sprinkler heads.

Pump and motor. Pipe from cistern/POD seen left.

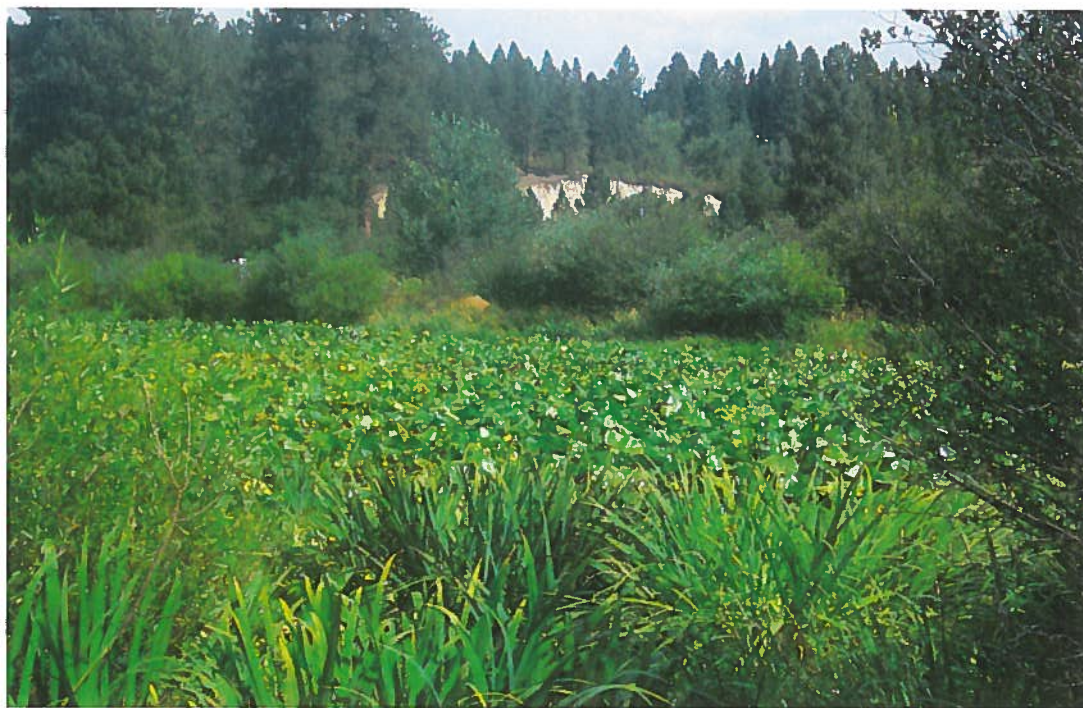
Pond surface is covered with lilies.

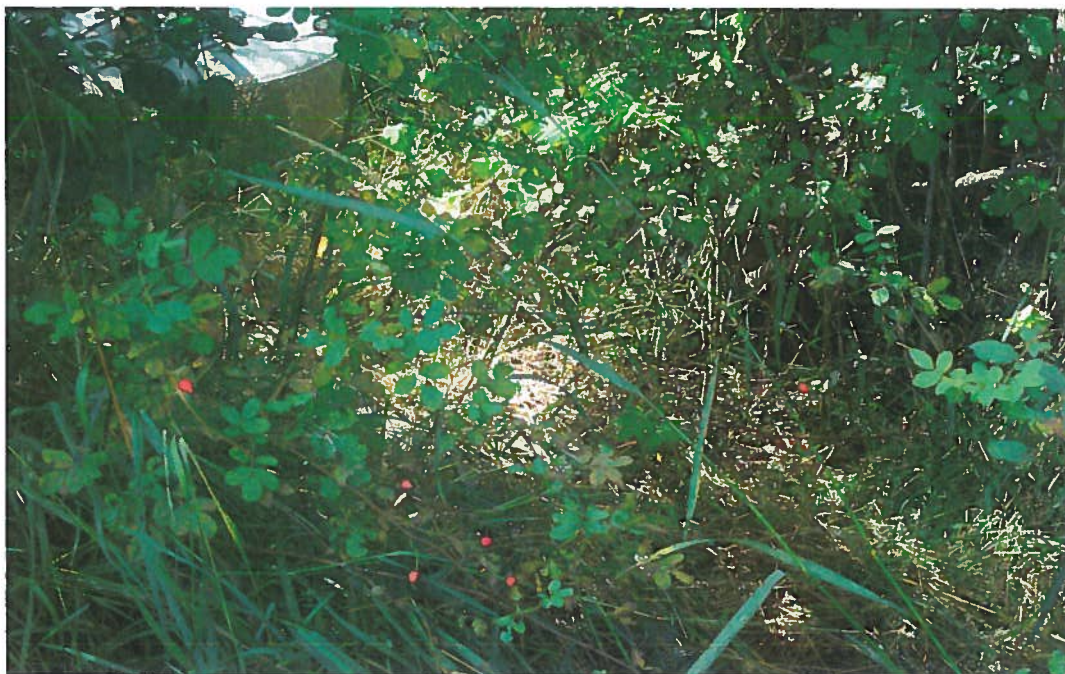
The point of diversion from the pond is a metal cistern. The cistern is about 2 feet away from the edge of the pond the day of the exam, however, Mr. Logan said that it was underwater during the early spring of each year. The GPS coordinates of the cistern are N 44.11169, W -115.97892. Mr. Logan said that the pond was about 2 feet deep the day of the exam, but during early spring, it is about 6 feet deeper. The pond is a natural feature that appears on topographic maps, and looks like a remnant of the Middle Fork of the Payette River.

Metal cistern that is the POD, seen far left.
