Application for Permit No. 75-14772

Attached are photographs and locator map supporting the above permit application.

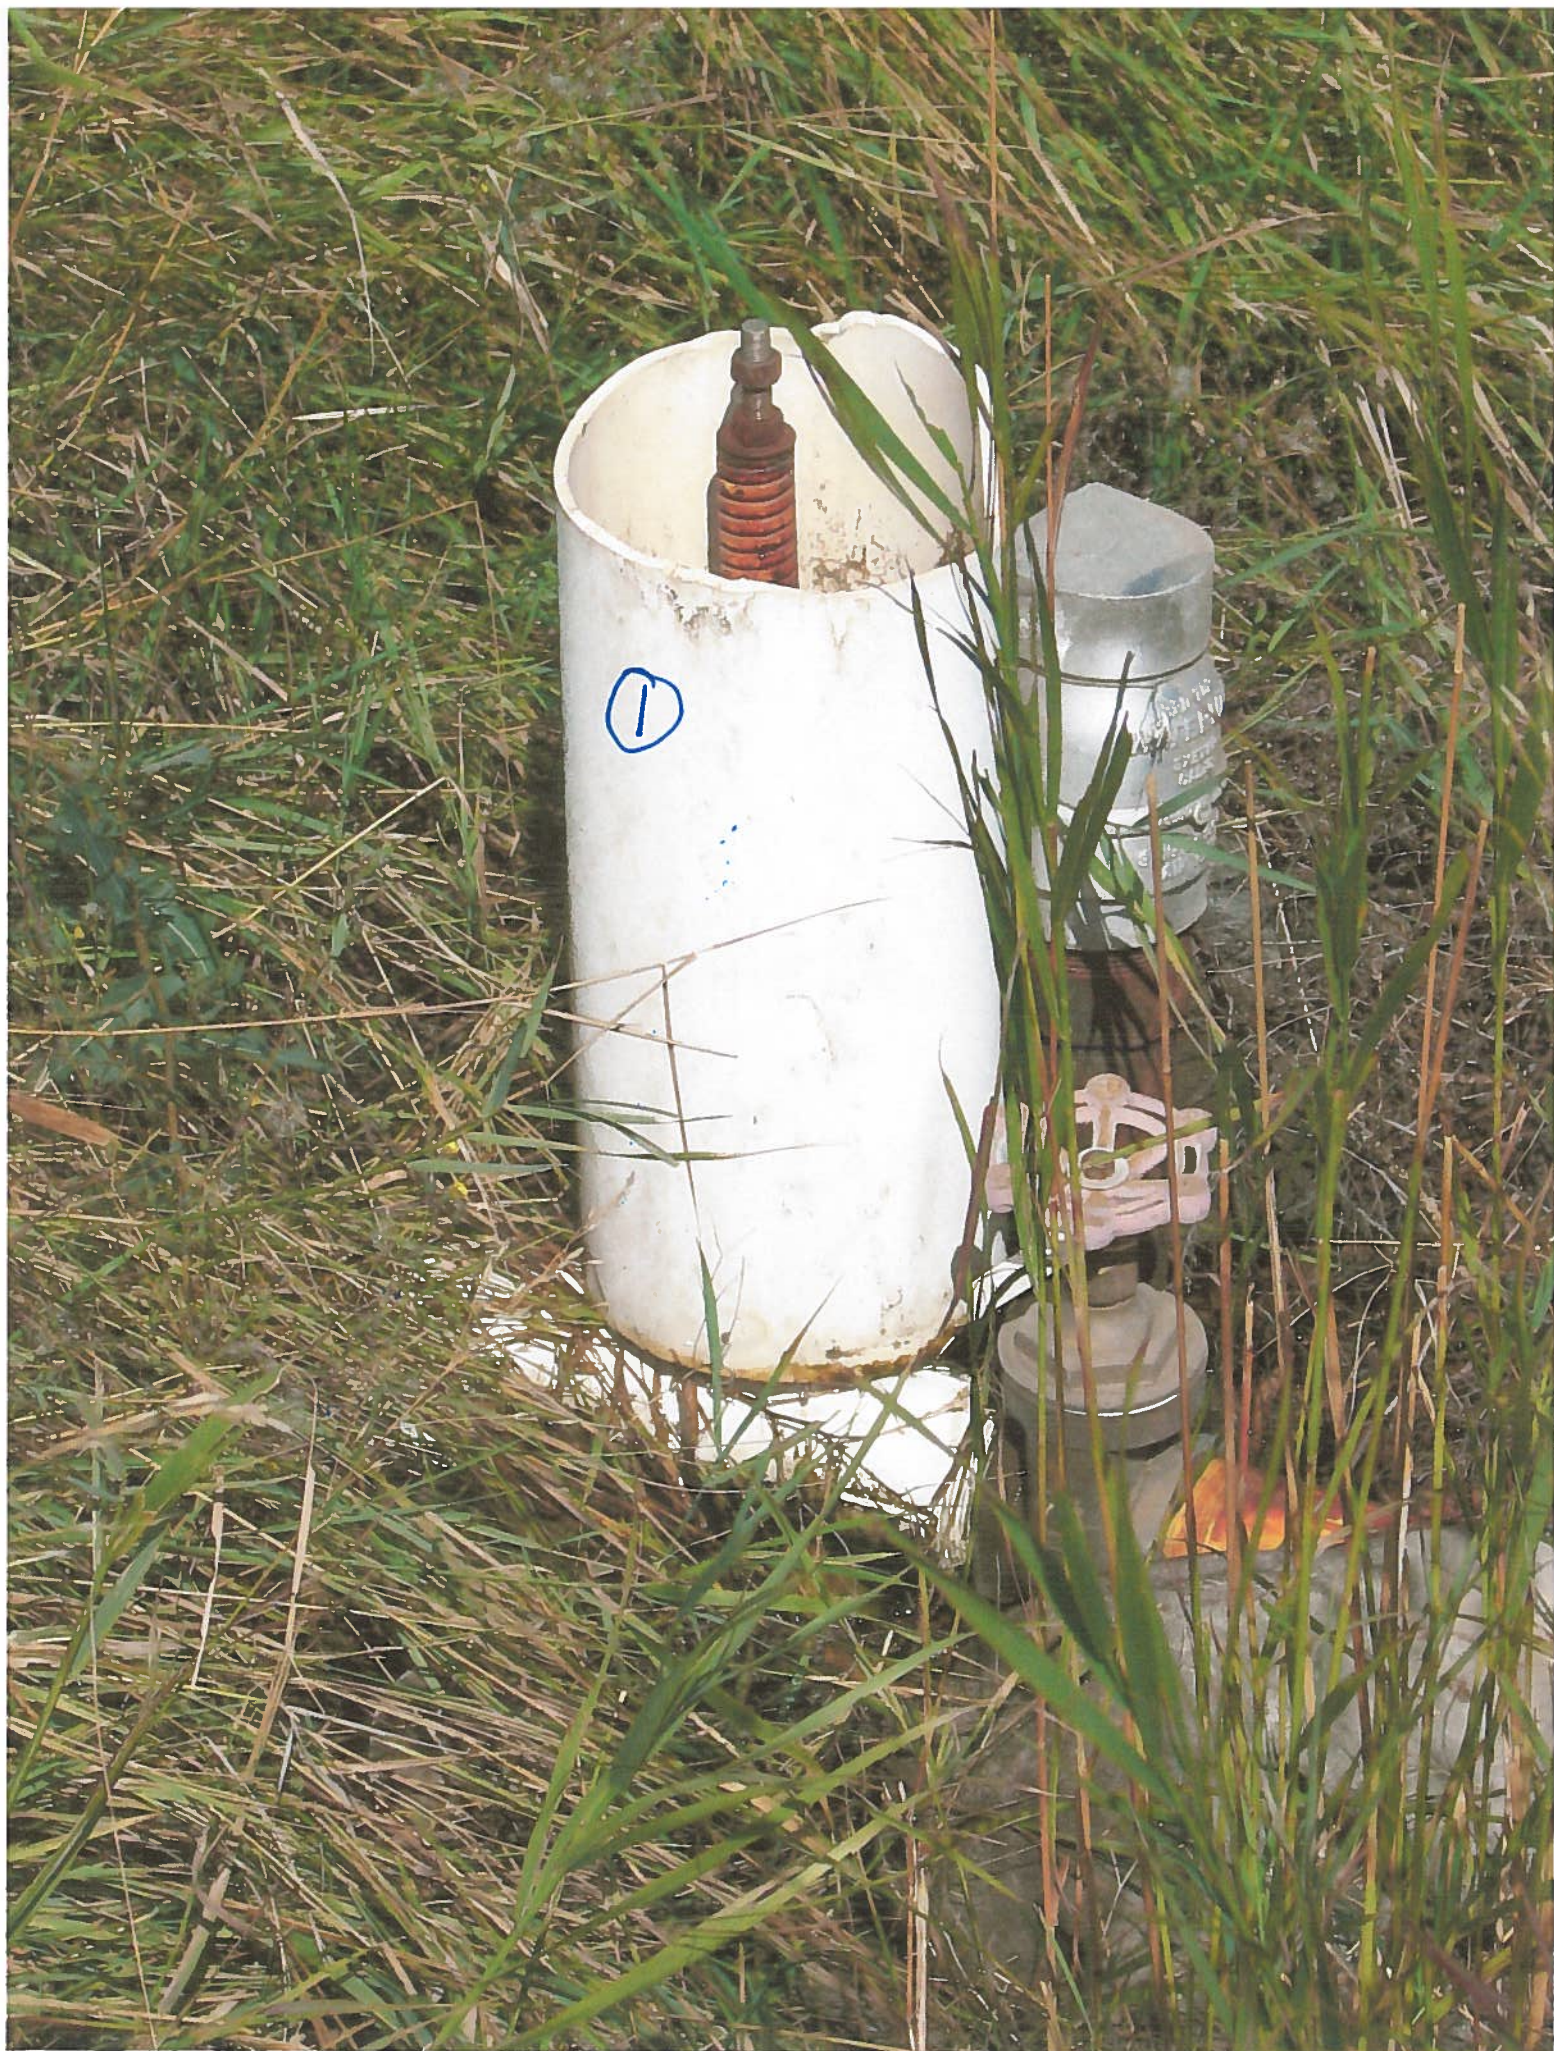
PHOTO #1 is near the proposed POD and is a close up of the pressure relief valve discharging the water I propose to divert.

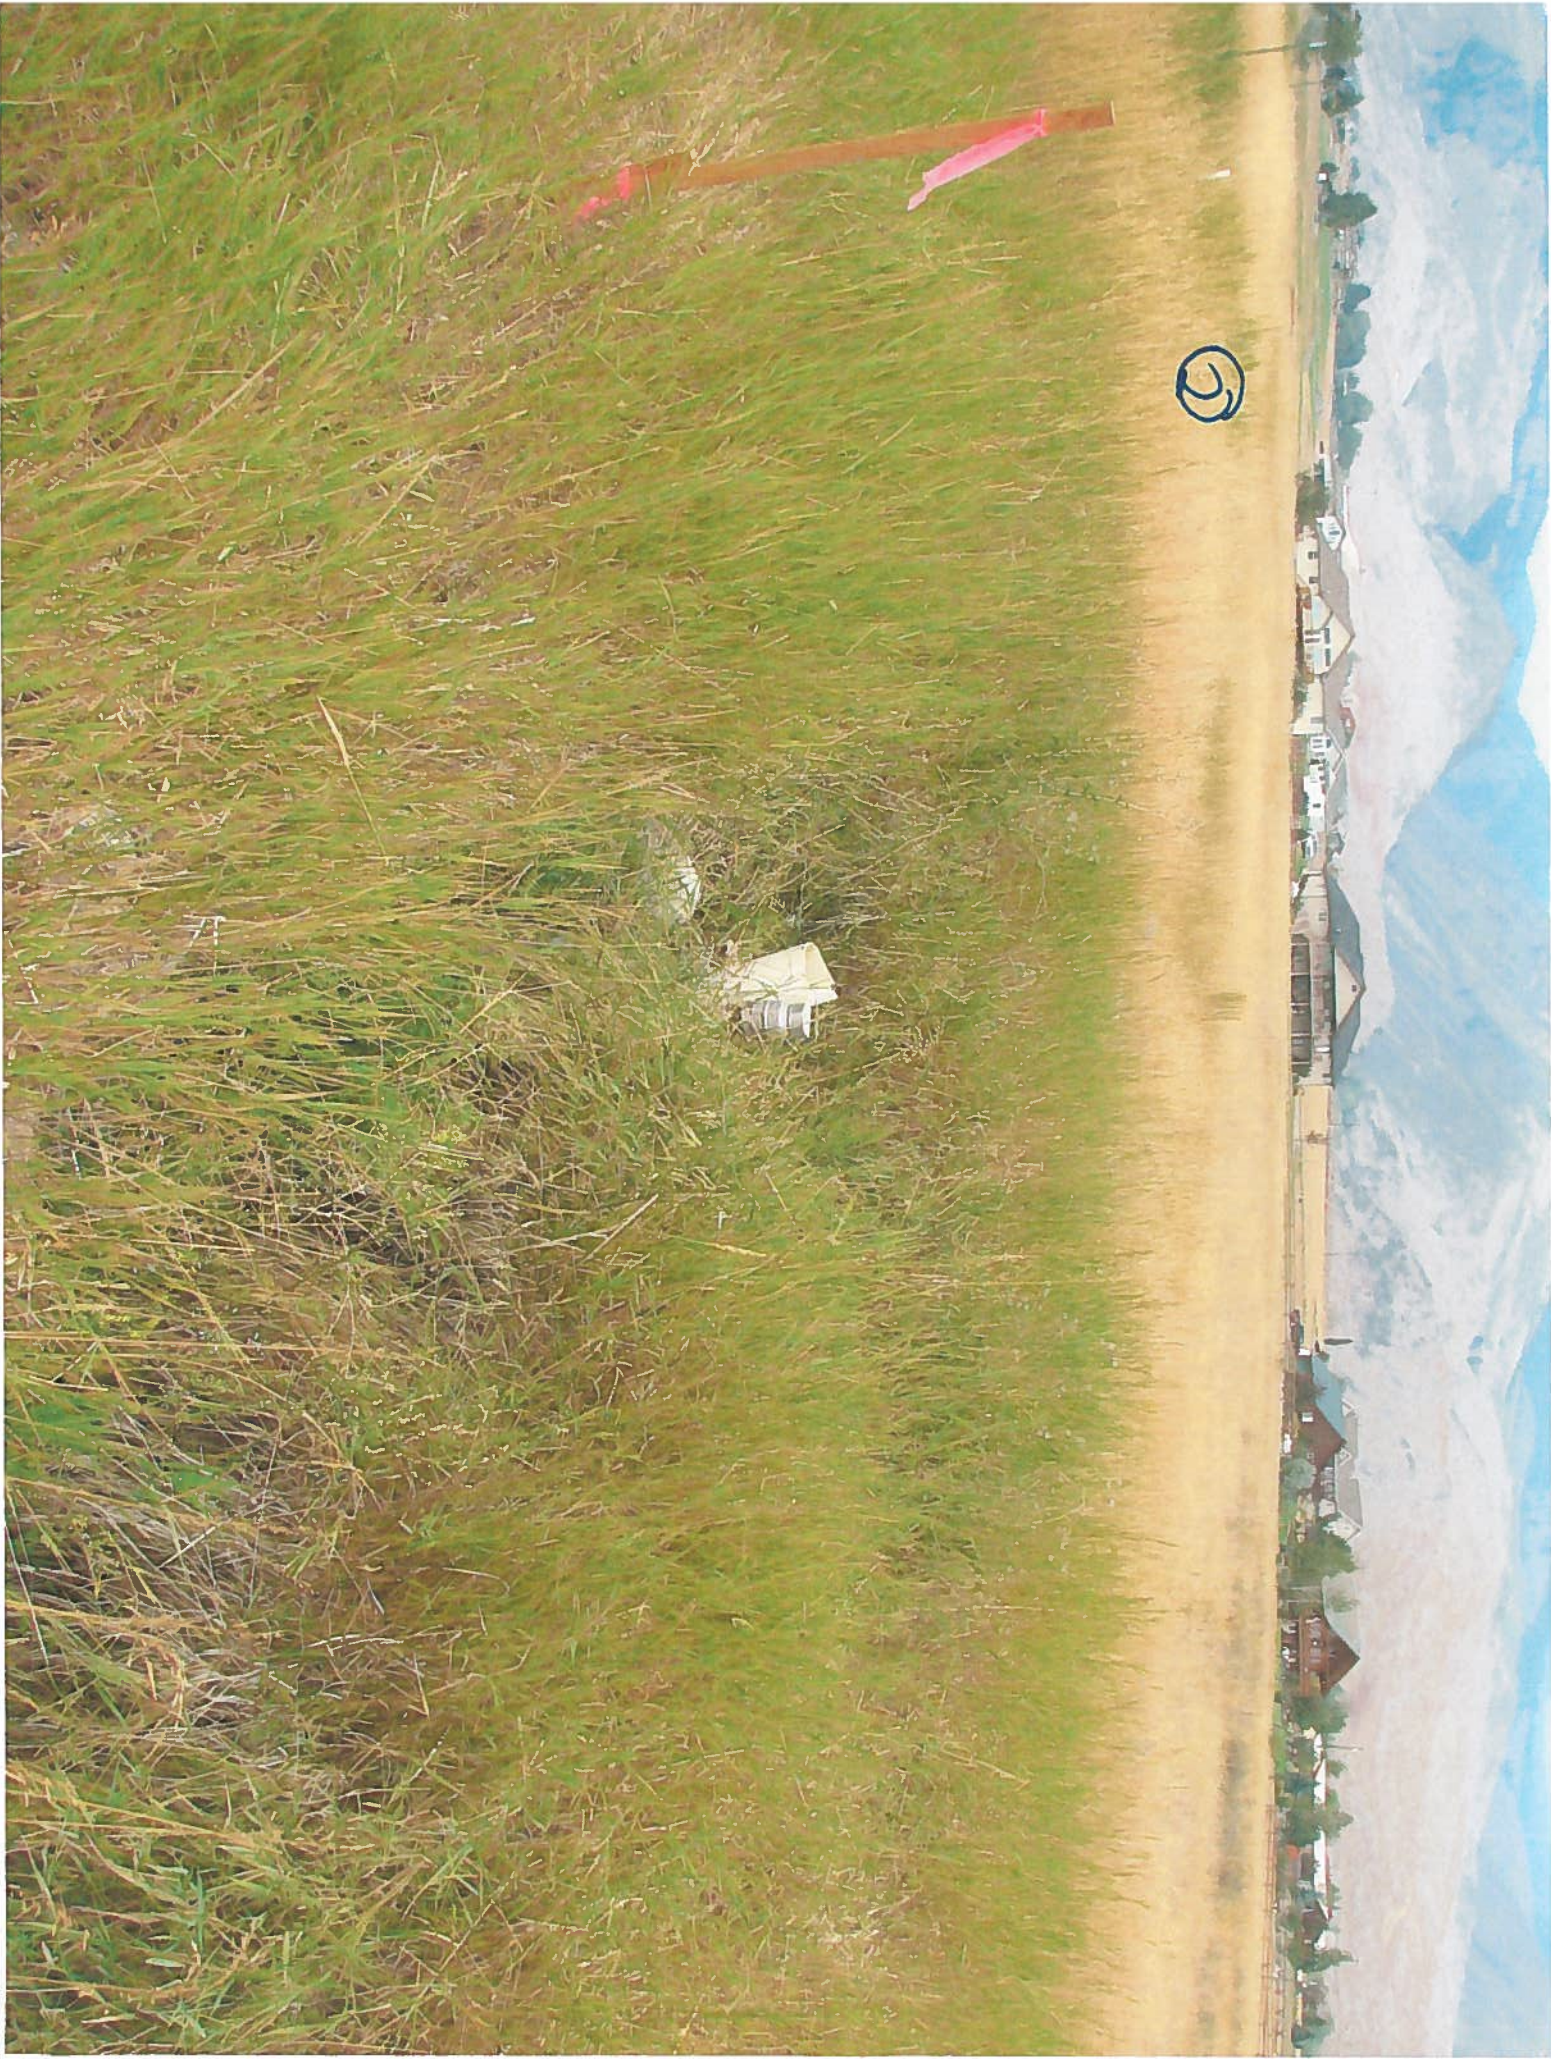
PHOTO #2 is a wider angle of the pressure relief valve. The shallow ditch carrying the discharged water runs from the valve towards the lower left of the photograph.

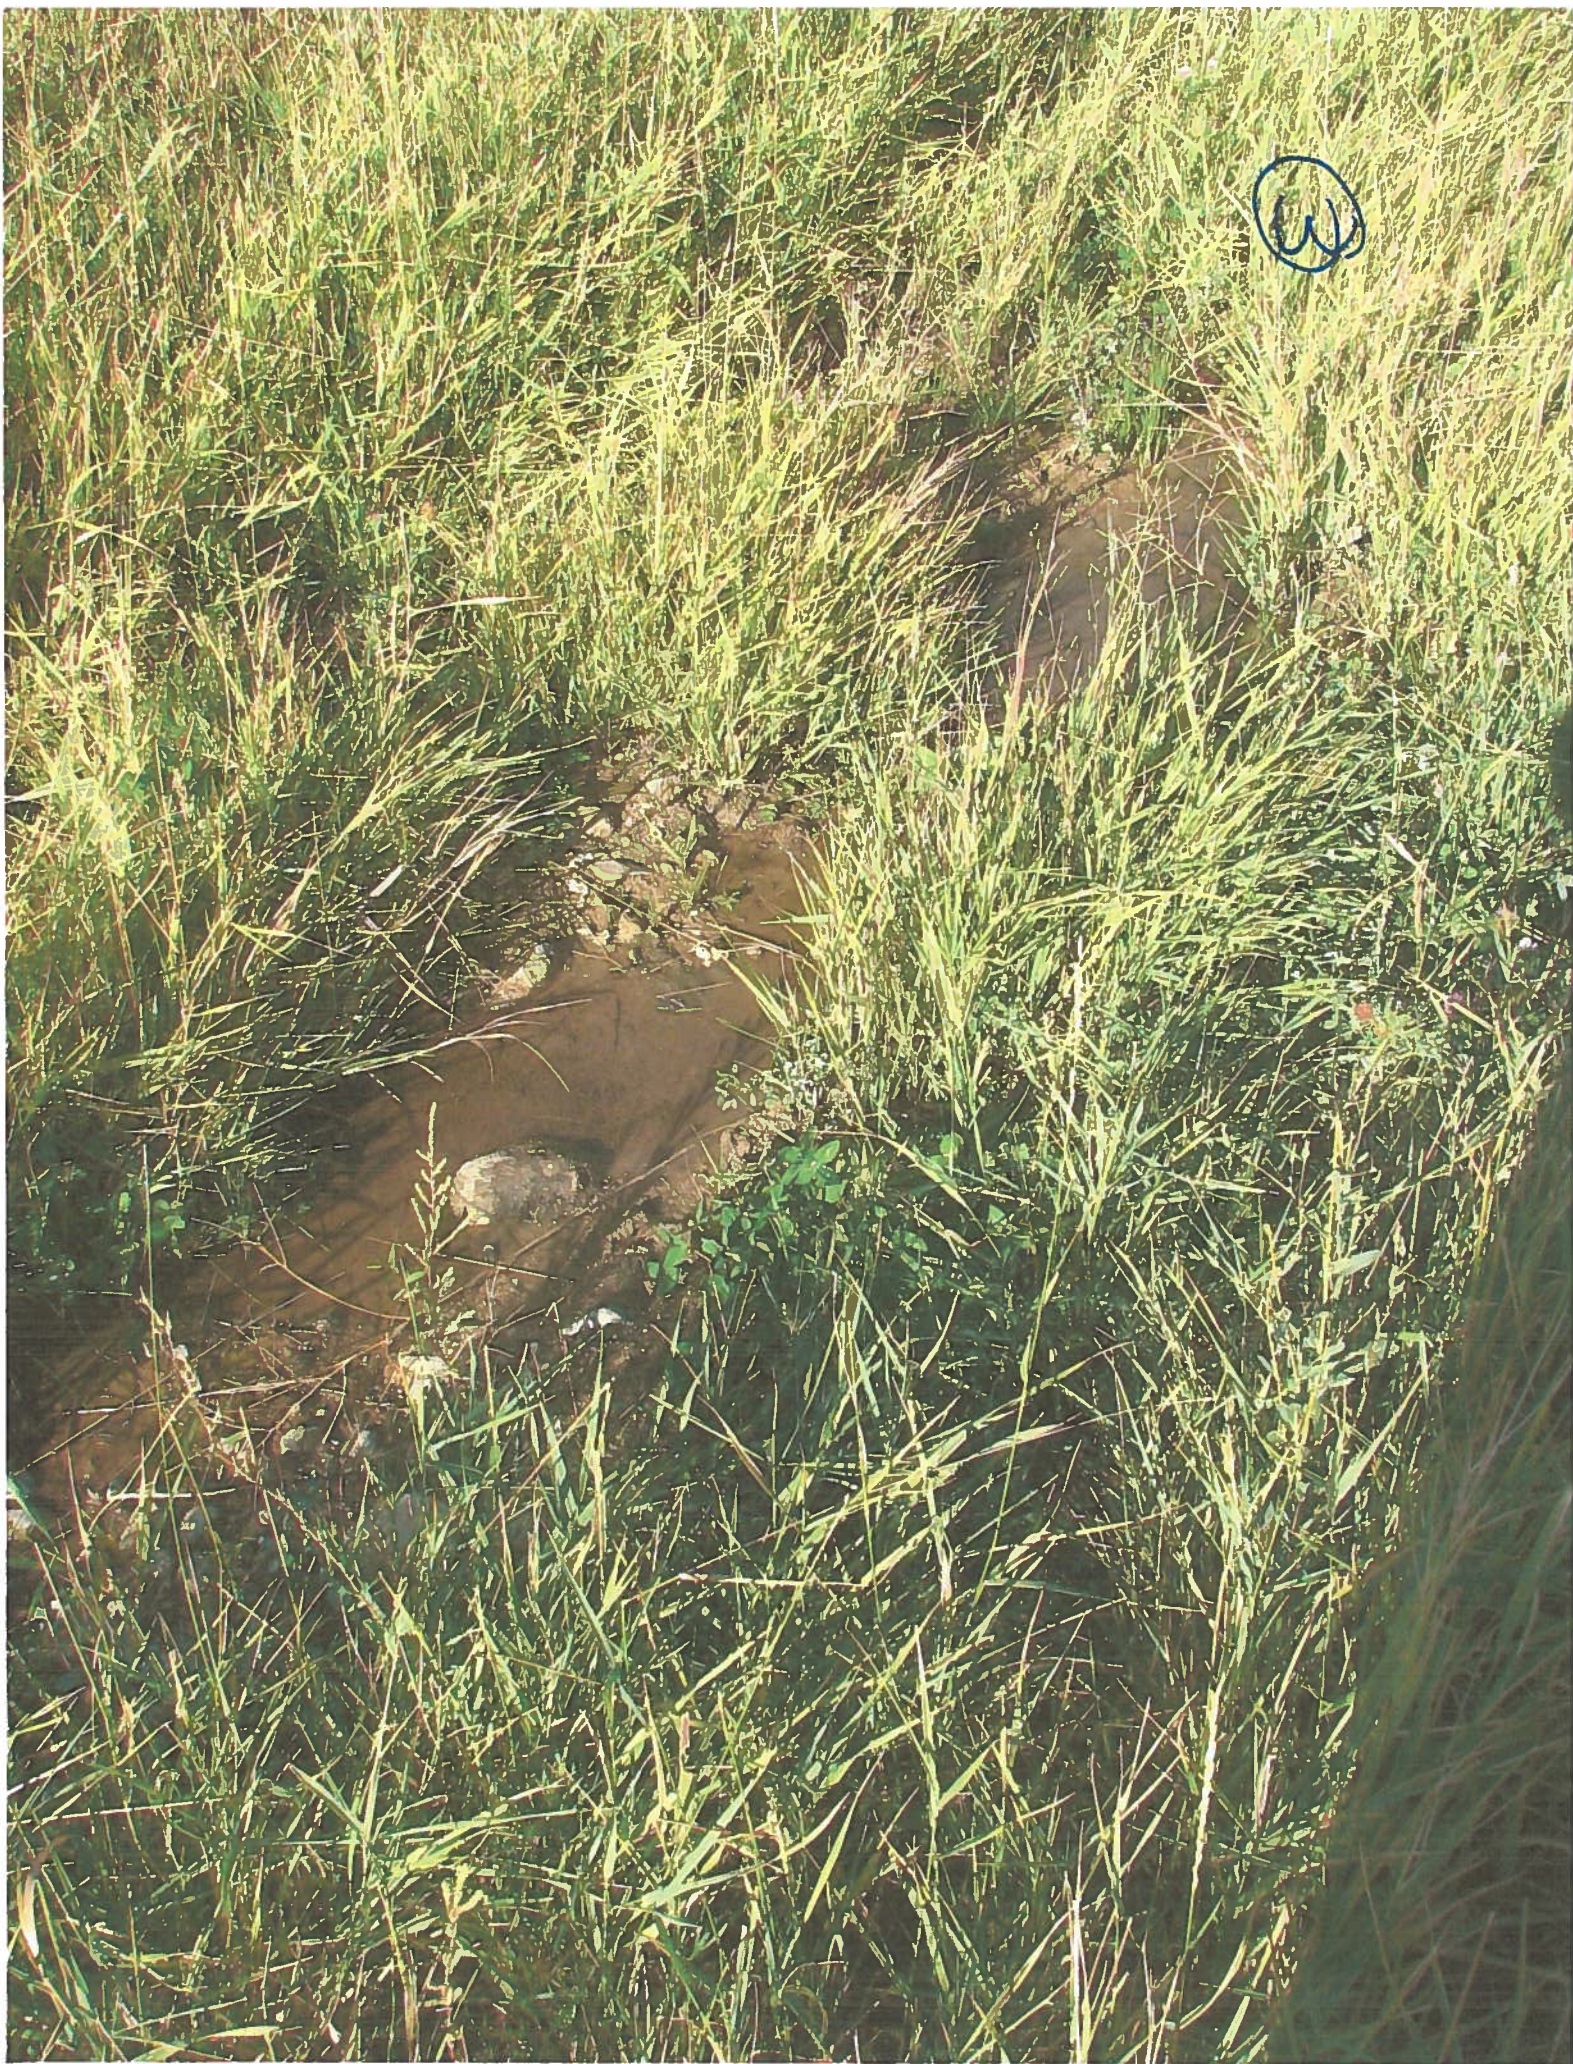
PHOTO #3 shows water running in the ditch about 30 feet below the valve.

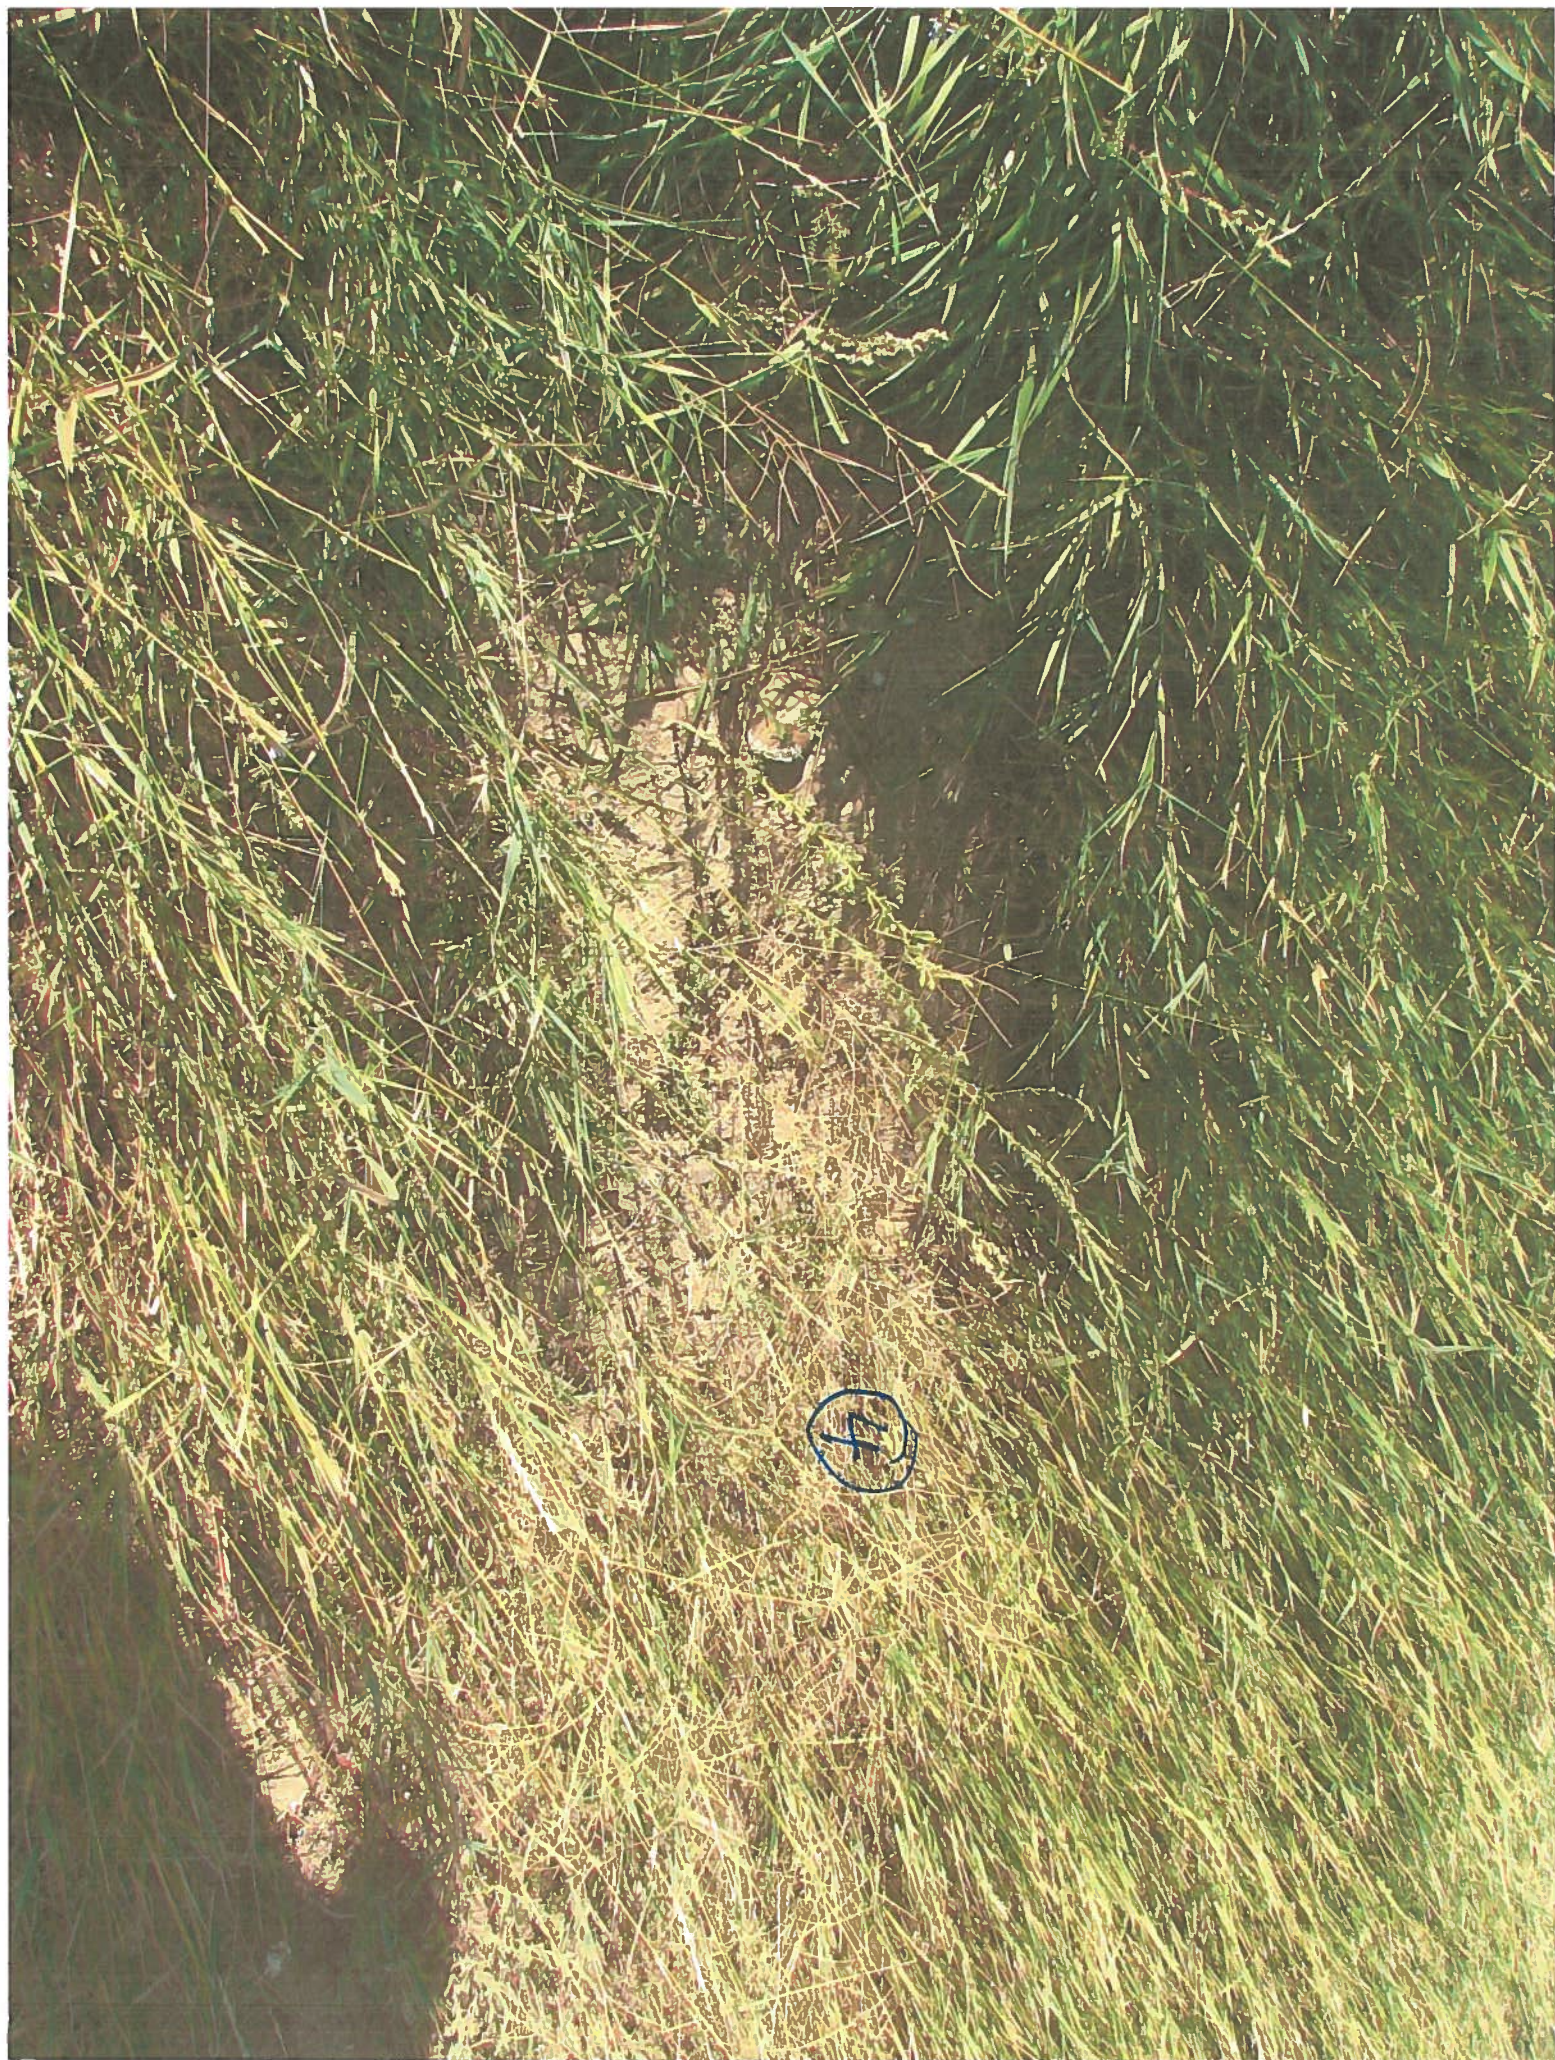
PHOTO #4 shows the same ditch about 50 feet below the valve. You will note the ditch is dry at this point.

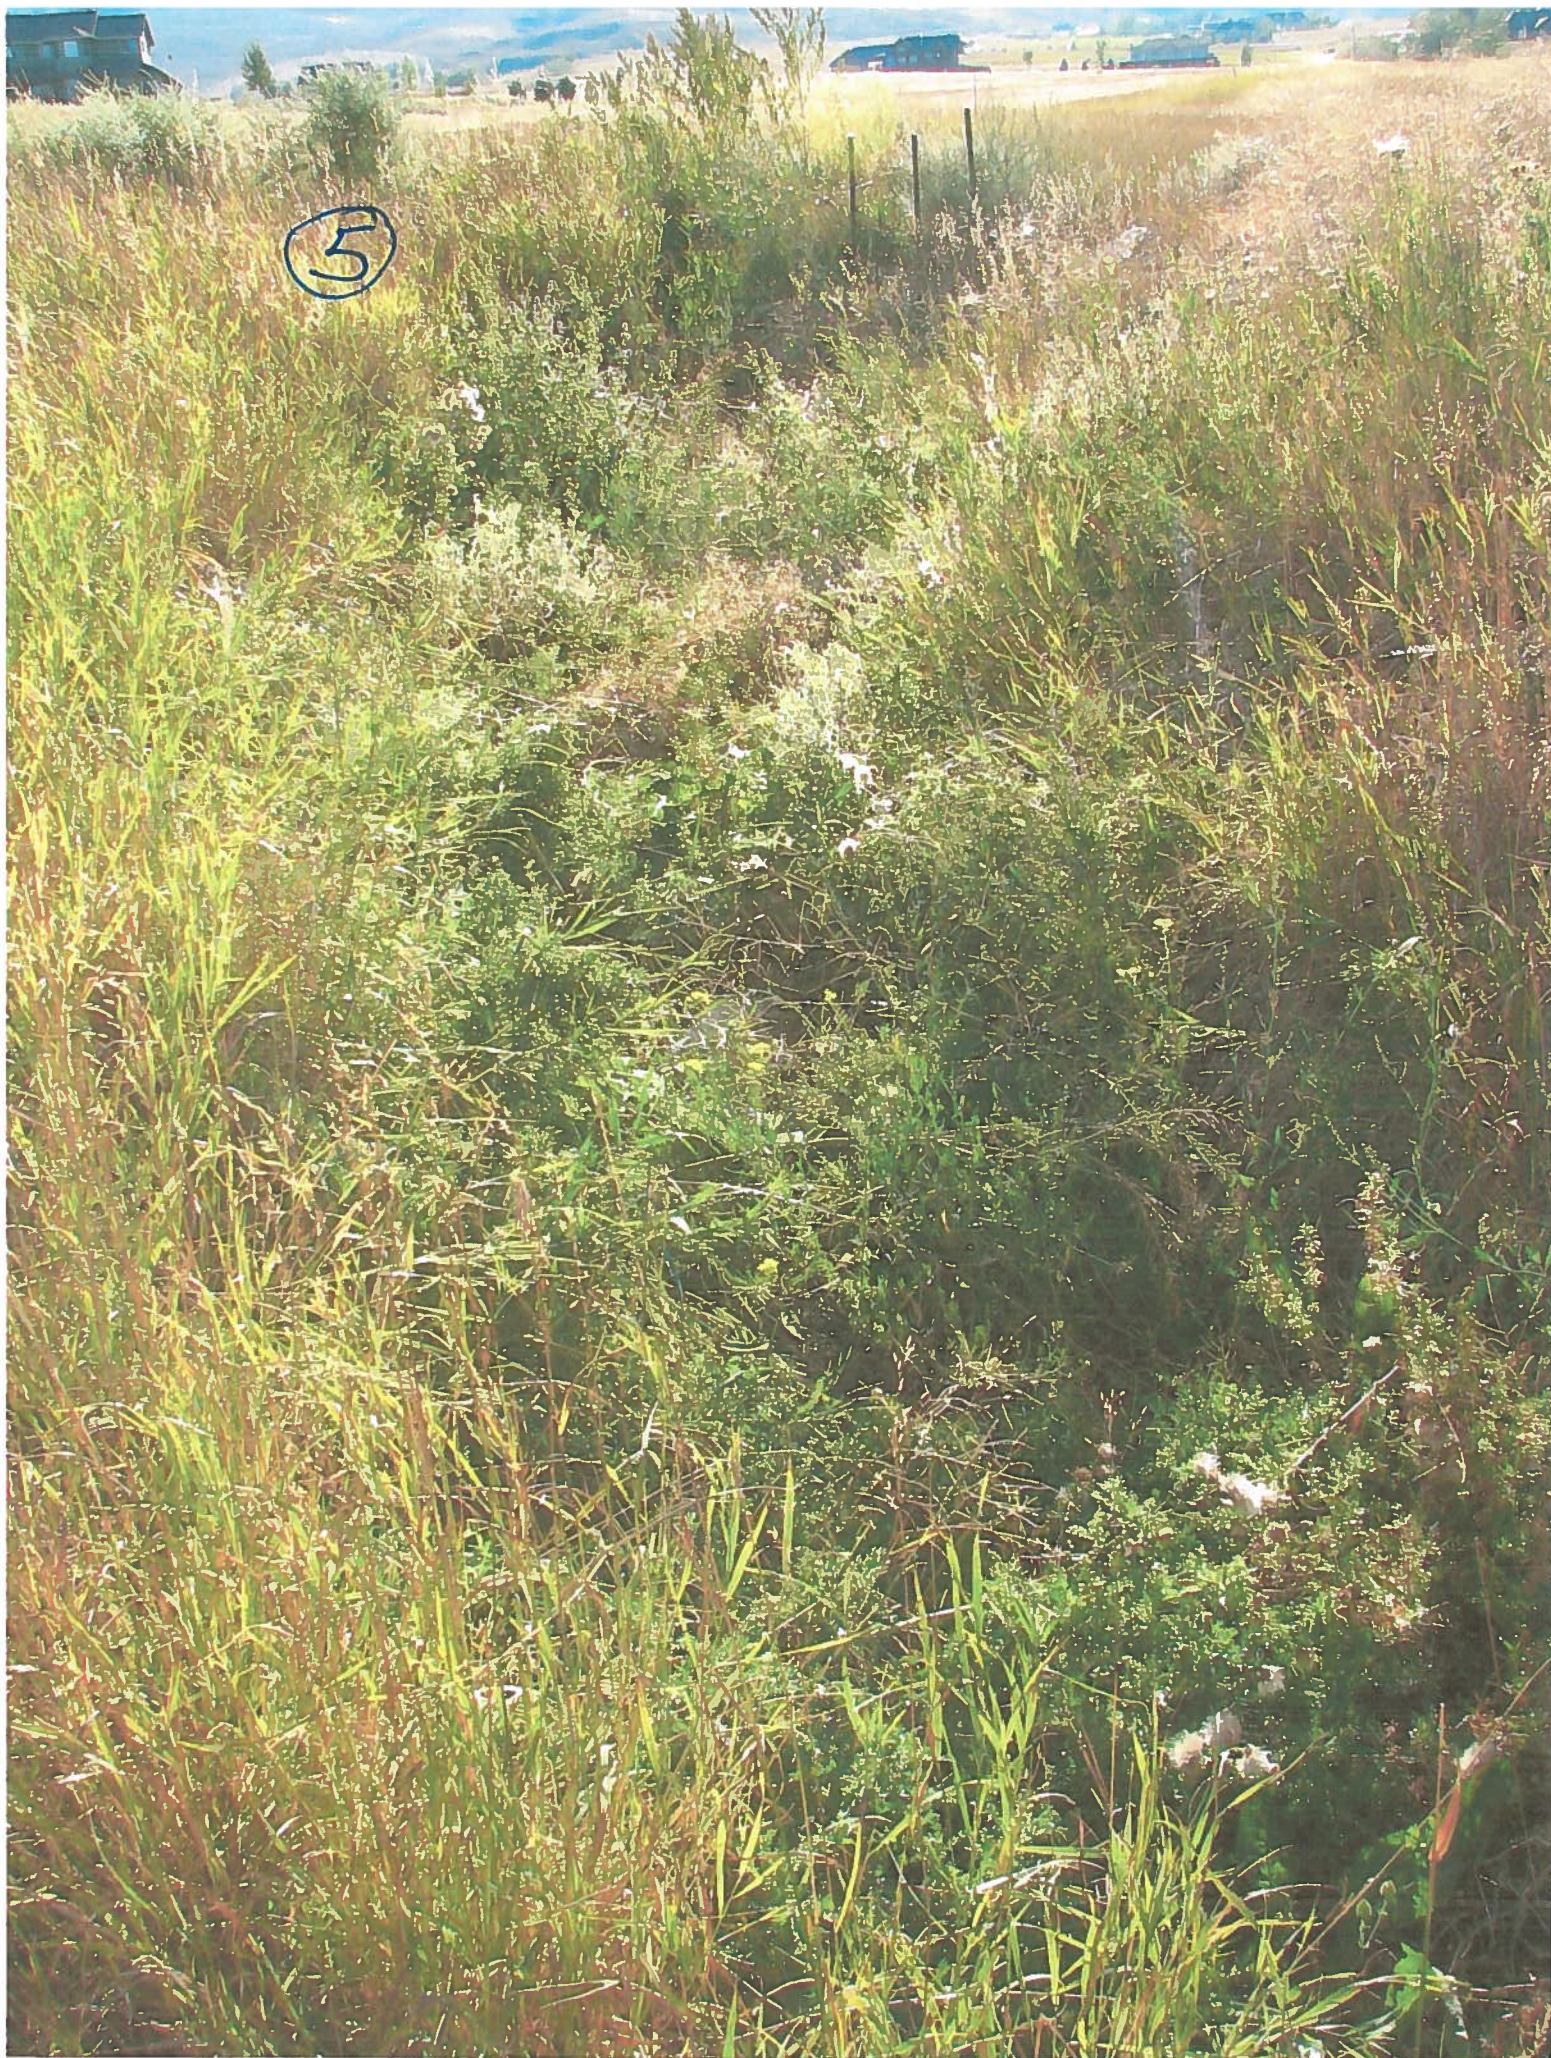
PHOTO #5 is a picture of the end of the ditch near the west borrow of South 9<sup>th</sup> Street. The three iron pins at the top of the photo are at the old abandoned head wall where the pressure relief valve used to be. The pipeline between this point and the present relief valve was abandoned after it ruptured from too much pressure. The line was not worth repairing.

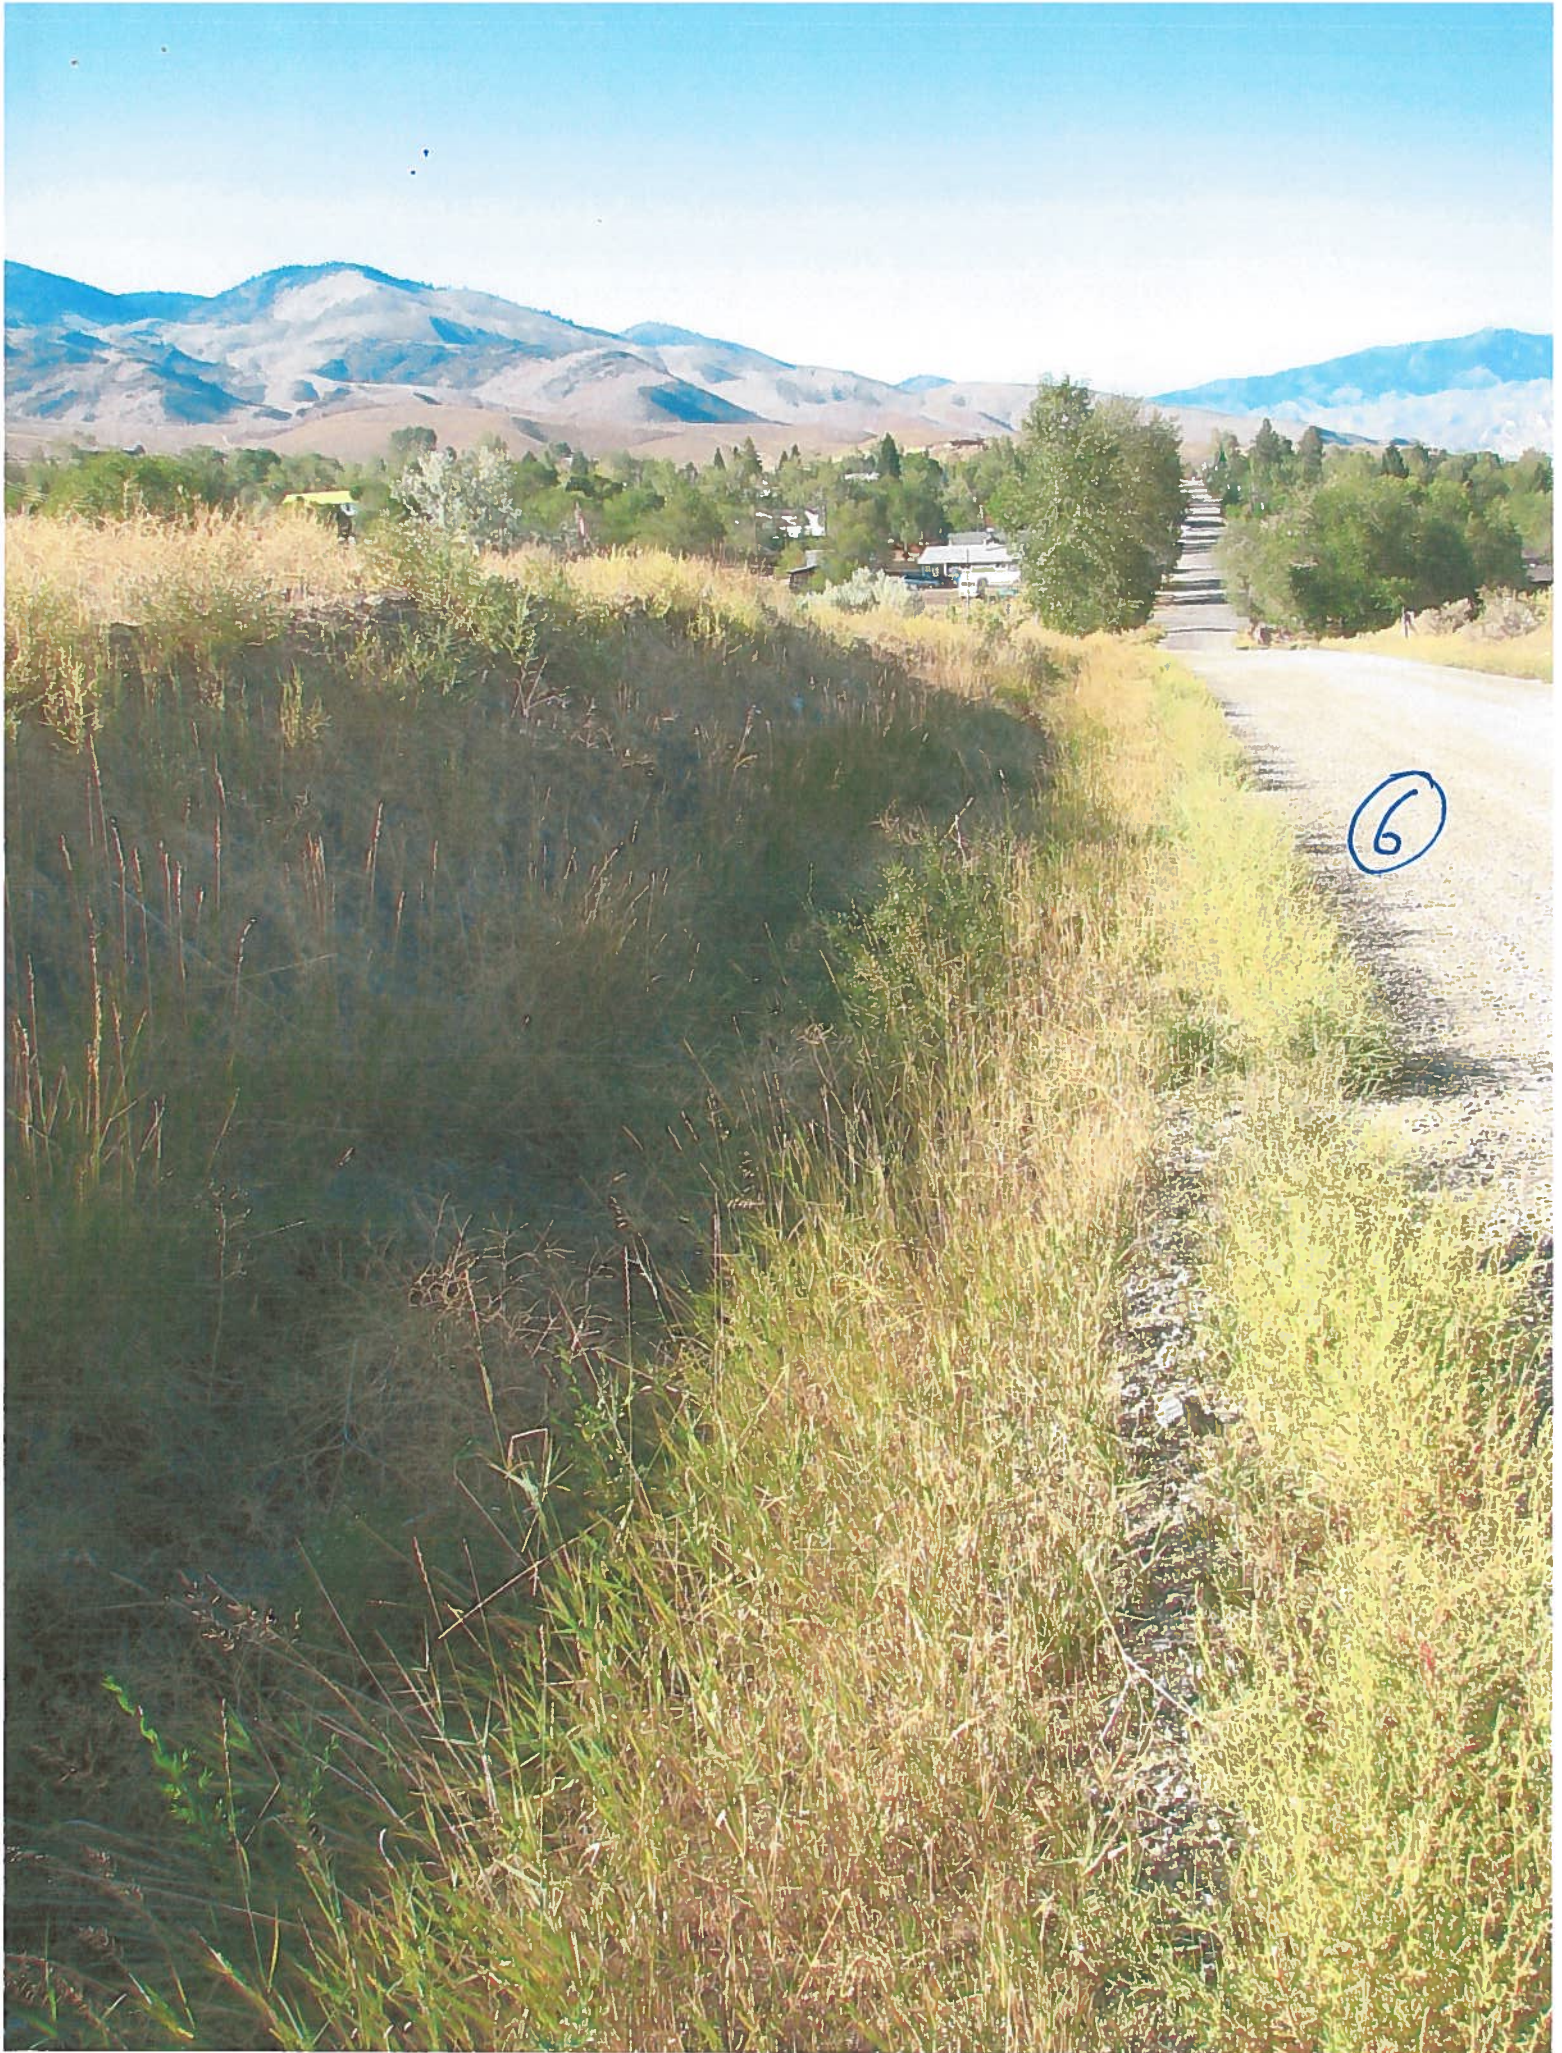
PHOTO #6 is a picture of the dry borrow on the west side of South 9<sup>th</sup> Street. Water from Arrowhead only reaches this point when they are flushing or draining the system.

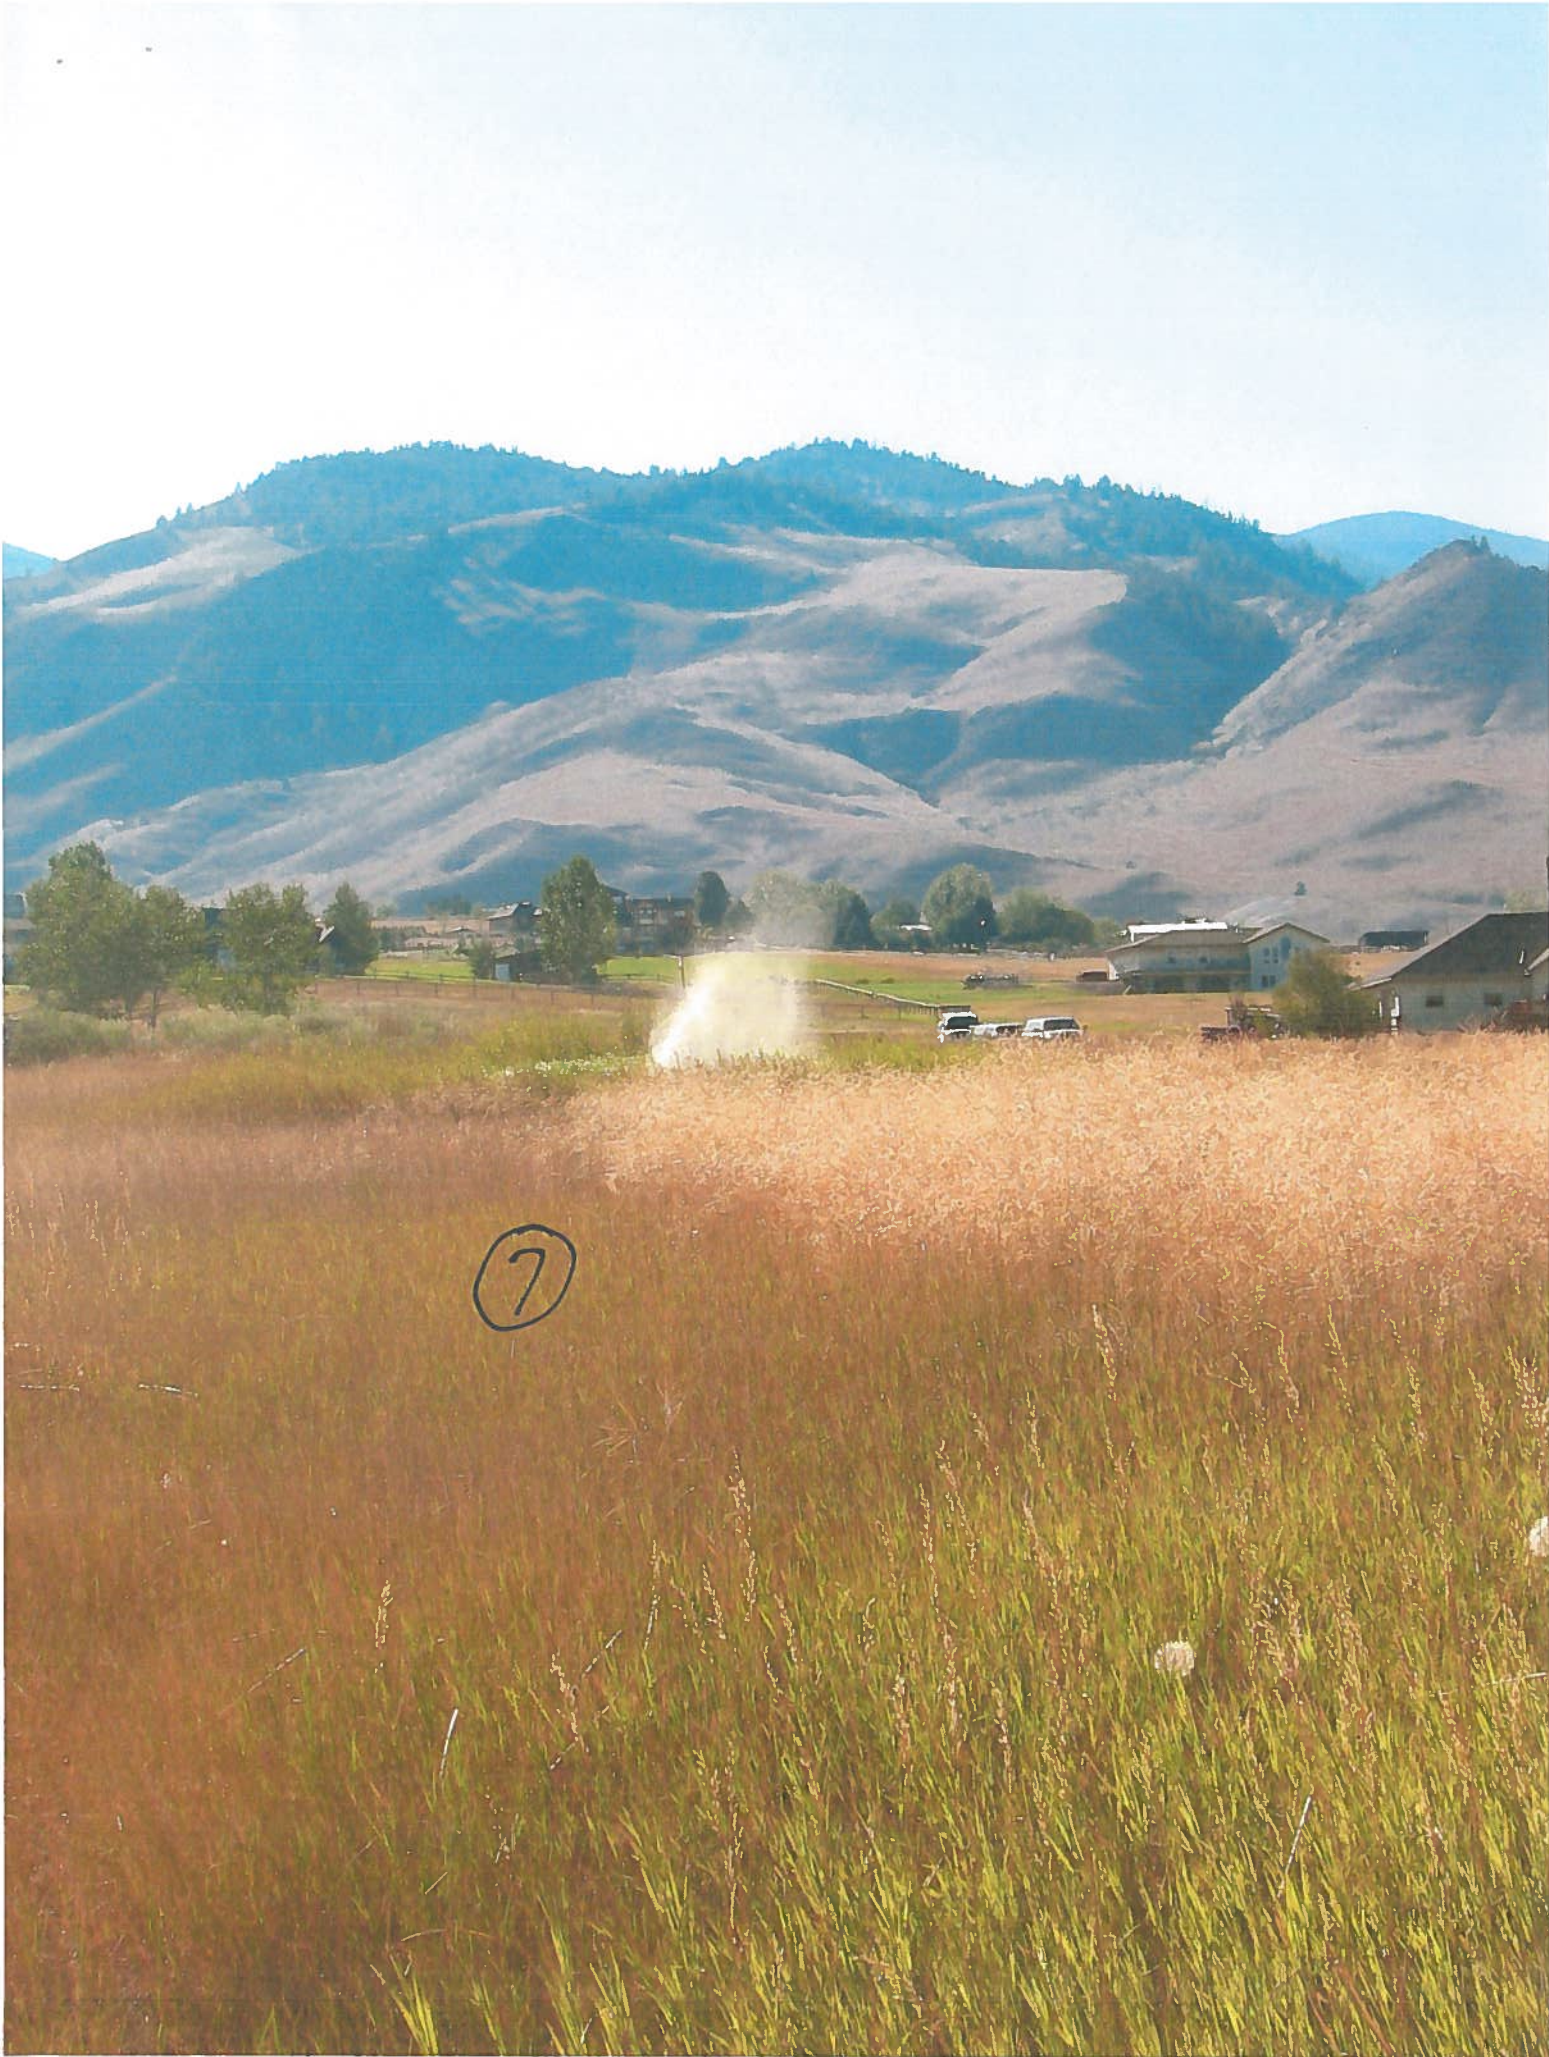
PHOTO #7 is taken up hill from the pressure relief valve. It is a picture of a old field riser with a small gasket leak. It shows the amount of pressure in the line even with the pressure relief functioning. There is a 500 foot drop in elevation in the Arrowhead system and the pressure at the relief valve is around 200 psi.
