Application for Permit No. 75-14772

Attached are photographs and locator map supporting the above permit application.

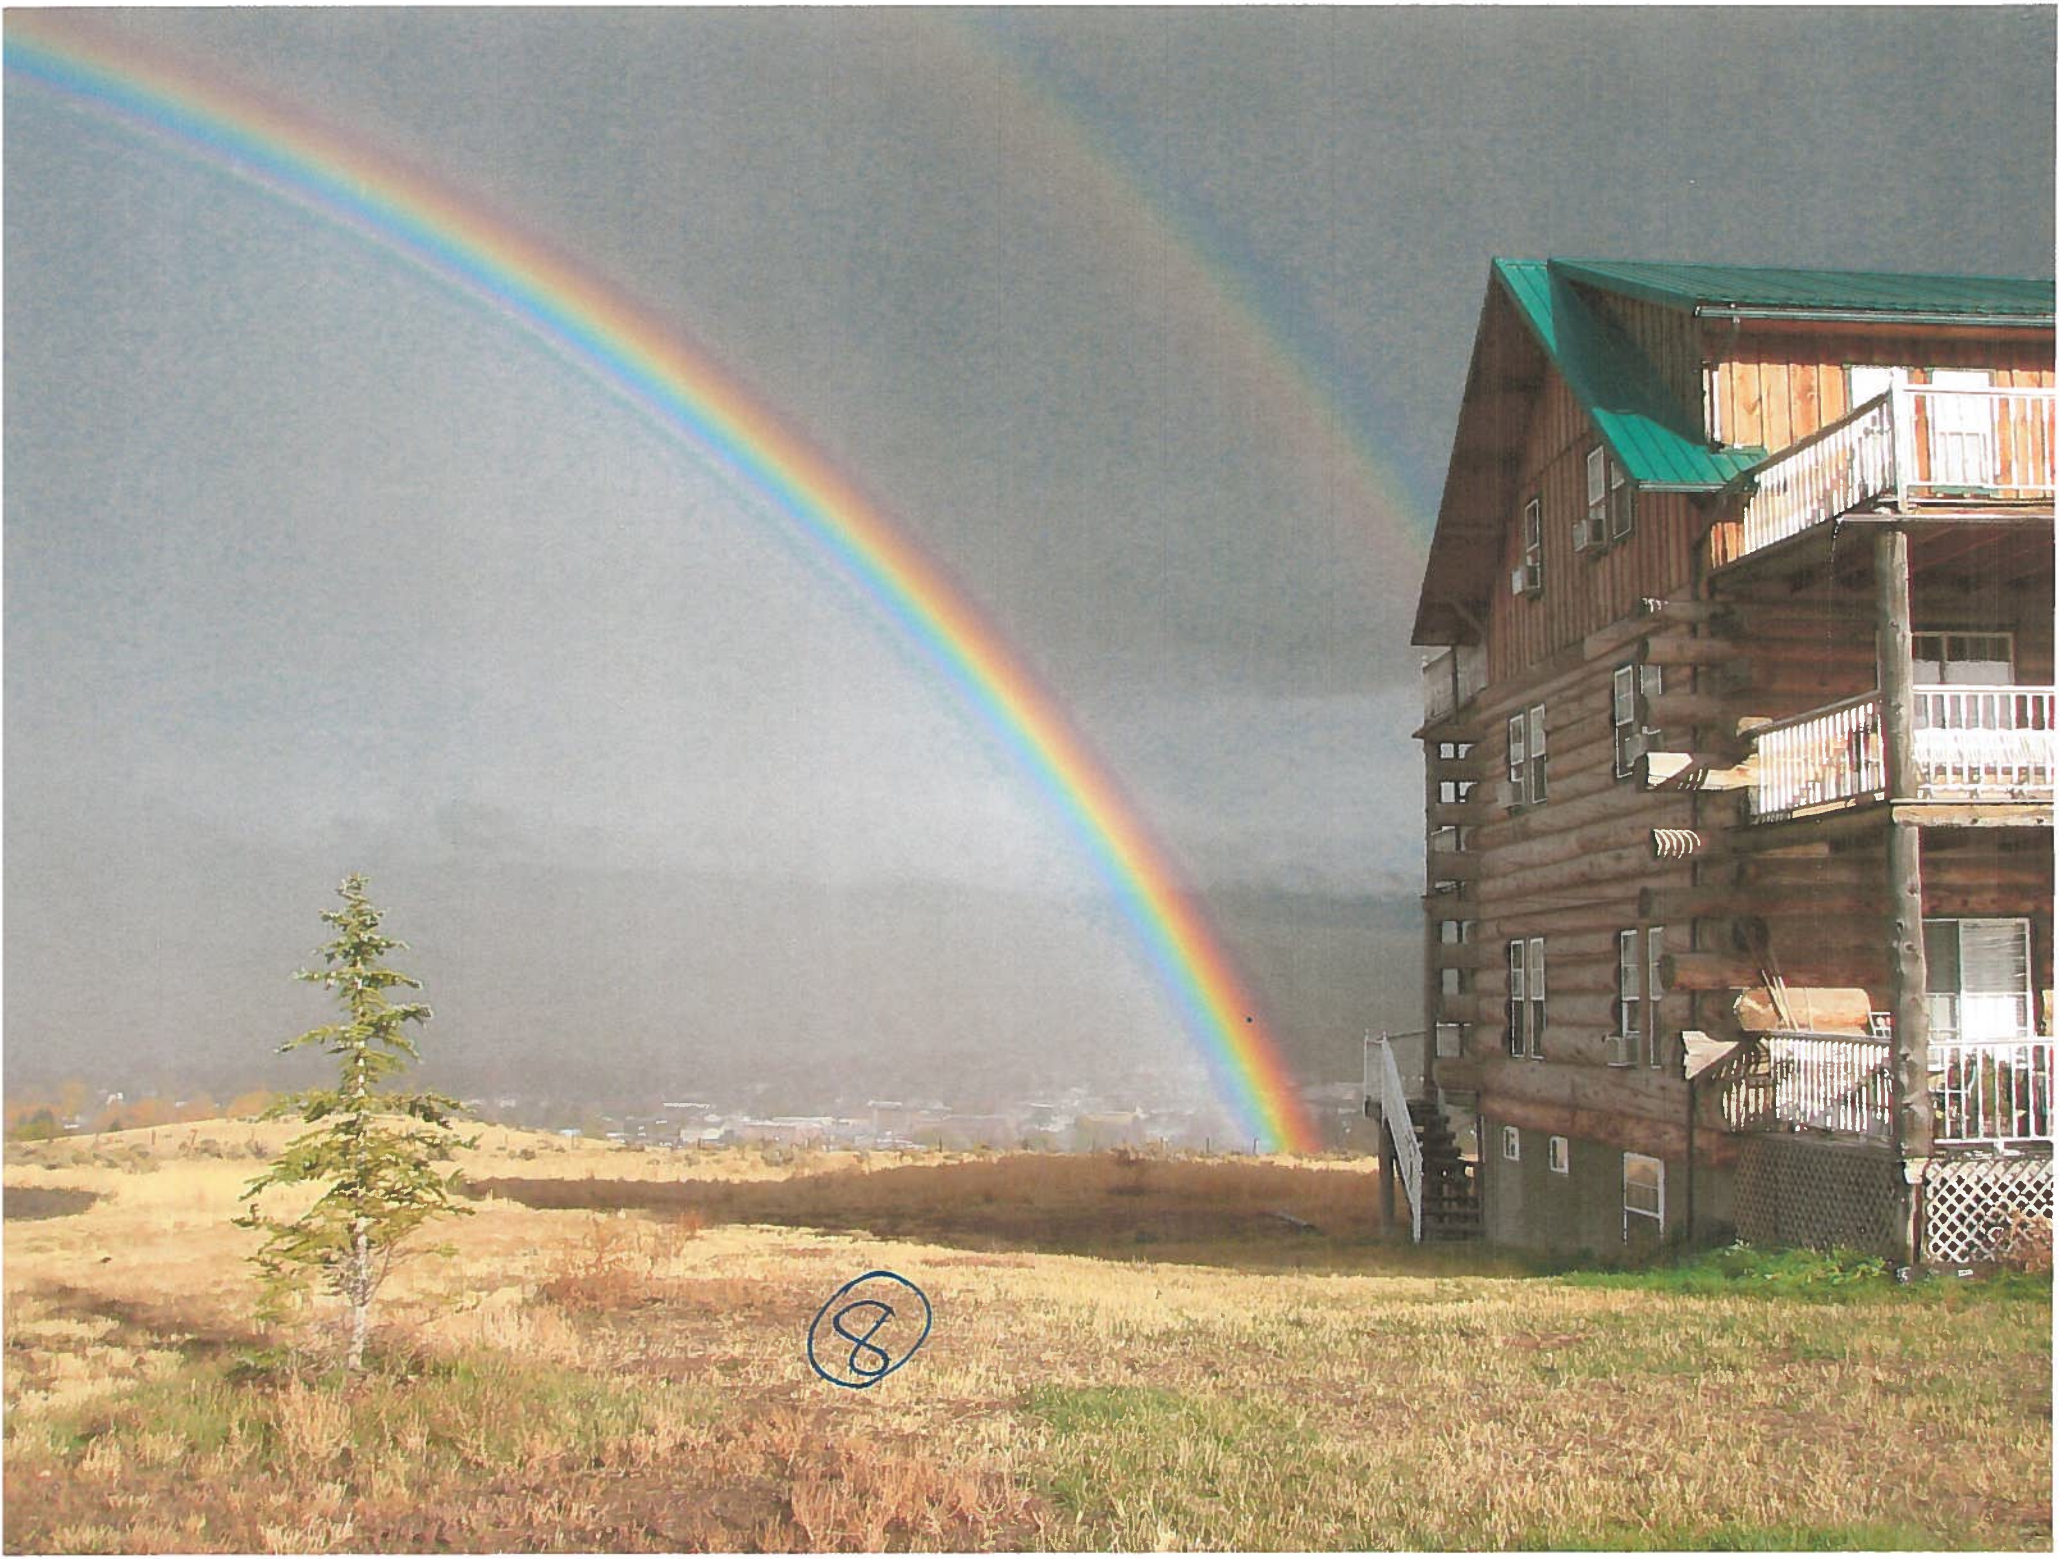
PHOTO #8 shows the POU area.
