STATE OF IDAHO  
DEPARTMENT OF WATER RESOURCES  
**BENEFICIAL USE FIELD REPORT**

Permit No: 65-13914

Exam Date: 10/9/2012

# Beneficial Use Field Report System Diagram & Map

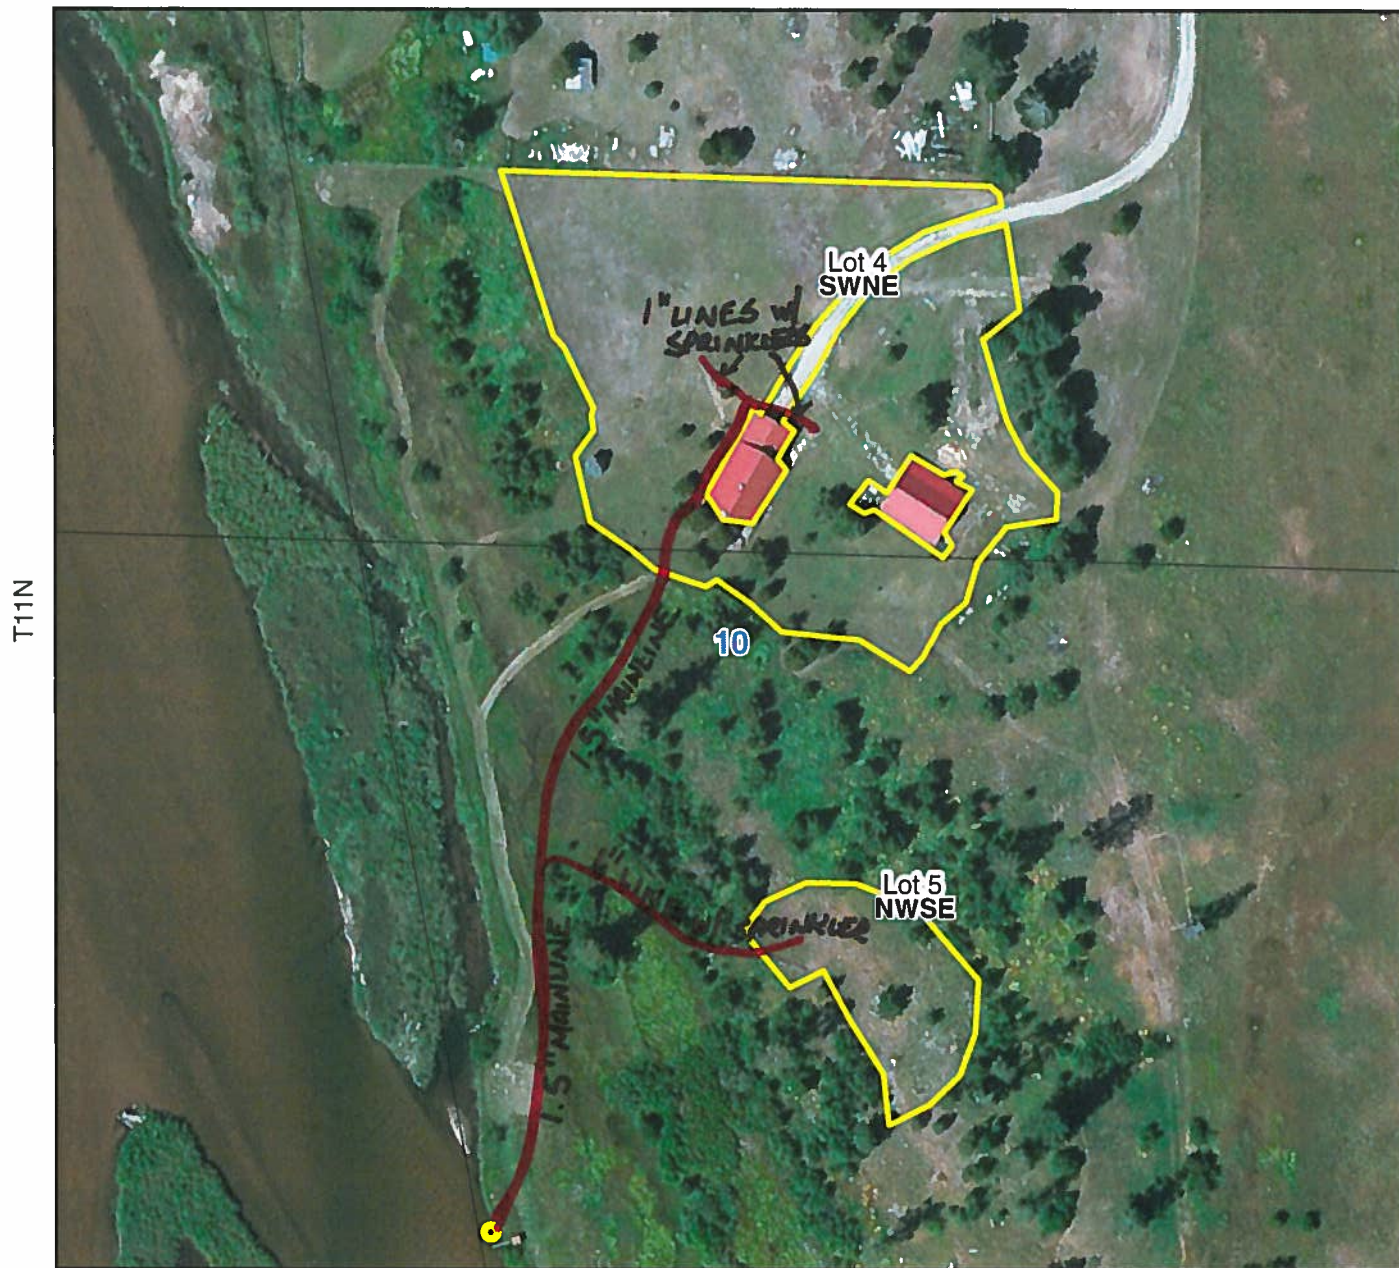
Bing (2011) Aerial Photo

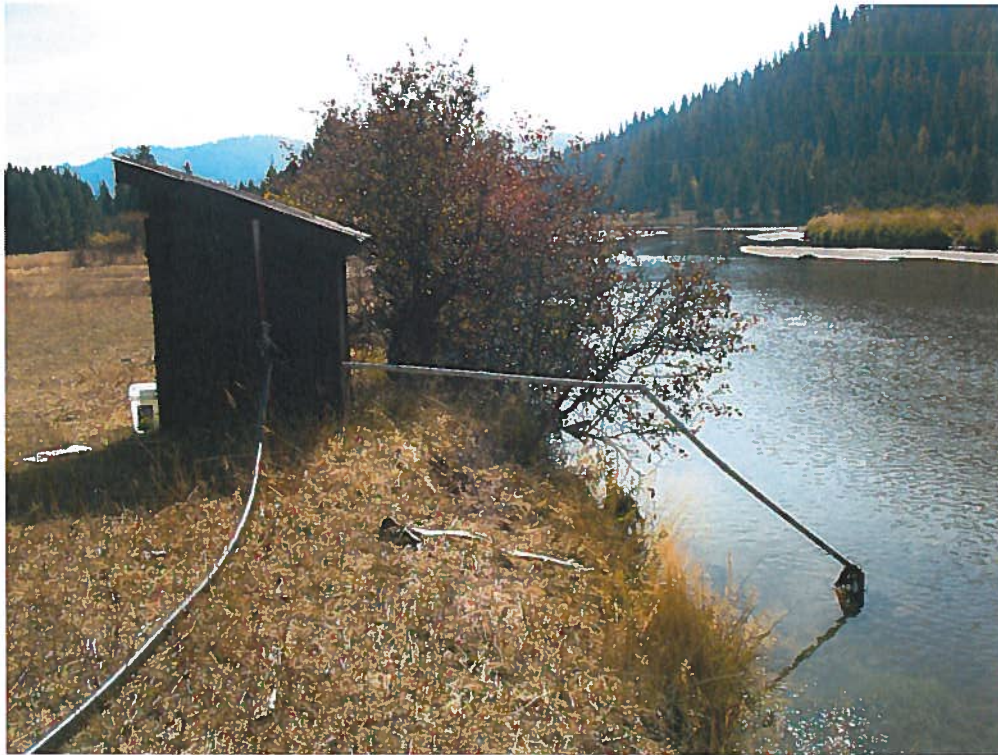
System consists of a 1 hp pump with a 1.5 in discharge line piped to a pump house (adjacent to river) piped to multiple (3) 1 in lines. The 1 in mainline "Ts" next to the house into 2 lines to which sprinkler heads are attached for lawn irrigation around house. Near center of the 1.5" mainline (between the river and the house), a third 1 in line is connected to the system.

**65-13914 Exam 10/9/2012:** P/D pump house and 1.5 in discharge line facing south.

Permit conditioned that a lockable controlling works is to be maintained on the diverting works. No lockable device is currently in place on the diversion itself. However, the pump has a dedicated power source at which point the diversion could be regulated should it become necessary. Mr. Nuzzo has discussed the rental pool with the watermaster and is aware of the procedures. Mr. Nuzzo stated he reports his diversions each year to the watermaster and pays to rent water from the rental pool for his diversion. Department Water Right Accounting data confirms Mr. Nuzzo's statement.

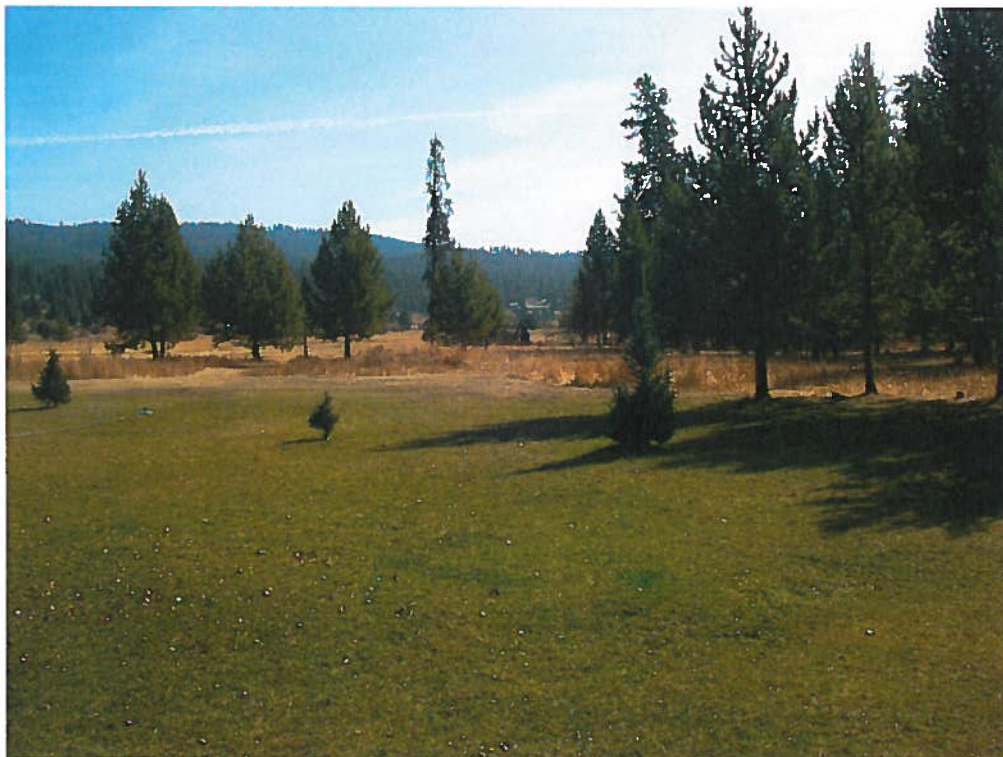
The lawn around the house is irrigated with 2 Gilmour oscillating sprinklers with 3/16 in nozzles. Typically Mr. Nuzzo irrigates the lawn from June or July through September. In August each year the owner uses the 3<sup>rd</sup> 1 in line (with

**65-13914 Exam 10/9/2012:** P/U facing south/southeast. Portion of lawn around house with sprinkler on left side of photo.
