**From:** Raymond, Kade  
**Sent:** Thursday, September 27, 2012 2:56 PM  
**To:** Saxton, Craig  
**Subject:** Banks Measuring Device  
**Attachments:** pics 041.jpg; pics 042.jpg

29-7391: Verification of Installed Measuring Device

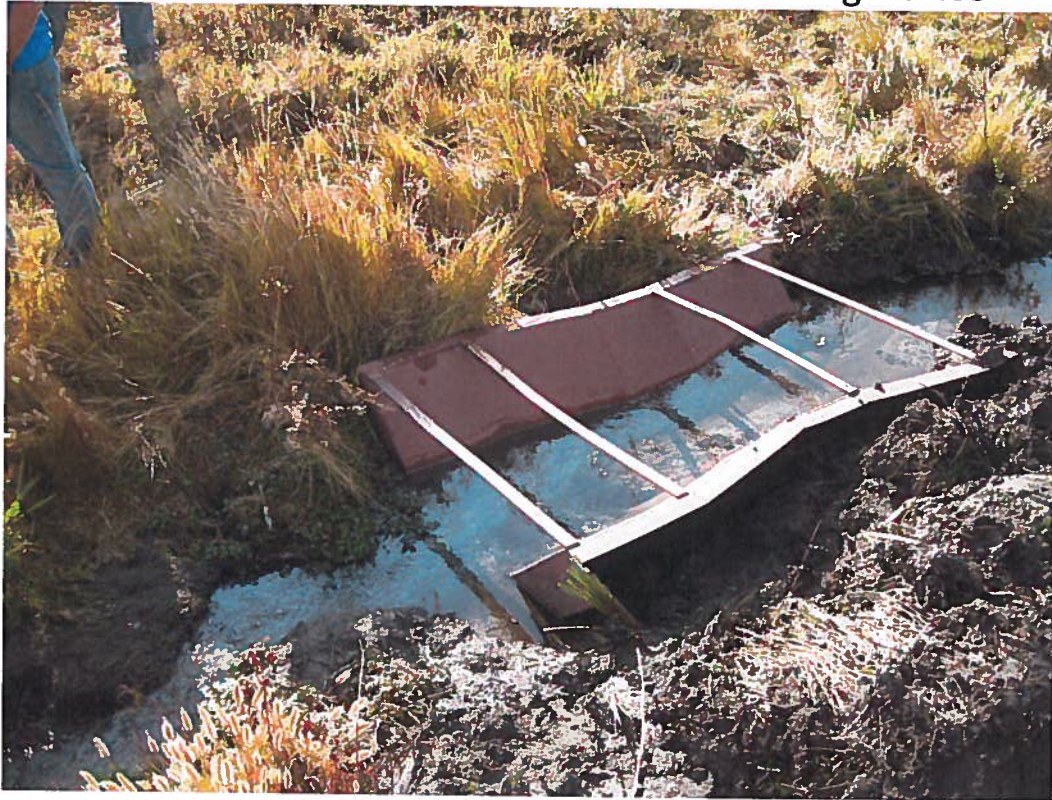
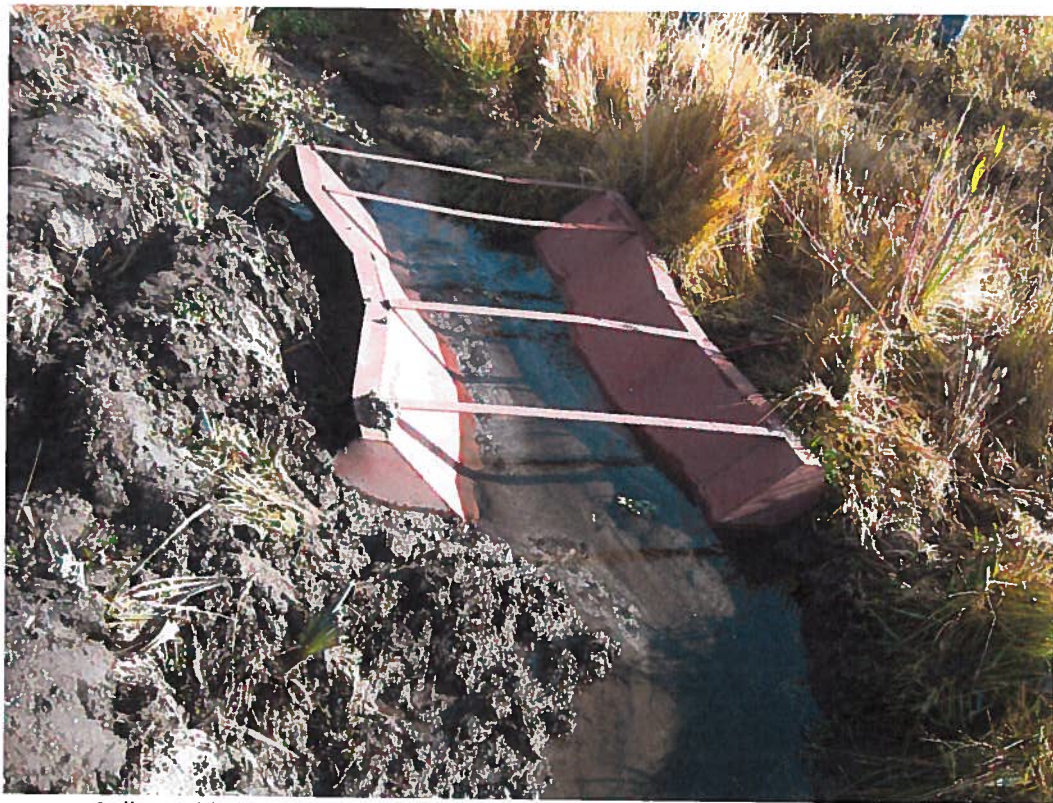
Me and Blake went out today and checked to make sure that Banks have their measuring device in. I have attached a few pictures that show the measuring device that was recently installed. It appears that the channel could supply 2.9 cfs when it is cleaned out; however we did not observe 2.9cfs moving through there today. David said that in the spring it flows quite a bit more and when cleaned out there would definitely be more water there. I hope this is what you needed. Please let me know if you have any further questions.
