## IDAHO DEPARTMENT OF WATER RESOURCES

### WELL INSPECTION FORM

1. DRILLING PERMIT NO: NONE OTHER APPLICABLE NO: 47-08147
2. OWNER: MARILYN and DEALYN BAKER Phone: (208) 734-1845  
Address: 3169 E 3500 N, TWIN FALLS, Idaho 83301

3. WELL LOCATION: Twp 11S, Rge. 17E, Sec. 02, SW 1/4 NE 1/4  
County TWIN FALLS (Provide sketch map and photo on reverse.)
4. DRILLER: UNKNOWN Lic. No. UNKNOWN  
When Drilled? UNKNOWN

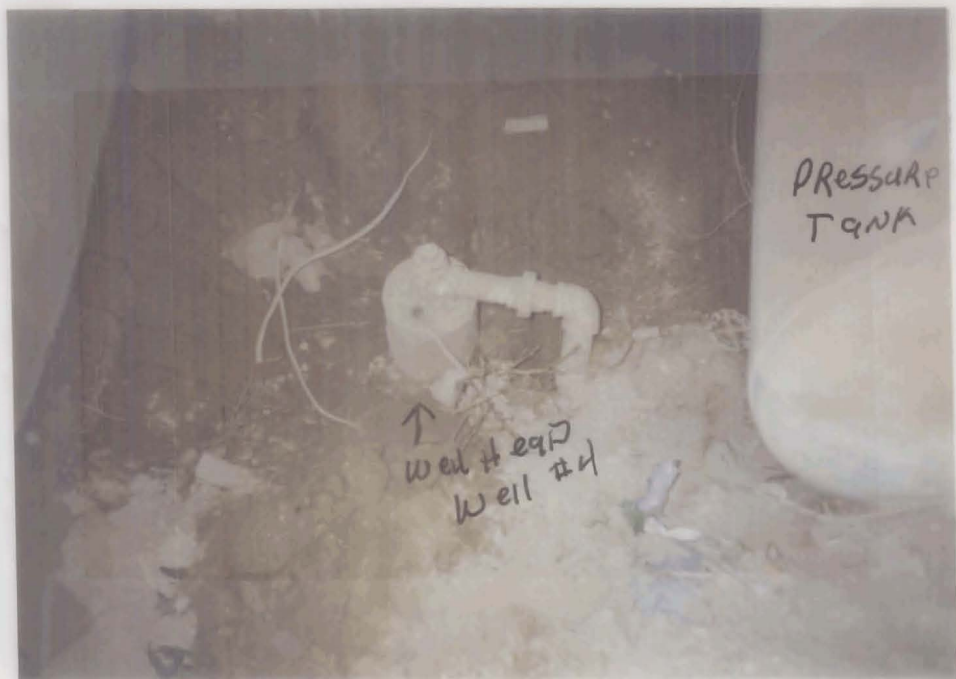
This is the well head for  
Well #4. It is not presently  
connected to power.

The pressure tank seemed to  
have water in it. I could not  
tell for sure, it was sealed.

9. REMARKS: MY MAIN CONCERN IS THAT THIS WELL IS NO LONGER  
CONNECTED TO A POWER SUPPLY YET THE ADJOINING  
PRESSURE TANK SEEMS TO BE FILLED WITH WATER.  
THIS WELL IS CONNECTED TO ~~THE~~ 3 OTHER WELLS.  
I AM CONCERNED THAT WATER FROM THE OTHER WELLS IS  
FILLING THE PRESSURE TANK WHICH COULD RELEASE  
WATER BACK DOWN THE WELL.
