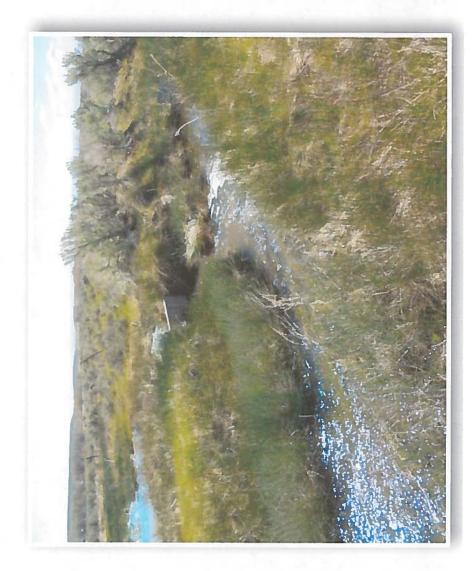
Some ponding in the area is due to the high-water table. Water in your figure 4 is used to sub-irrigate the 65 acres to the South.
