## FIELD EXAMINATION OF PRBA WATER RIGHT CLAIM

**Claim Identification Number:** 87-4181

**Examination Location:** 17873 Coyote Grade, Genesee, ID

**Purpose of Visit:** Determine if source diverted is spring or groundwater

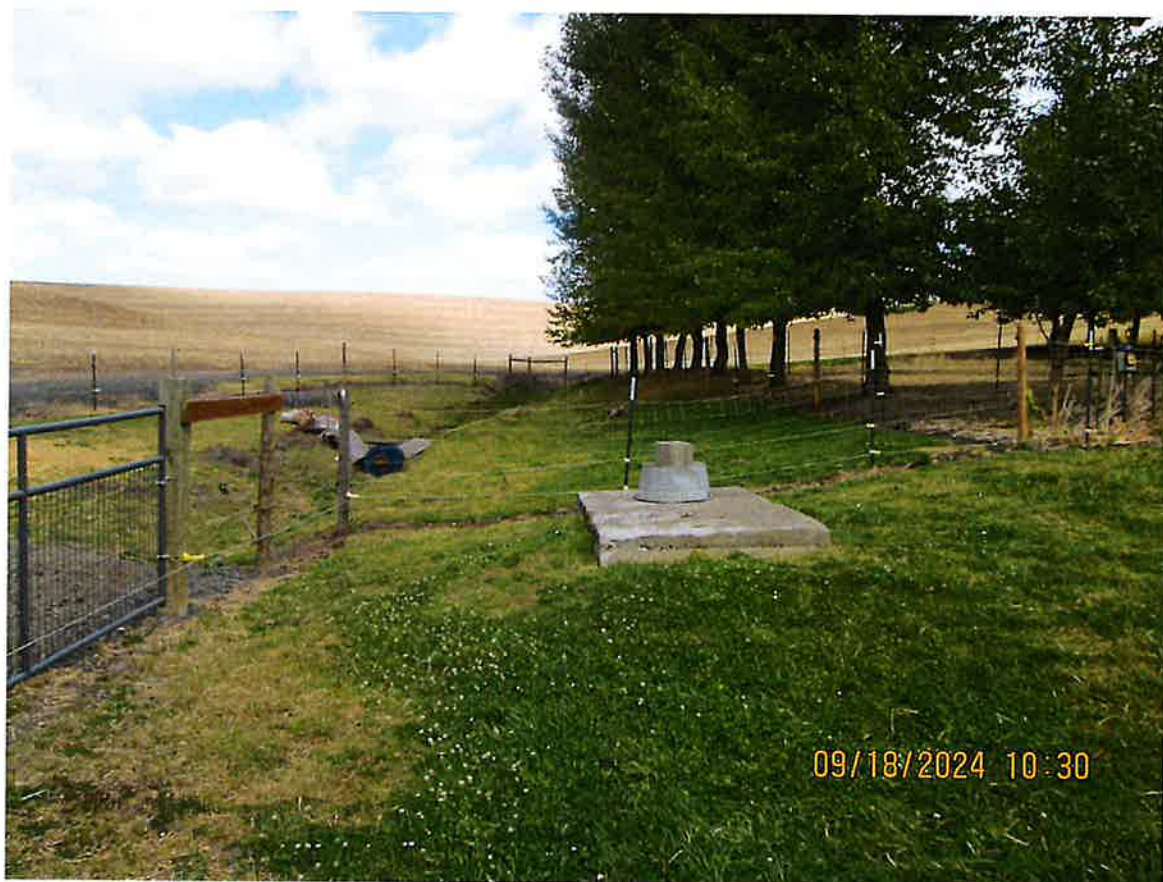
The diversion works observed consist of a large rectangular concrete cistern buried in the ground, with a porous or open floor that allows water to percolate into it from below. The access port on the top of the cistern is approximately 2 ft. in diameter, and is covered with a metal wash tub and a cinder block over top to weight it down (Picture 1). The depth to water within the cistern was measured at 2.3 ft. below ground surface, with an approximate total depth measured at 5.2 ft. below ground surface (Pictures 2 & 3). Water line staining was observed on the internal walls of the cistern, indicating a potential high-water mark of 4-5 in. above its current level. The water in the cistern was observed to be clear, with some sediment settled on the bottom. From the cistern, water is pumped to stock tanks (Picture 5) and yard irrigation via portable submersible sump pump (Picture 4).

A small depression/channel was observed running past the cistern, approximately 5-10 yards from away, but it was dry and vegetated with grass. Mr. Thomason stated that it

rarely ever has water in it, and only from surface runoff. The vegetation surrounding the concrete cistern consists primarily of domestic variety grasses and clover, and is consistent with that of the surrounding area. Mr. Thomason explained that the row of trees nearby were planted in past 10 years, and also that some fruit trees present on the property were planted by the previous owner. No vegetation was observed that would commonly be found in the vicinity of riparian or heavily saturated areas. There are no formed channels, rills, or any other indicators of water expression to the surface at the POD's location. However, the groundwater table in this vicinity has historically been very shallow as Mr. Thomason described his experience in the past of water slowly seeping into the bottom of a shallow trench he had dug to replace a water line.

1) Concrete cistern and surrounding area

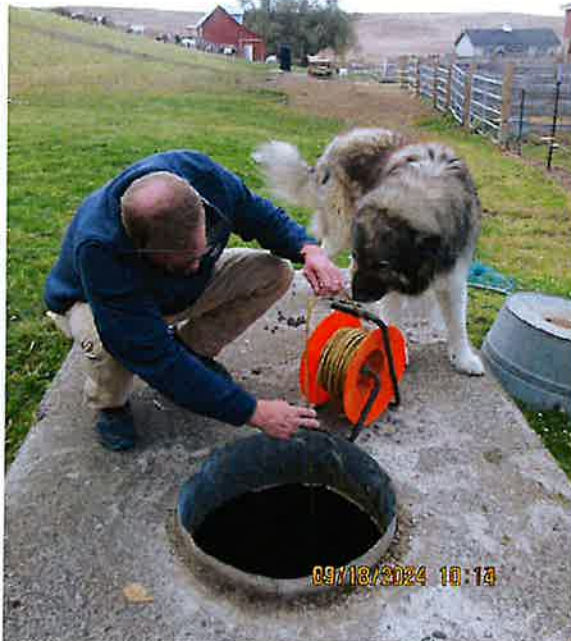
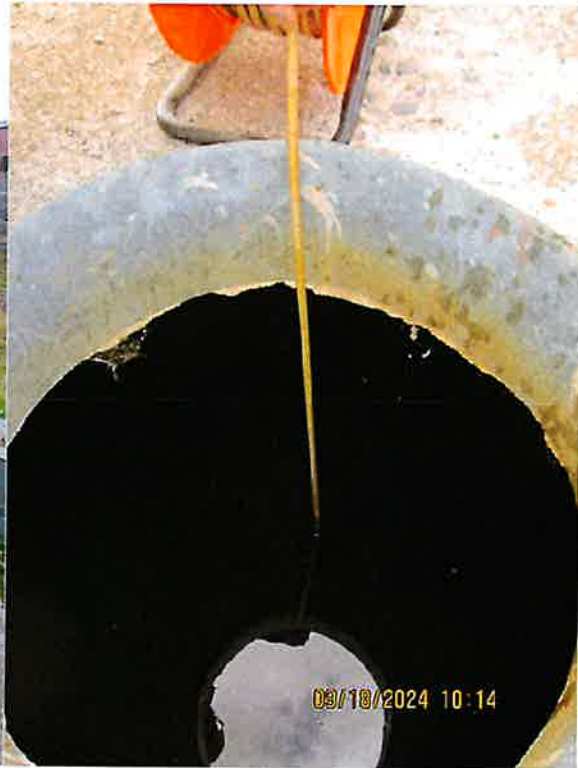
As the water within the cistern has a static level approximately 2 ft. below ground surface, and is withdrawn from below that point, it can be concluded that the water source for this claim is best described as groundwater. IDWR hydrogeologist, Daniel Sturgis, concurred with this assessment and conclusion.

2 & 3) D. Sturgis measuring depth to water in cistern

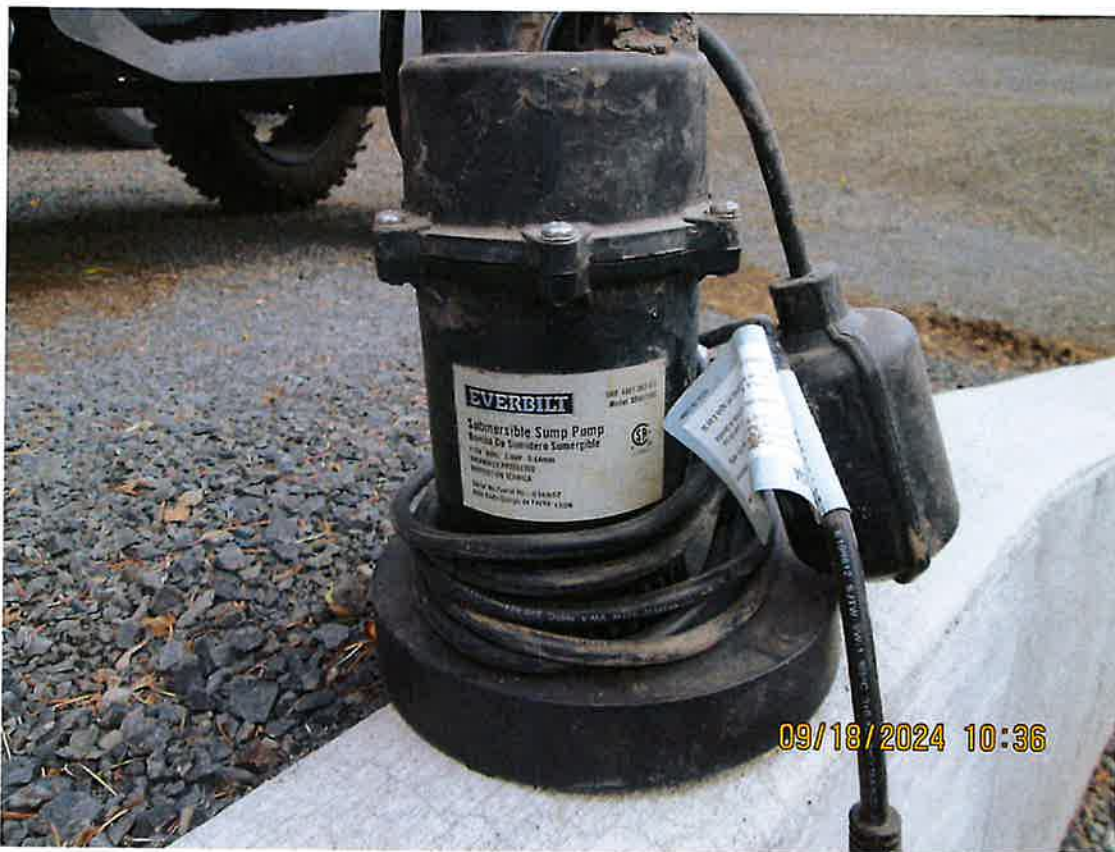
4) Everbilt SBA025BC portable submersible pump used to divert water to stock tanks

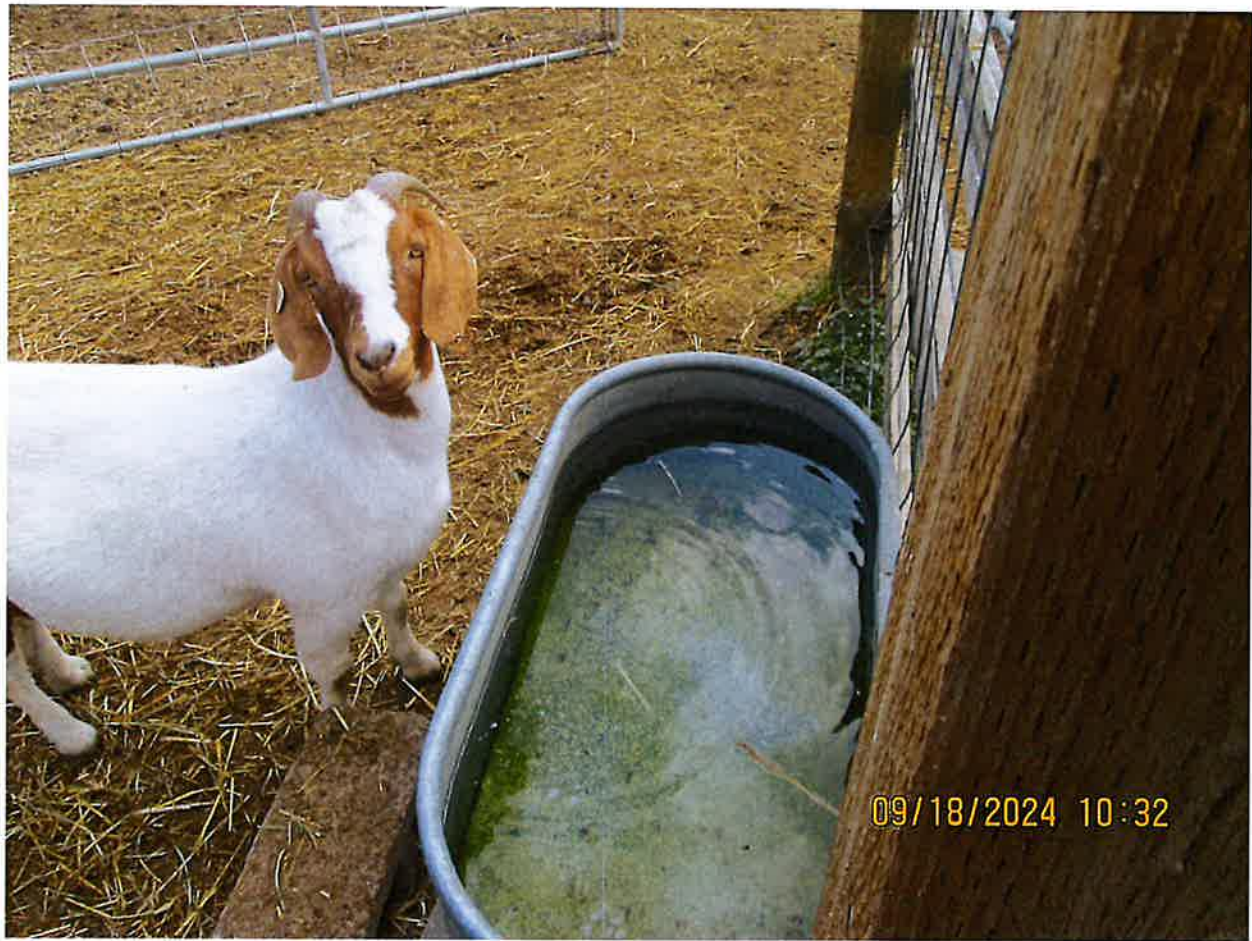
5) One of observed stock tanks watering livestock
