STATE OF IDAHO  
DEPARTMENT OF WATER RESOURCES  
**BENEFICIAL USE FIELD REPORT**

**Permit No:** 57-12009  
**Exam Date:** July 1, 2025

3. **SOURCE:**  
SPRING

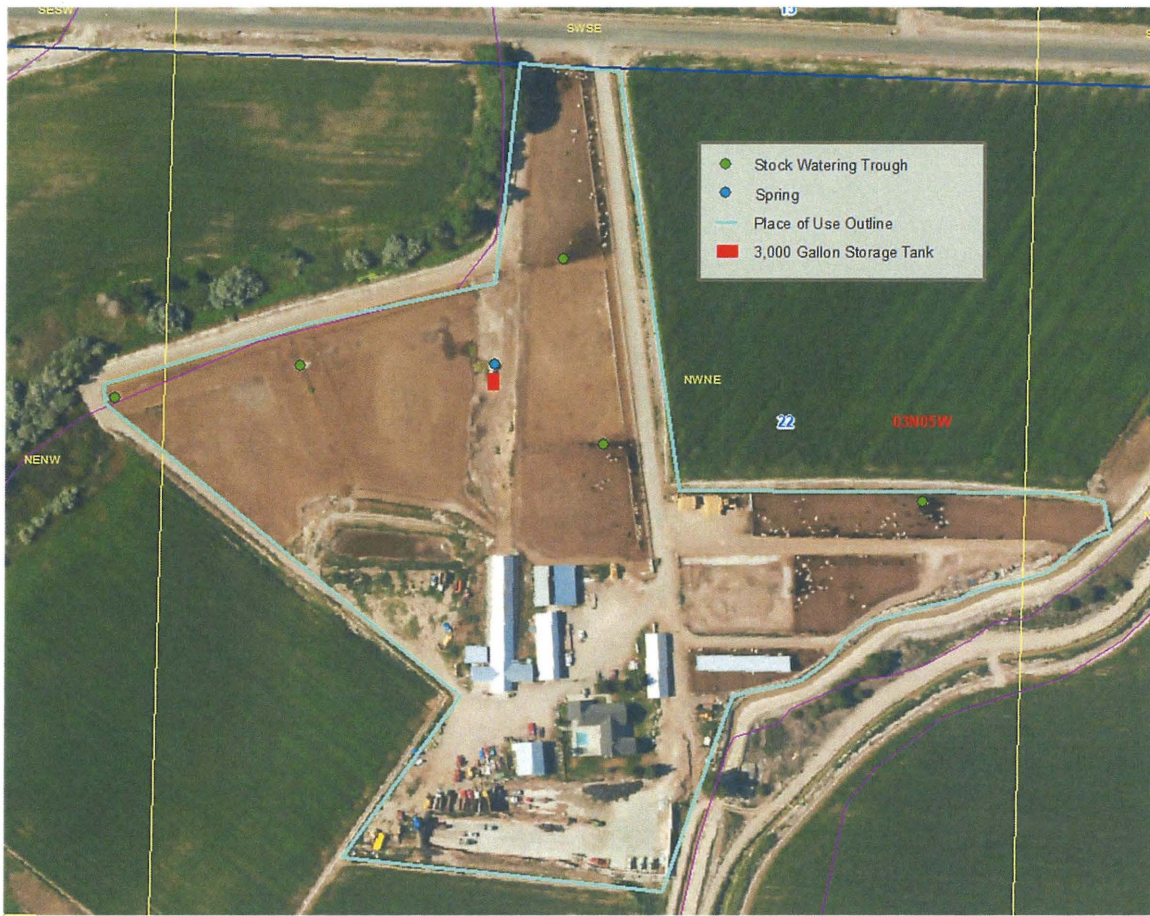
Figure 1 System diagram including the place of use outline, point of diversion (spring), storage tank location, and watering trough locations. Mainlines from source to troughs are unknown due to being subsurface.

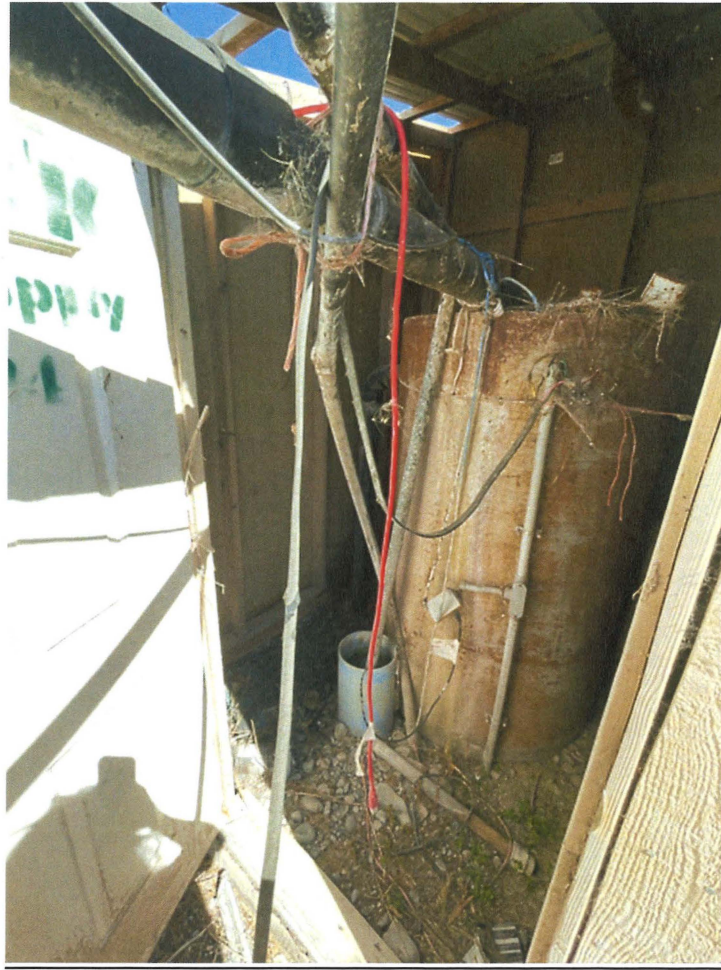
Figure 2 Point of diversion including power source for 5hp pump from spring and 1.25" pipe diverting water to storage tank.

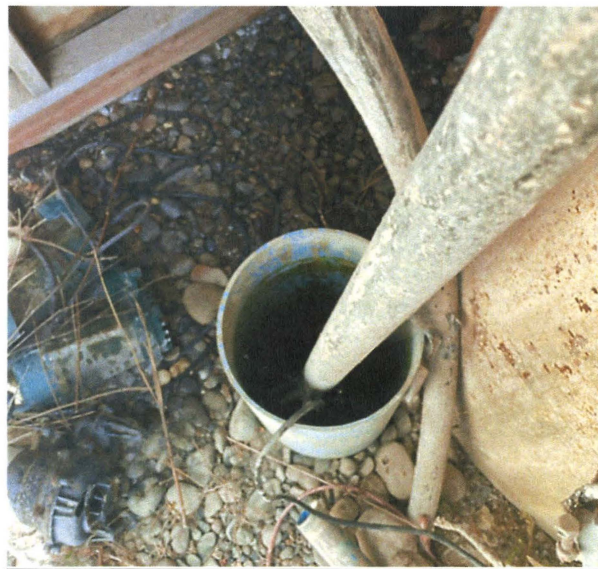
Figure 3, 1.25" pipe diverting water from 5hp pump upwards towards storage tank.

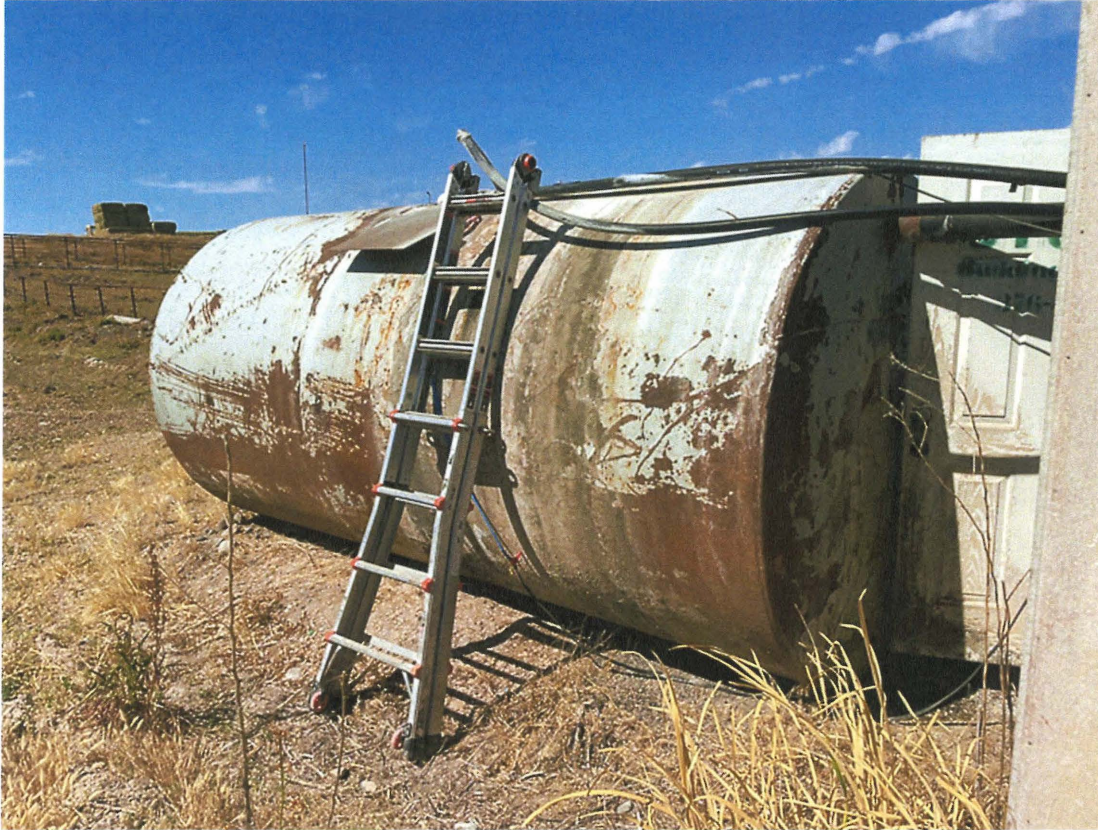
Figure 4 Storage tank with a 3,000 gallon capacity. The 1.25" water line is featured, running along the top of the tank where water is diverted to the tank.

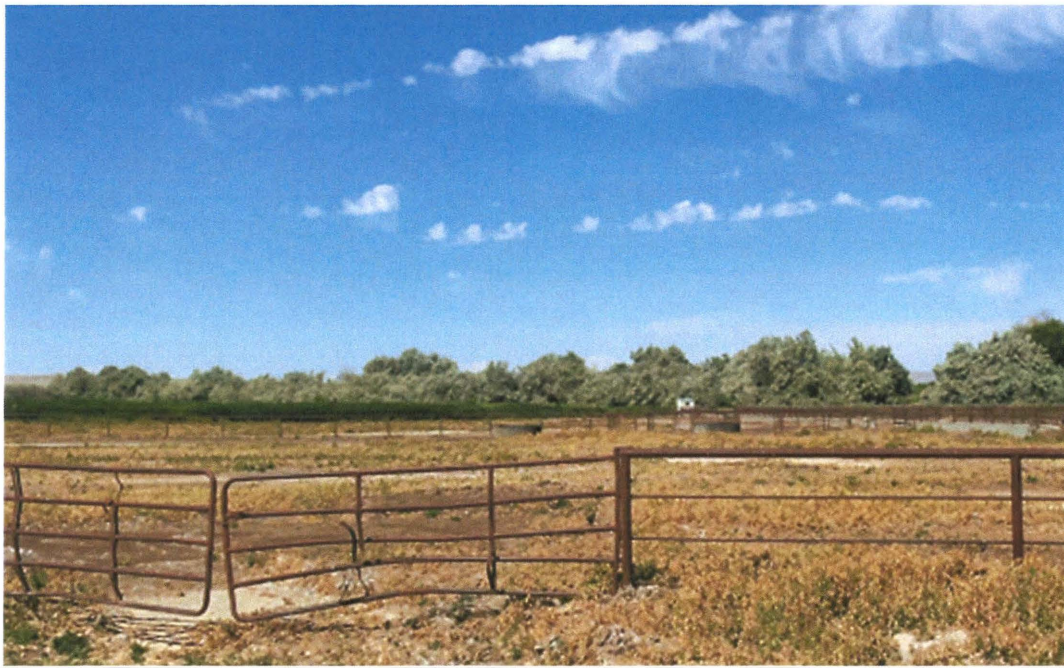
Figure 2 Place of use including two of the five watering troughs.
