**APPLICATIONS FOR PERMIT NOS. 67-15292 –  
67-15298, 67-15300 AND 67-15322 AND  
APPLICATION FOR TRANSFER NO. 82712  
IN THE NAME OF ECKHARDT FAMILY LLLP**

**Applications for Permit Nos. 67-15292 – 67-15298,  
67-15300 and 67-15322 and Application for Transfer No. 82712  
In the Name of Eckhardt Family LLLP**

DATE: April 20, 2018  
SUBJECT: Eckhardt Pond Nos. 9 and 11 Site Visit

DATE: May 31, 2018  
SUBJECT: Eckhardt Pond Nos. 1, 2, 3 and 4 Site Visit

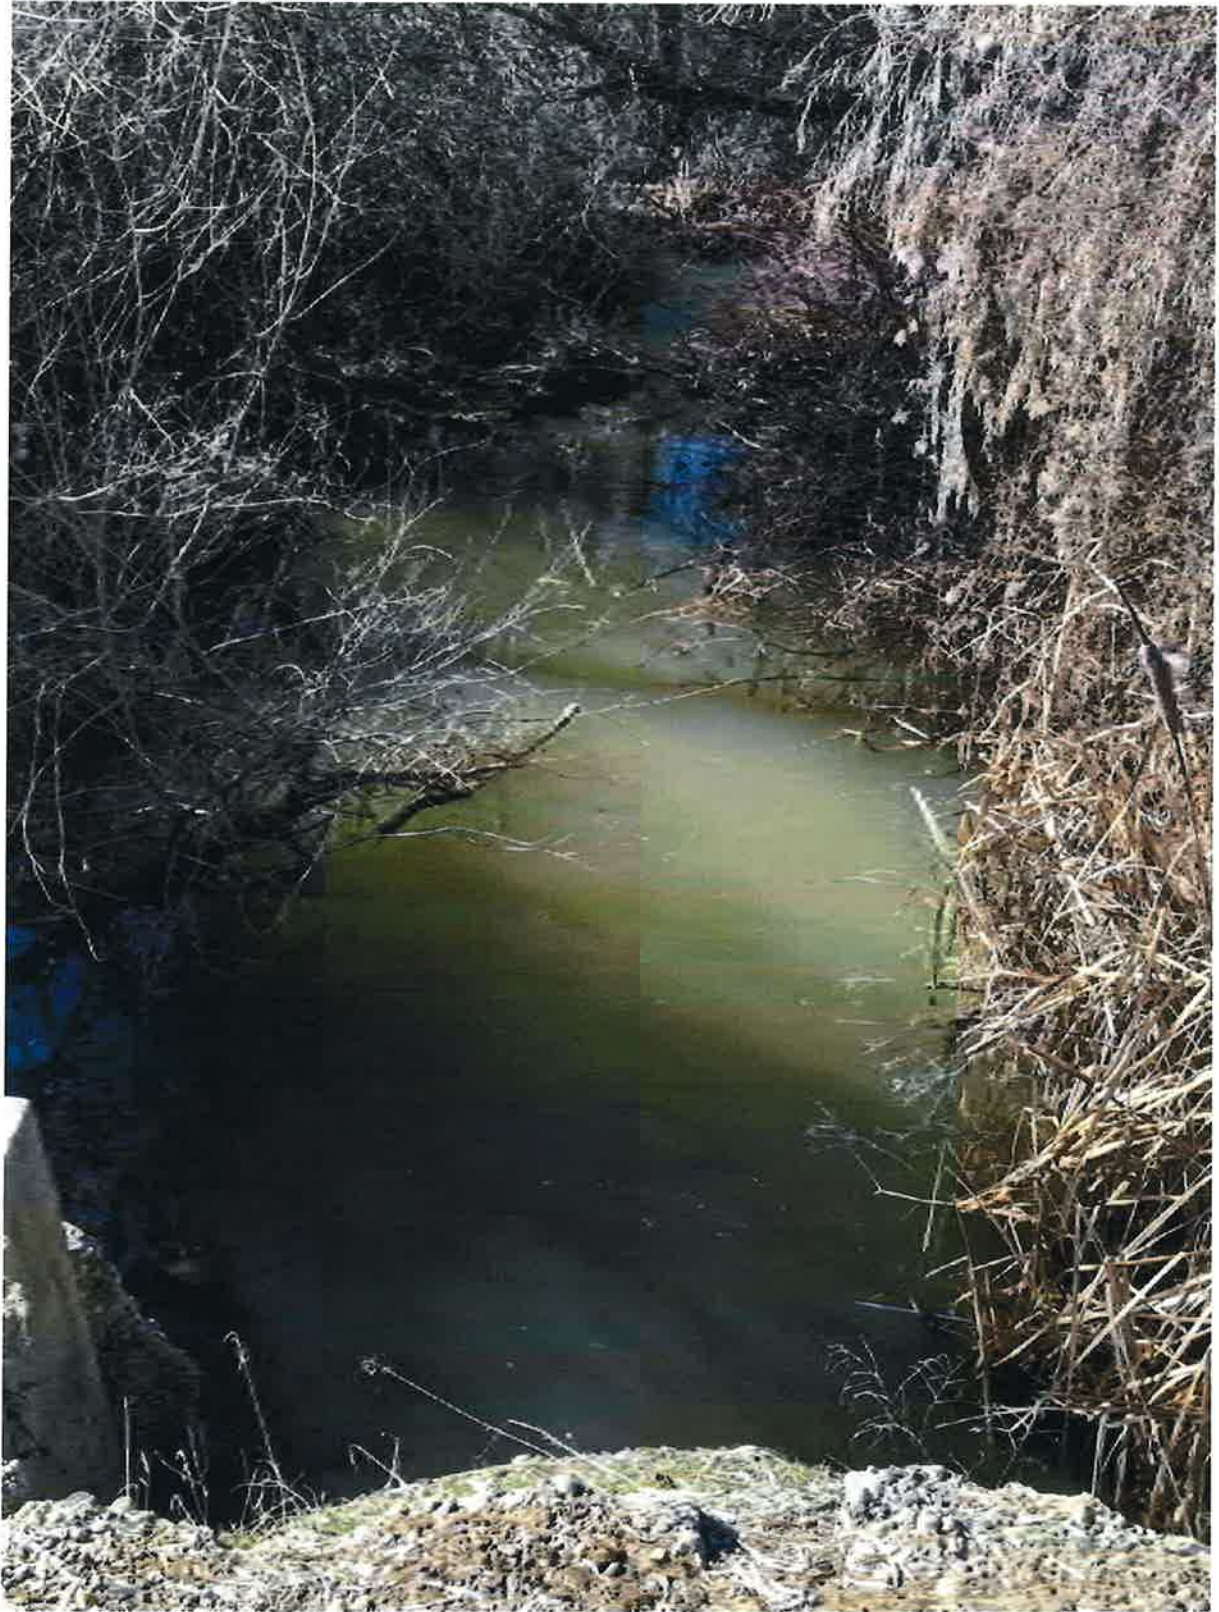
**Exhibit 9**

Jenkins Creek Road Crossing 3-11-2019
